Journal of Building Engineering

Analysis of structural integrity through the combination of non-destructive testing techniques in heritage inspections: The study case of San Segundo's hermitage (Ávila, Spain)

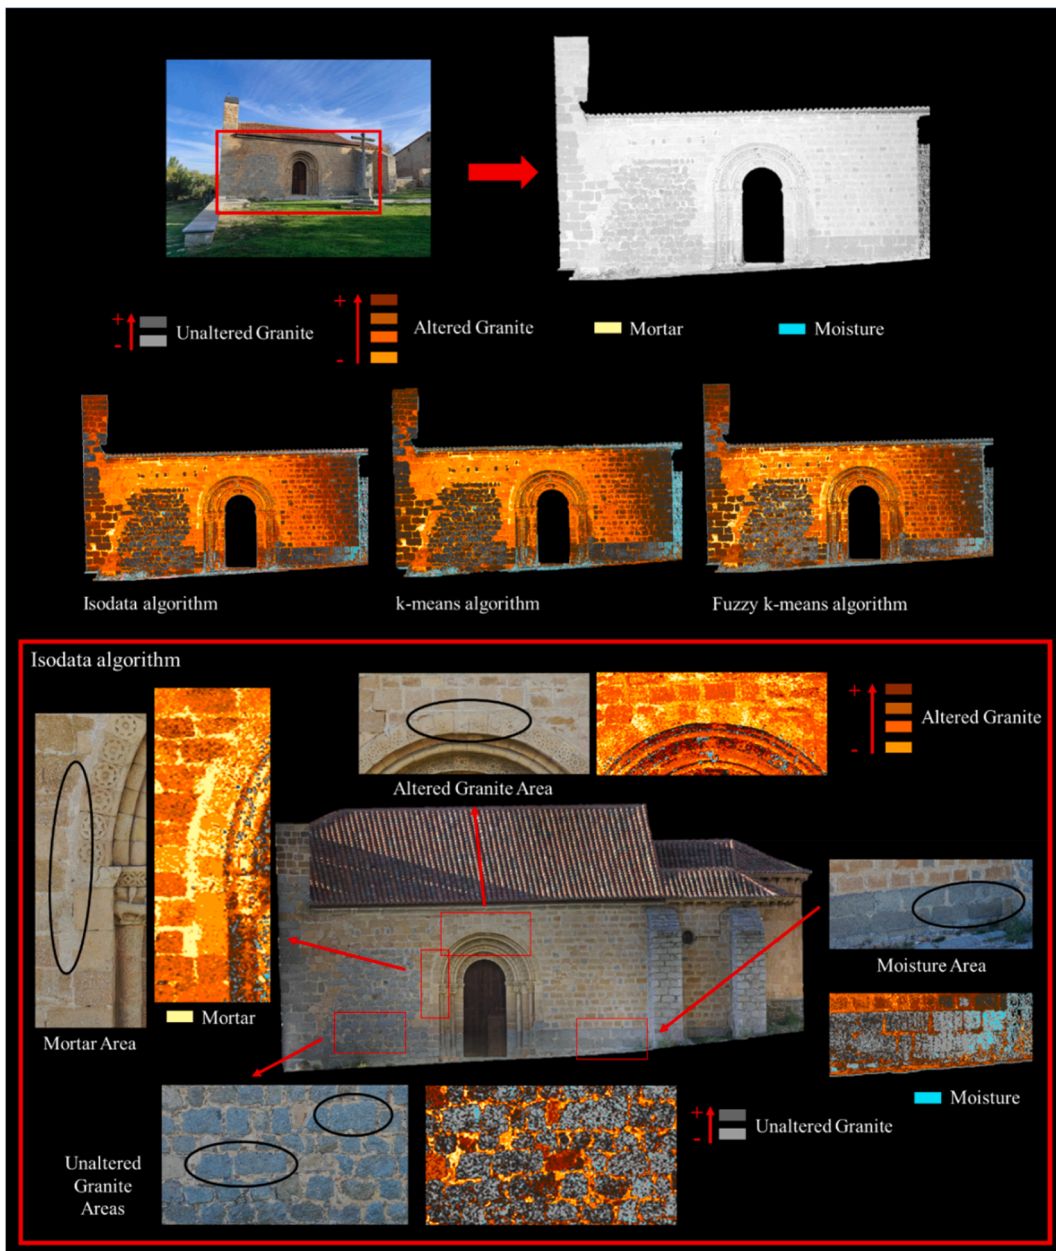
In the first case, the external wall of the south façade was analyzed. Fig. 9 shows the classification obtained in the identified classes, which are: unaltered granite (in two levels, without deposits and without moisture evidence), altered granite (in four levels, with a high rate of erosion), lime/mortar remains and ashlar with high moisture content.

Fig. 9. Results of the unsupervised classification for each of the algorithms applied in the external wall of the south façade. \pm signals of the scale refer to the level of alteration in each granite typology.

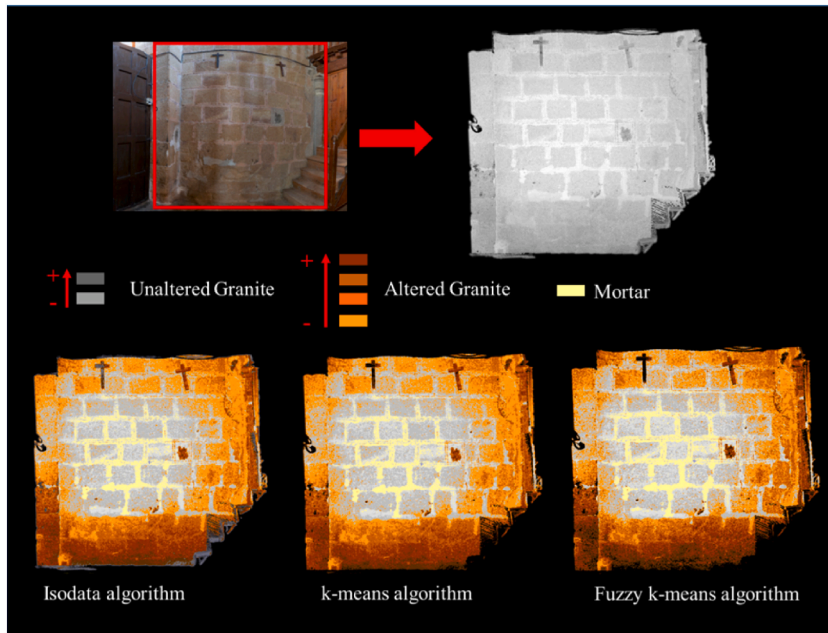
In the second case, the wall of the south façade was analyzed from the inside. Fig. 10 shows the classification obtained in the identified classes, which are: unaltered granite (in two levels, without deposits or without moisture evidence), altered granite (in four levels, with a high rate of erosion) and lime/mortar remains.

Fig. 10. Results of the unsupervised classification for each of the algorithms in the internal wall of the south façade. \pm signals of the scale refer to the level of alteration in each granite typology.

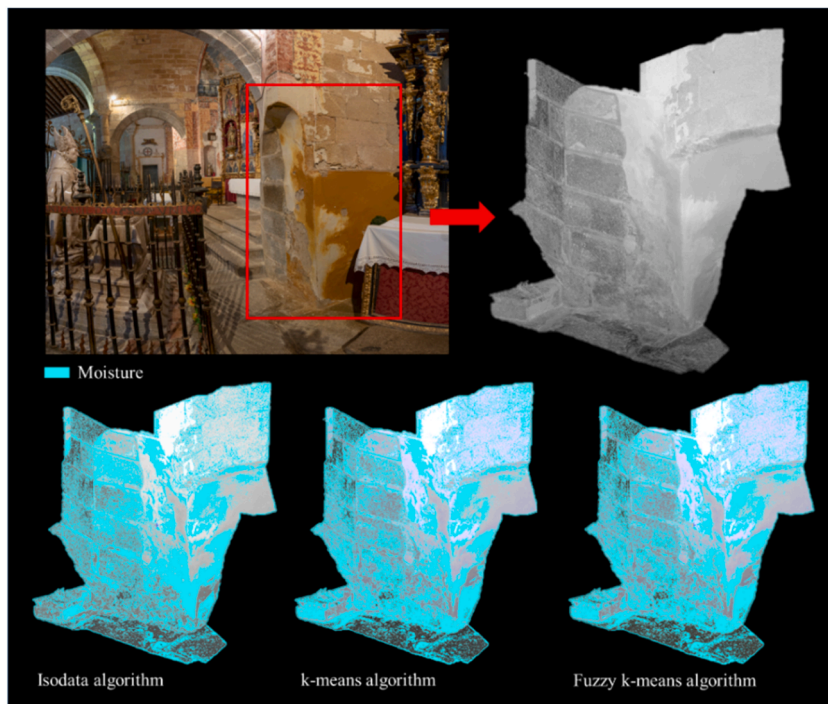
And finally, in the third case, the side wall of the altar was considered for its analysis. In Fig. 11 it is possible to observe the classification obtained from the humidity of the wall and the damage it causes.

Fig. 11. Results of the unsupervised classification for each of the algorithms in the side wall of the altar.

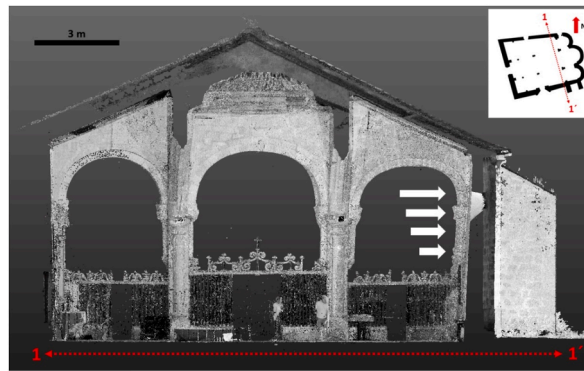
and quick inspection can be made to locate critical or damaged areas in the assets. In the case of the Church of San Segundo, the north-south cross section shows a great deformation in one of its arches (Fig. 12). This deformation is the result of a north-south lateral thrust of the main nave on the south façade. With the objective of minimizing this damage, two buttresses were built on the south façade. Given that these buttresses are made with a type of stone different from that used in the original construction, it may be concluded that they were added at a later time, although it is not exactly known when.

Fig. 12. North-south cross section of the church.

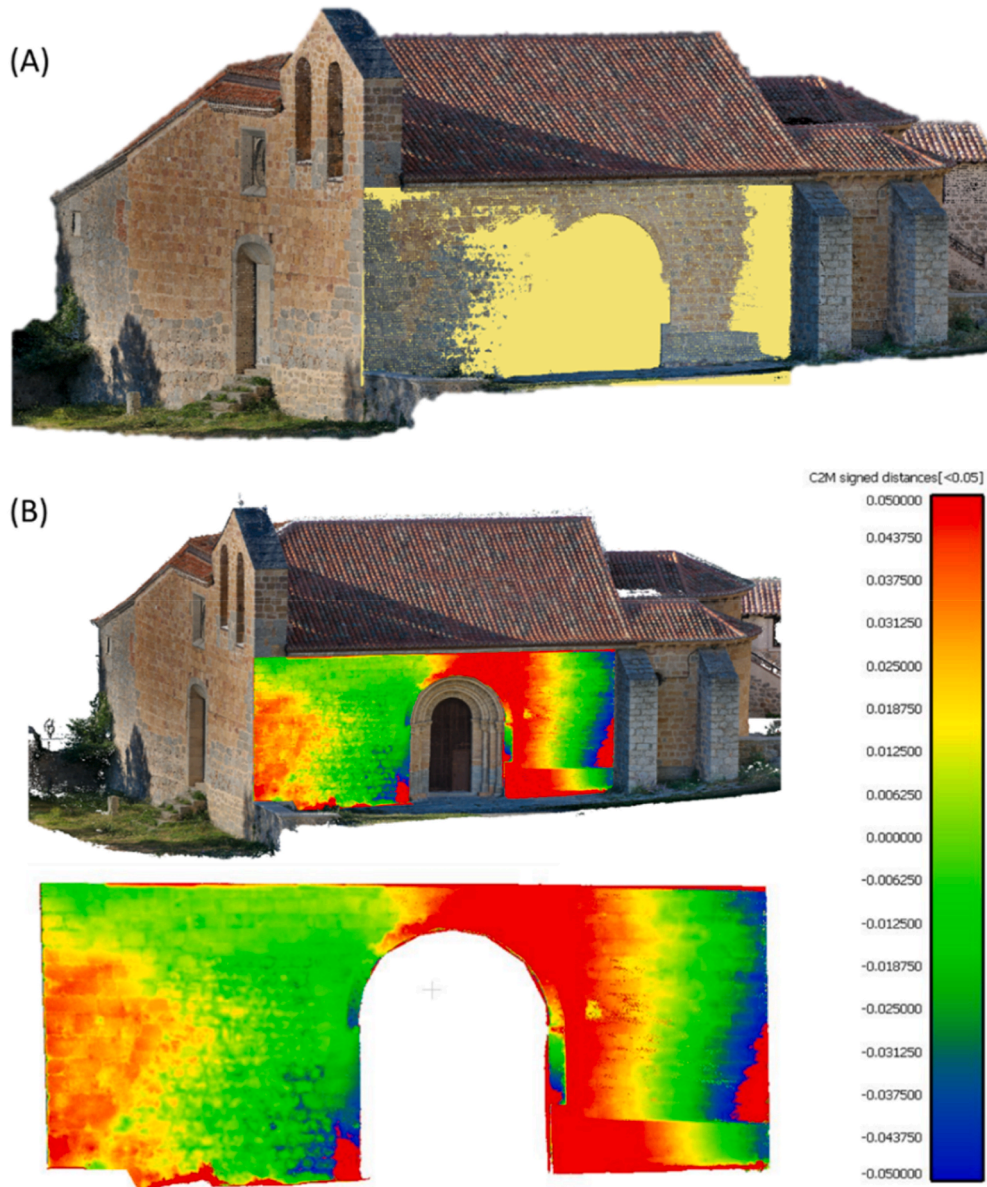
Furthermore, thanks to the point cloud it is possible to locate other types of deformations or collapses in the walls, comparing the morphological discrepancies between the scanned model (which would be a reliable reflection of the current state of the heritage asset) and a theoretical model (that is, a wall without deformations). Through this comparison, maps can be extracted for analyzing flatness, slopes, structural deformations, collapses, etc. This kind of analysis applied to the south façade of the building here considered can be seen in Fig. 13, in which chromatic patterns applied to the point clouds have allowed the detection of the façade deformations. For this, the theoretical plane that best fits the point cloud of the wall has been developed for subsequently define the difference in distance between the plane and the point cloud (Fig. 13) through the use of the “Compute cloud/mesh distance” tool, in CloudCompare software [66]. This is the plane that best fits the position of an even mesh of points on the façade.

Fig. 13. (a) Plan that best fits the wall of the south façade. (b) Image of façade flatness analysis.

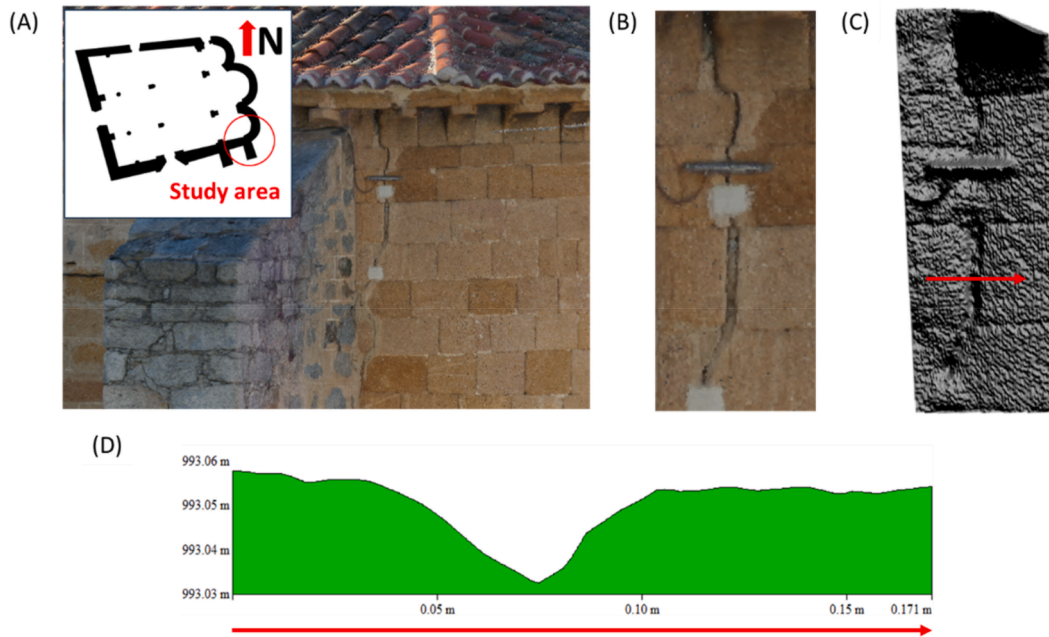
On the other hand, as already mentioned, deformations can cause other types of pathologies such as cracks. Fig. 14 shows how through the cloud of points it is possible to analyze the cracks, being able to evaluate their shape and size, which also will contribute to define their origin.

Fig. 14. Crack located in the south apse. (A) 3D point cloud image where the crack can be seen. (B) Detail image of the crack in the 3D point cloud. (C) Elevation grid model of the crack and its surroundings, along with the location where the section was made. (D) Cross section of the crack.

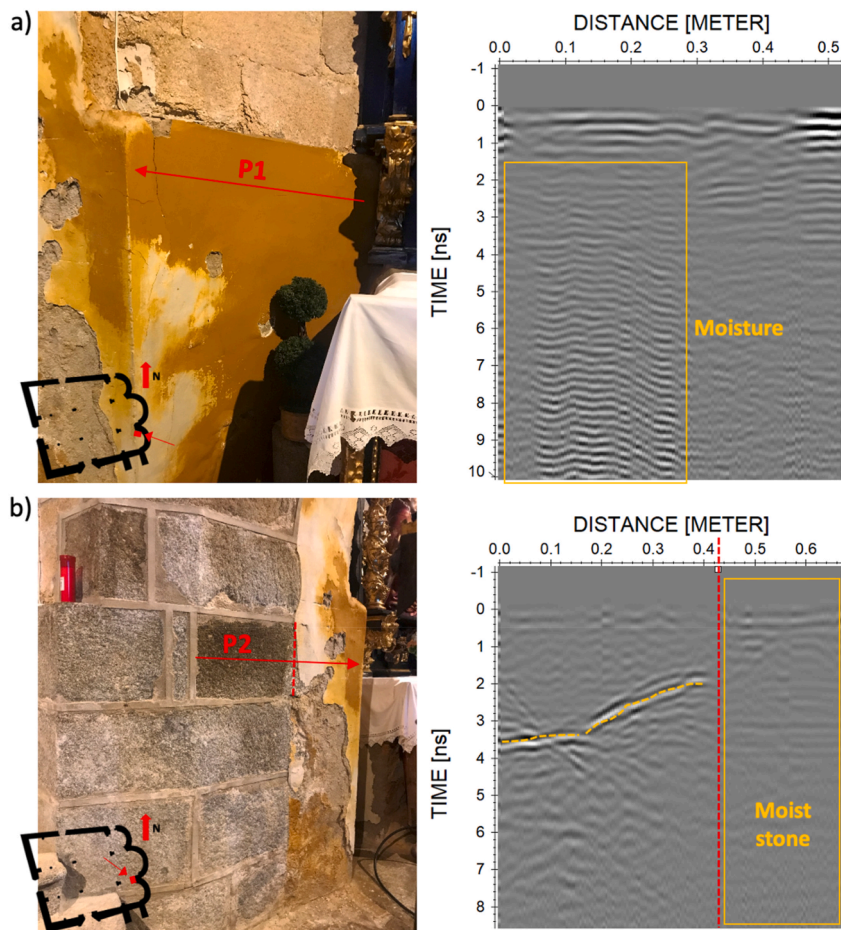
Fig. 15 presents the results obtained from the GPR survey aimed to detect moisture in the side wall of the altar (case 1 in Table 1). First, Fig. 15-a shows the 2.3 GHz data obtained at the lateral wall of the right nave of the altar. In this wall it is possible to observe detachments of the render painting, as well as stone disintegration. Observing the interpretation of the GPR data produced (profile line P1), moisture was identified in the form of parallel continuous reflections, like a reverberation, with higher amplitude values (from 3 ns to the end of the radargram in the time axis). It is more certainly indicating the presence of moisture accumulated in the interior of the stonework, giving higher dielectric contrast between media (stone and water). On the other hand, Fig. 15-b displays the 2.3 GHz data obtained at the front wall separating the main and right naves of the altar. As seen in the picture, there are two different types of stone in this sector (red dashed line). Observing the signal behavior through the stone at the left, or main nave of the altar, it is possible to detect the interface between consecutive blocks (orange dashed line). However, the situation is much different in the stone at the right, or the right nave which was built later, showing critical disintegration. For this case, the GPR signal shows severe attenuation and losses of information due to the presence of salts from the demineralization of the stone. In this sector, water would have dissolved the internal salts of the stone, dragging and depositing them on the surface (spots typically known as efflorescence). The stone has therefore lost internal consistency because it has been demineralized, leaving an external protective mineral layer. When this mineral layer disappears (e.g., through cleaning interventions), the stone is completely exposed to disintegration.

Fig. 15. 2.3 GHz data produced in the side wall of the altar: a) lateral wall, and b) front wall. Moist areas are highlighted into orange boxes, and the red dashed line in b) indicates the separation between apparently healthy stone and disintegrated stone. (For interpretation of the references to colour in this figure legend, the reader is referred to the Web version of this article.)

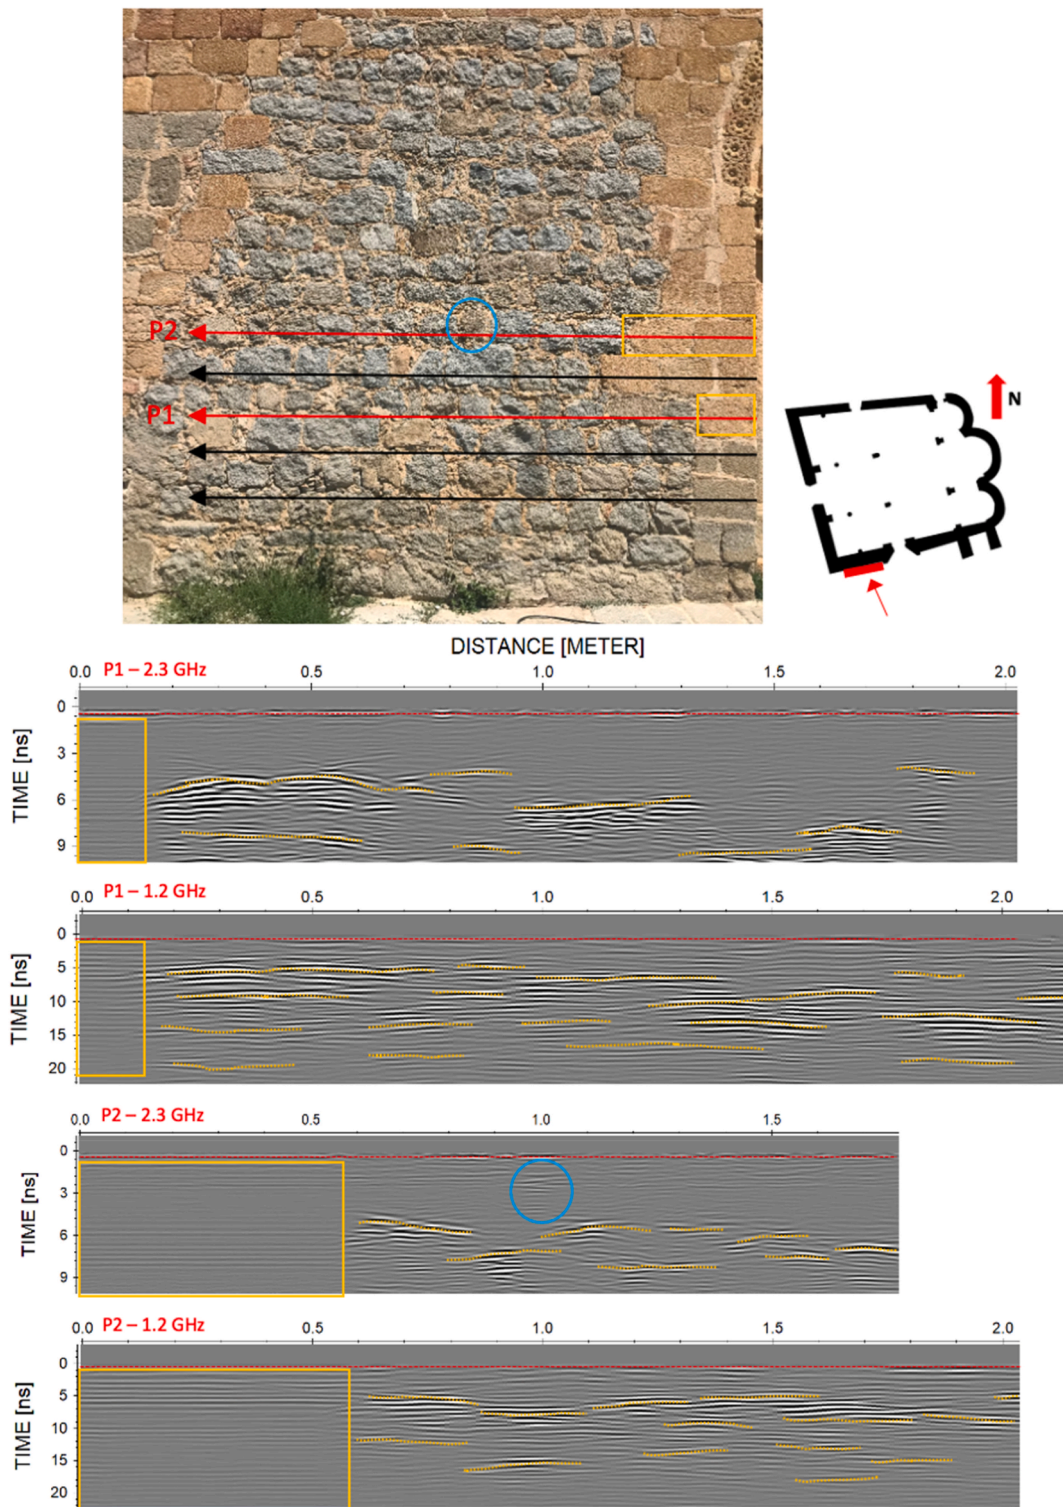
Fig. 16. 2.3 GHz and 1.2 GHz data produced for the characterization of the stonework materials in the external wall of the main façade. Moist areas are highlighted into orange boxes, while different ashlars (thicknesses) are marked with orange dashed line (the red line indicates the surface level), and rough stones are highlighted into a blue ellipse. (For interpretation of the references to colour in this figure legend, the reader is referred to the Web version of this article.)

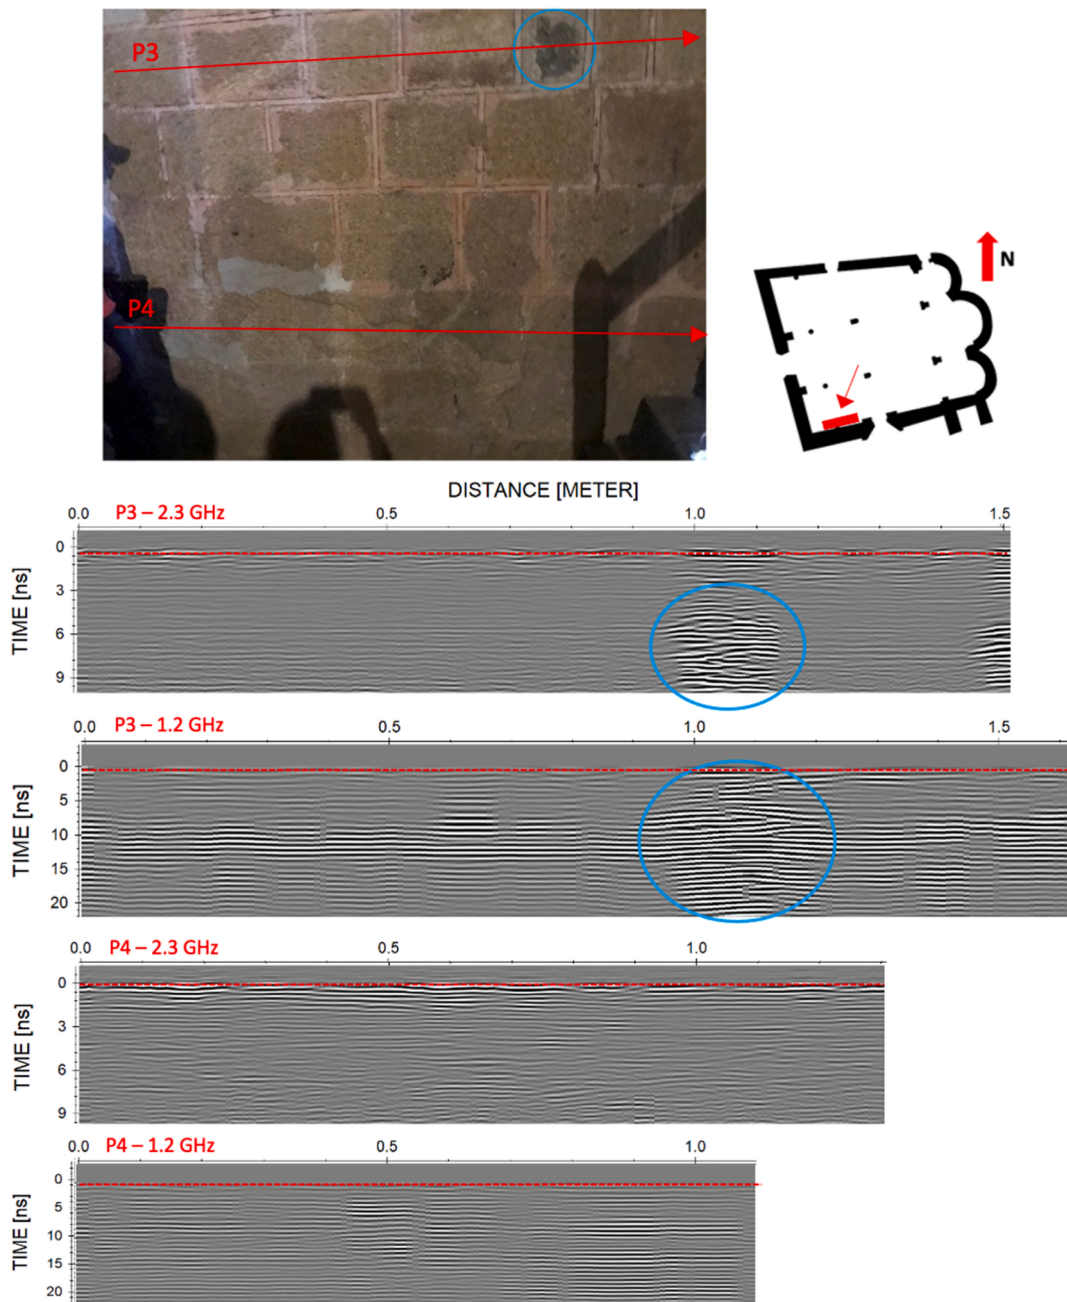
Fig. 17. 2.3 GHz and 1.2 GHz data produced for the characterization of the stonework materials in the internal wall of the main façade. The red line indicates the surface level, and the blue ellipses highlighted rough stones. (For interpretation of the references to colour in this figure legend, the reader is referred to the Web version of this article.)

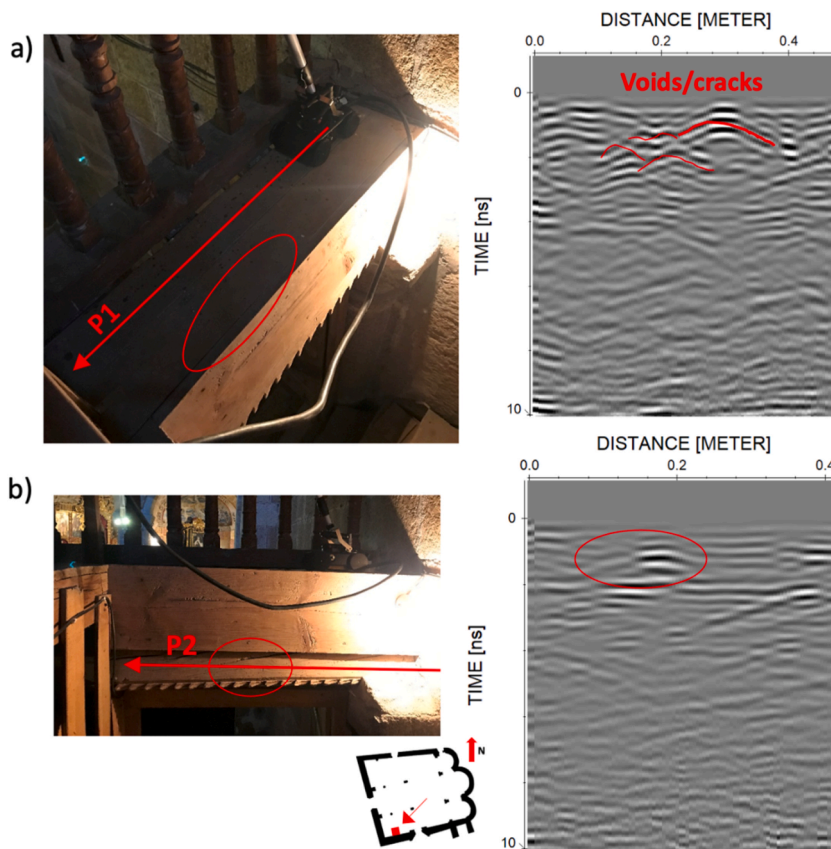
Fig. 18 shows the results obtained from the GPR survey carried out to detect inner defects in wooden beams (case 3 in Table 2). The 2.3 GHz data revealed the presence of cracks and voids, showing their typical reflection pattern in the form of small hyperbolas. However, the poorer resolution of the 1.2 GHz antenna was not enough to detect such features. Observing the interpretation of the radargrams produced in Fig. 18, the defects were detected to occur at the first 1 ns. Considering a velocity of propagation of the GPR signal into wood of about 13.5–17.4 cm/ns [67], it means a depth of about 6.7–8.7 cm.

Fig. 18. 2.3 GHz data produced in wooden beams showing the interpretation of voids and cracks (red lines/ellipses): a) superior face and b) lateral face of the beam. (For interpretation of the references to colour in this figure legend, the reader is referred to the Web version of this article.)

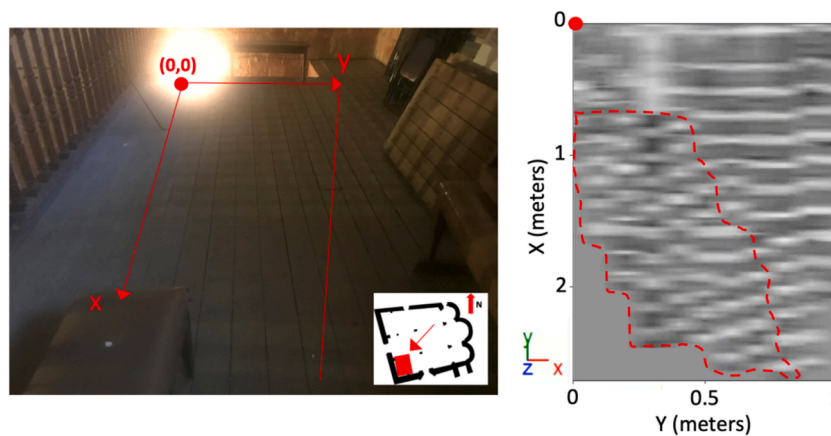
Fig. 19 presents the 3D time-slice (XY image) produced at 0.3 ns (approx. 2.0–2.5 cm deep) in the wooden floor. Observing the interpretation of the time-slice, it was possible to map a region of irregular reflection patterns (highlighted into a dashed red line),

instead of the linear beams identified in the rest of the image. As the media is homogeneous wood, this effect is most probably produced by a different wood condition, with different media permittivity due to moisture. It should be mentioned here that the length of the profile lines, in the X direction, was variable, and the grey areas means non data.

Fig. 19. 1.2 GHz 3D time-slice or XY image at 0.3 ns depth (2.0–2.5 cm considering a velocity of propagation of 13.5–17.4 cm/ns), showing the interpretation of a region with a different signal behavior (highlighted into a dashed red line). (For interpretation of the references to colour in this figure legend, the reader is referred to the Web version of this article.)

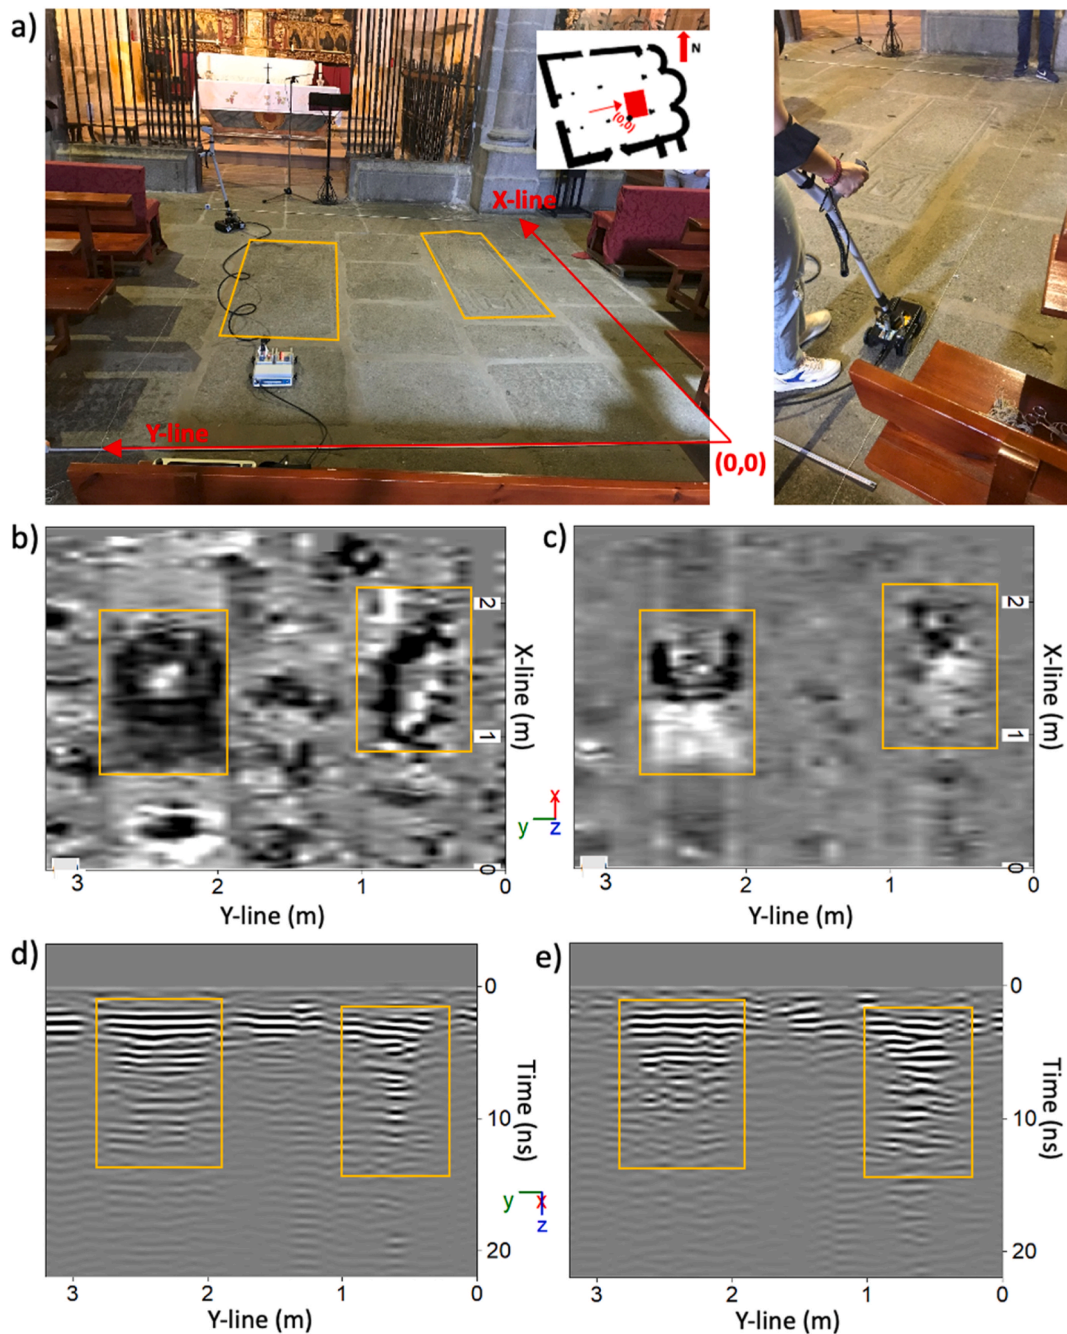
Fig. 20. 1.2 GHz 3D cube highlighting the presence of two hidden tombs (into orange boxes): a) GPR grid, b) time-slice or XY image at 3.6 ns depth (20 cm considering a velocity of propagation of 0.1 m/ns), c) time-slice or XY image at 6 ns depth (30 cm considering a velocity of propagation of 0.1 m/ns), d) YZ image in x-line at 1.4 m, and e) YZ image in x-line at 1.55 m. (For interpretation of the references to colour in this figure legend, the reader is referred to the Web version of this article.)

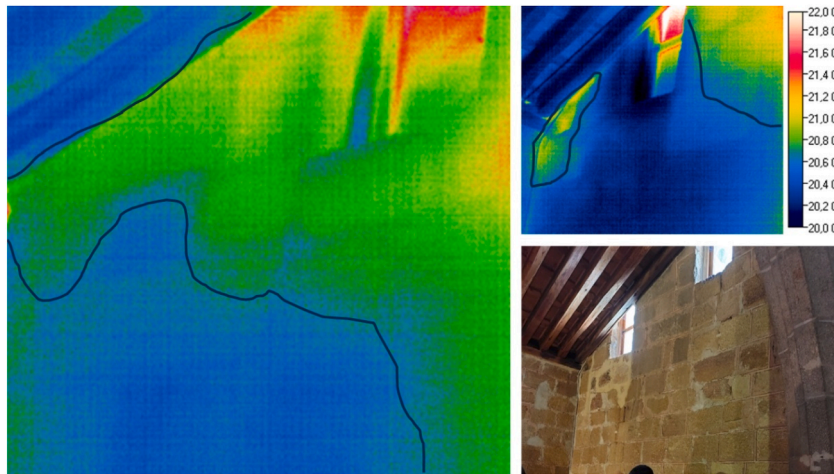
Fig. 21. Moisture detected in the internal surface of the main façade, due to the infiltration of water from the roof.

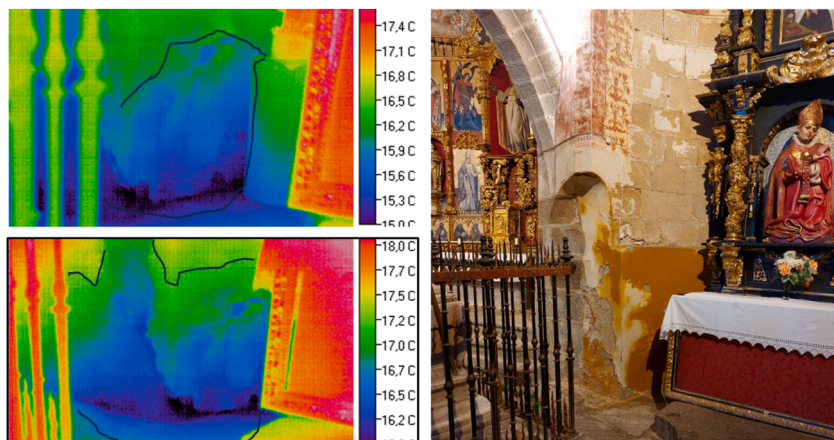
Another example of detection of moisture is shown in Fig. 22, in this case detected in the wall of the altar. The defect appears at a lower temperature than the healthy area, with a higher intensity towards the ground and decreasing with height. This is due to the

origins of the moisture that can be associated with capillarity. The different temperatures in the surroundings of the moisture area show that although the accumulation of water is not constant, it has had an effect on the material, provoking detachment and delamination at the surface.

Fig. 22. Delamination in the column of the altar. Damage visible for the human eye; the thermographic inspection allowed to determine that the cause is the entrance of humidity in the walls through capillarity (the temperature increases from the floor upwards).

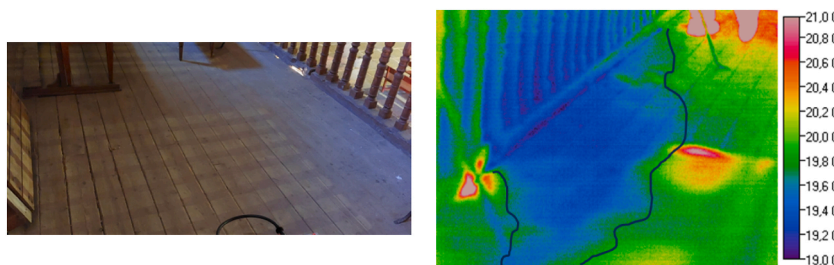
Fig. 23. Moisture detected on the wooden floor of the balcony. The areas that appear at temperatures higher than 21 °C are discarded as pathologies since they are caused by the steps of the operator.

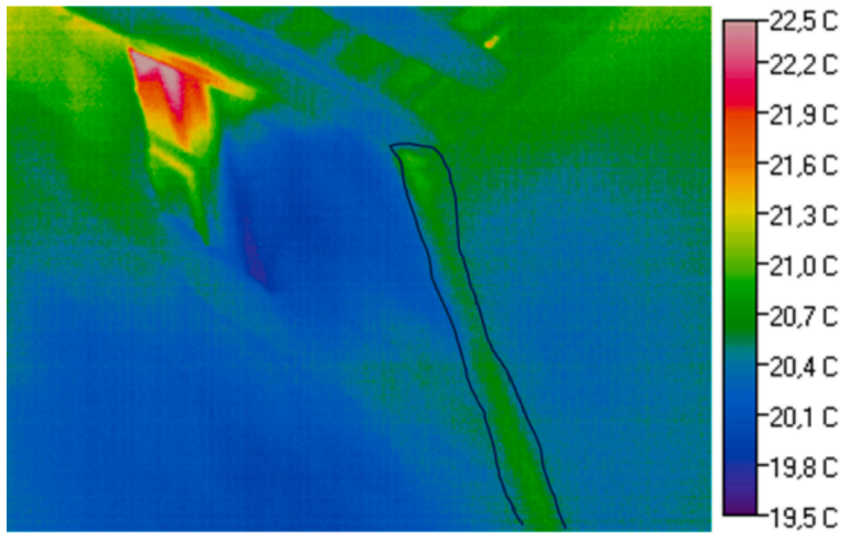
Fig. 24. Air infiltration between walls, signal of a thermal bridge.

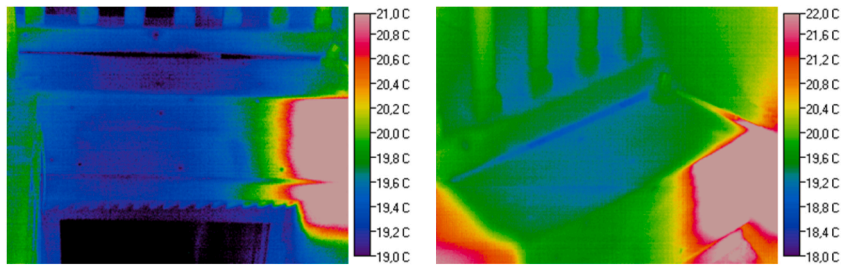
Fig. 25. The wooden beam supporting the balcony does not show any sign of defect with thermal affection.

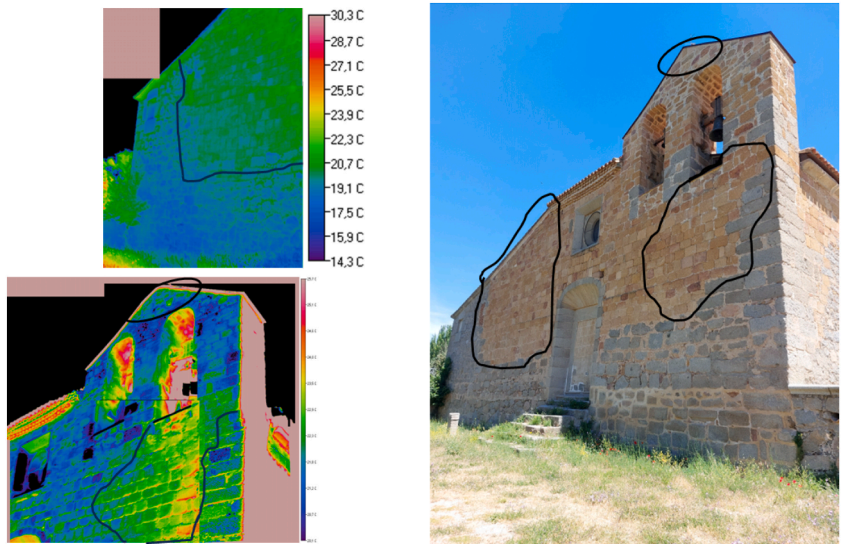
Fig. 26. Thermographic mosaics of the back façade. The black areas indicate the pathologies detected. Top left image represents the area highlighted in black at the left of the façade in the right photograph. Bottom left image represents the area of the bell tower.
