**INTEGRATING GEOMATIC APPROACHES, OPERATIONAL MODAL ANALYSIS,
ADVANCED NUMERICAL AND UPDATING METHODS TO EVALUATE THE
CURRENT SAFETY CONDITIONS OF THE HISTORICAL BOCO BRIDGE**

This paper proposes a multidisciplinary approach, combining the terrestrial laser scanner, ambient vibration tests and minor destructive tests, to characterize an early reinforced concrete bridge in Portugal: the Bôco Bridge. All methods are complemented by advanced numerical simulations and a coarse to fine calibration strategy, based on the Douglas-Reid and the non linear least squares approaches. Results obtained corroborate the robustness of the proposed approach, with an average relative error in frequencies of 1.2% and an average modal assurance criterion of 0.91. Considering this model, its current safety conditions were evaluated, obtaining a minimum safety factor of 2.1.

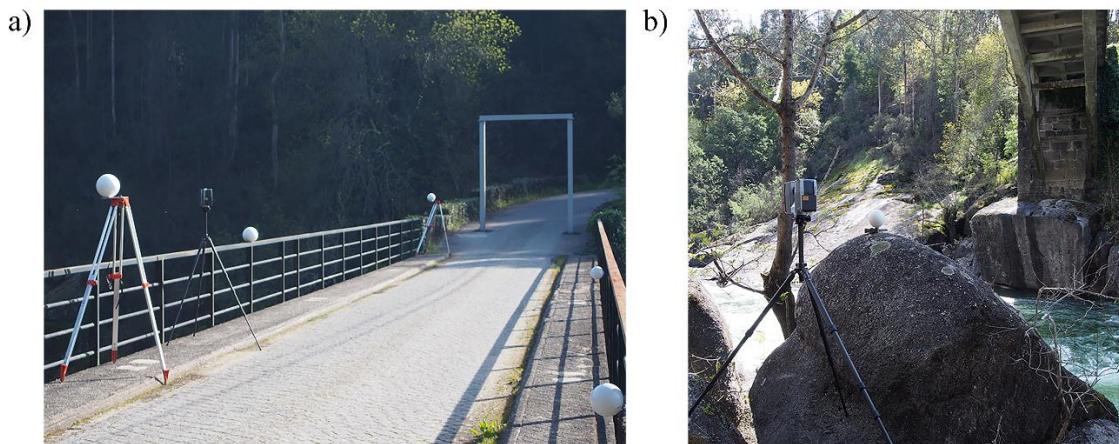
Considering the complexity of the structure, as well as the lack of accessibility to certain zones, the lightweight Faro Focus 3D 120 TLS system (Table 2) (Fig. 5), based on the phase shift

physical principle [14], was used to assess the geometry of the bridge. Additionally to the TLS system, several registration spheres, with 20.0 cm and 14.5 cm of diameter (Fig. 5a), were used to align the different scans stations following the algorithm defined by [15].

Figure 5: TLS and registration spheres used during the data acquisition: a) during the recording of the deck; and b) TLS surveying at the lower part of the bridge.

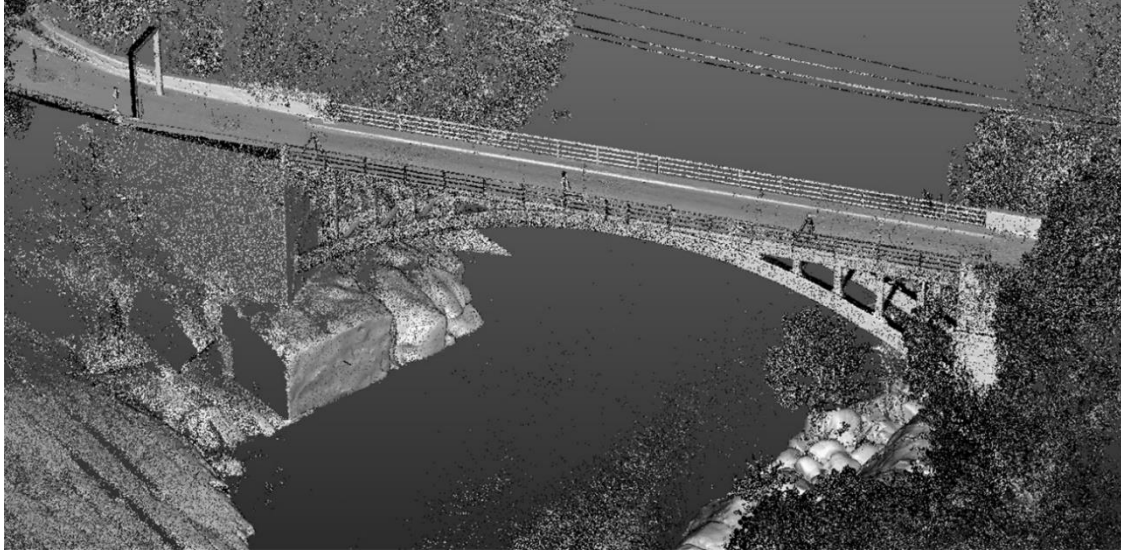
As a result, 18 scan stations were needed to record the whole structure: i) 12 scans under the bridge; and ii) 6 scans on the bridge's deck, obtaining an alignment error of 0.003 ± 0.002 m. The huge amount of data captured, with a total of 672,316,191 points, required an optimization of the point cloud for further evaluations. Applying to this end, the following decimation filters: i) a

distance filter with an average threshold of 40.0 m; and ii) a curvature-based decimation filter [16], with a threshold of 0.01 m, with the aim of simplifying flat areas while maintains relevant details, such as beam edges. As a result, an optimized 3D representation of the bridge was obtained, made up by 9,853,819 points (1.47 % of the original point cloud) (Fig. 6).

Figure 6: 3D representation of the bridge resulting of the point cloud optimization.

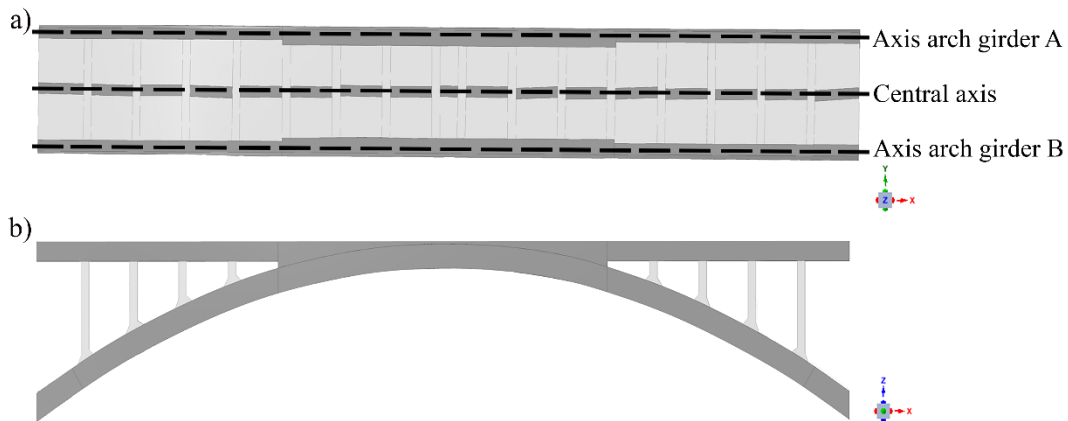
With the aim of creating an accurate CAD model suitable for subsequent numerical evaluations, the geometrical modelling strategy used by [17] was considered, following the next stages: i) meshing the point cloud; ii) creation of the manifold mesh; and iii) creation of the CAD model, based on standard reverse engineering approaches [18]. As a result, an as-built CAD model was obtained (Fig. 8), on which the geometrical deviations during the bridge construction were taken into account (Fig. 9).

Figure 8: As-built CAD model obtained by the proposed method: a) plant view (arches A and B); and b) elevation view.

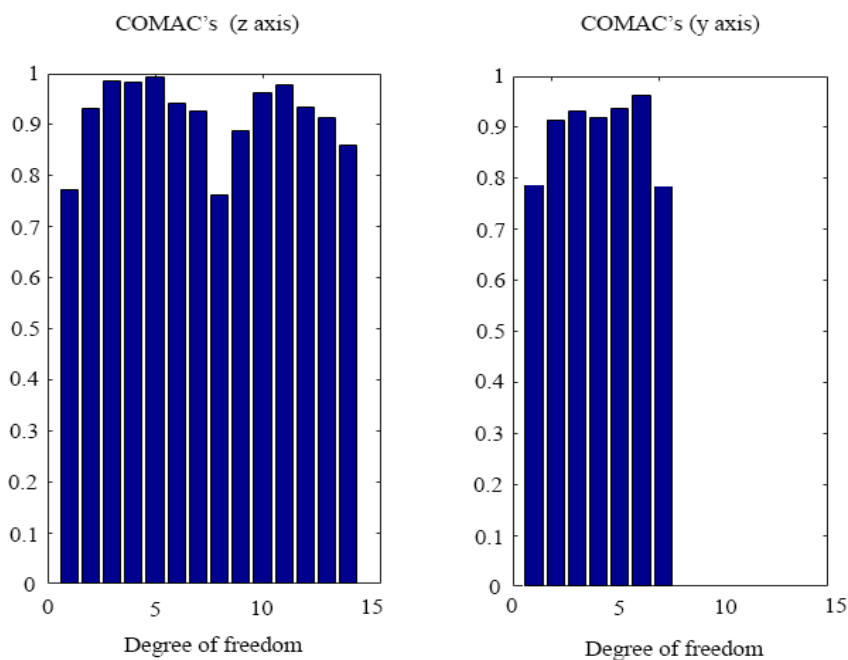
To evaluate the possible origin of these discrepancies, the coordinate modal assurance criterion (COMAC) [25] was used. Results derived from this index show a concentration of discrepancies in the first, eighth, fifteenth and twenty-first degree of freedom (Fig. 17). These discrepancies correspond with the supports of the arch girders as well as the areas with higher concentration of damages (see Section 2.3 and Section 3.2).

Figure 17: COMAC values obtained during the first calibration: a) COMAC values in z axis; and b) COMAC values in y axis.

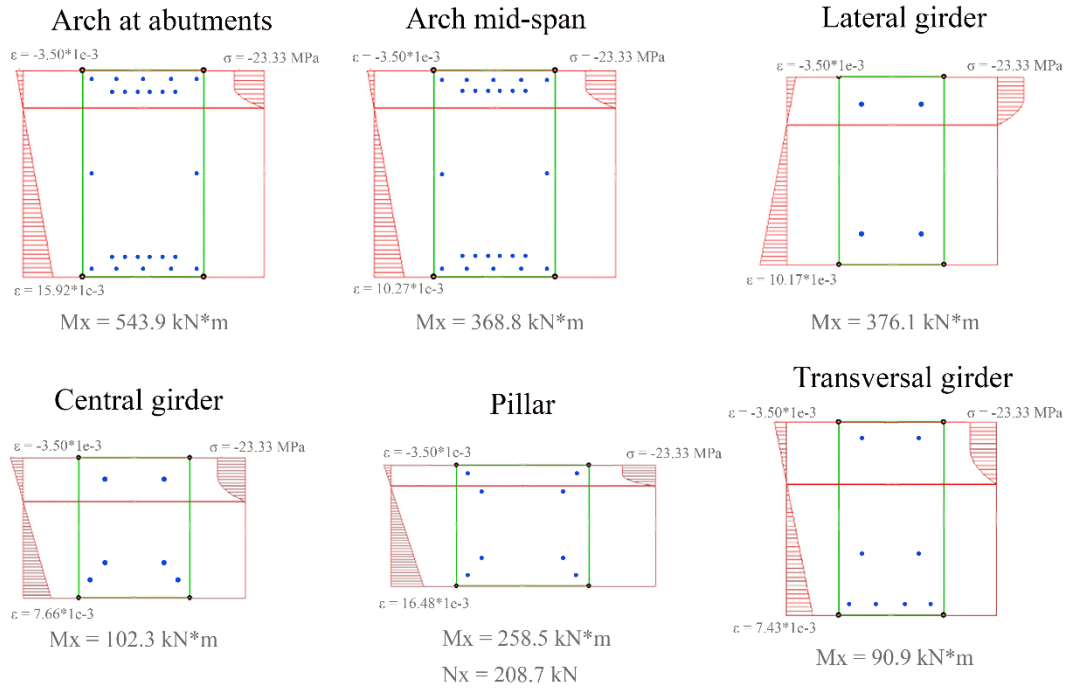
These loads were combined applying the Eurocode, where the safety factors for the most unfavourable case were considered (1.2 for gravity load and 1.5 for distributed load and concentrated load), obtaining the flexural moments of all structural elements and the compression axial force in the pillars (Fig. 24).

Figure 24: Maximum flexural capacity of structural members and maximum compression axial force in the pillars. Results obtained by CSA analysis [38].
