TESIS DOCTORAL

Damage evaluation in constructions based on geomatic and dynamic approaches

Luis Javier Sánchez Aparicio

Ávila, 2016

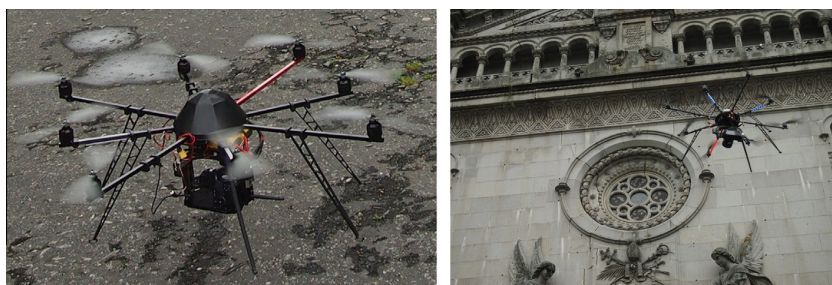
Fig. 1. Image of the UAV platform and the digital camera (left). Image taken during the data collection of the point cloud SfM (right).

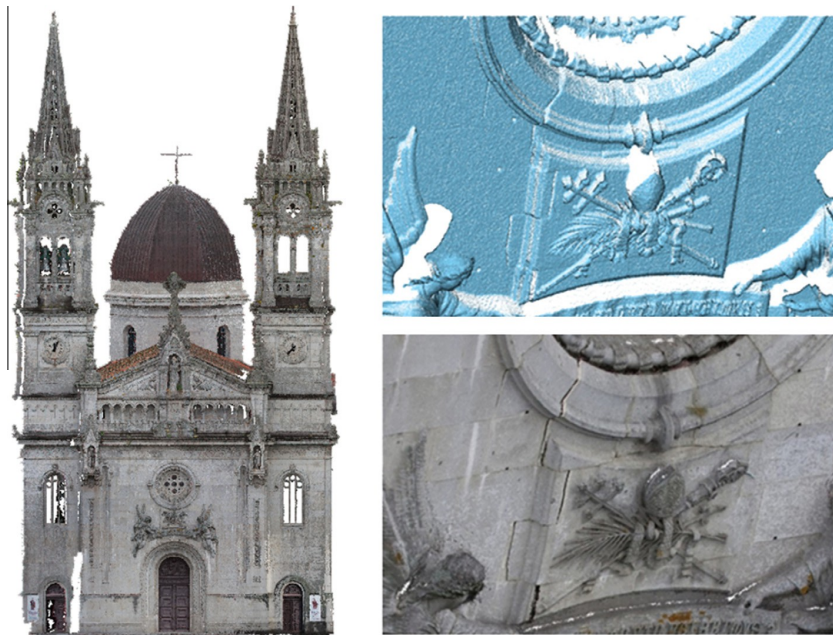
Fig. 7. Front elevation of the point cloud obtained through SfM technique and PW software (left). Detailed comparison between the laser scanner point cloud and the one obtained in PW software (right).

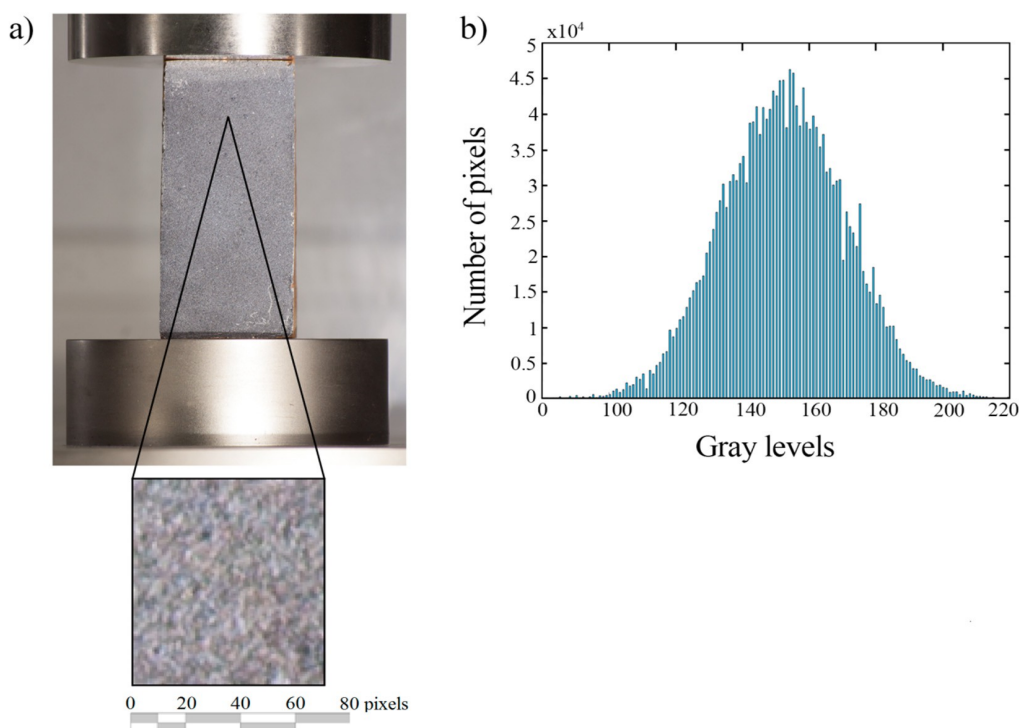
Figure 1. (a) Detail view of the brick and speckle pattern applied during the Digital Image Correlation (DIC) test; (b) Histogram of the speckle pattern.

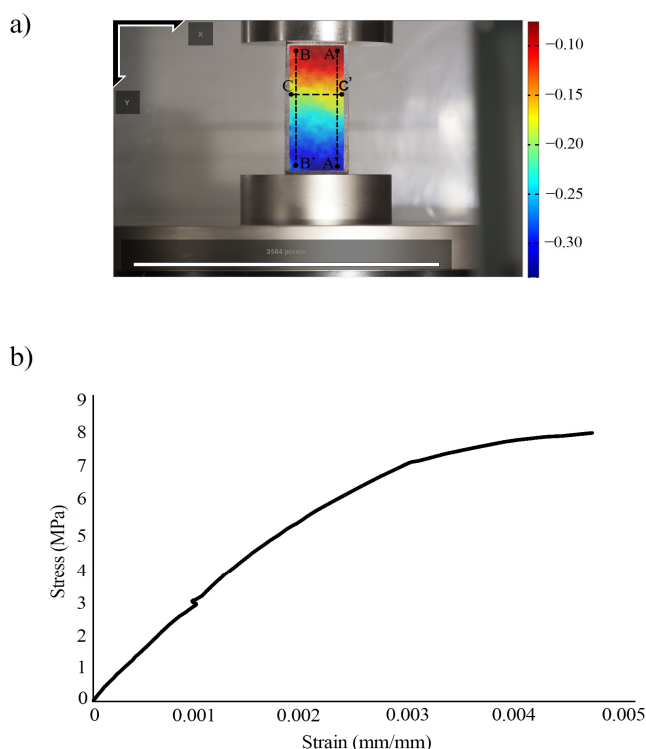
Figure 3. Results after the experimental campaign (2D DIC). (a) Deformation measurement, expressed in pixels, between two captures and positioning of the virtual extensometers; (b) Stress-strain curve obtained with the virtual extensometer A-A’.

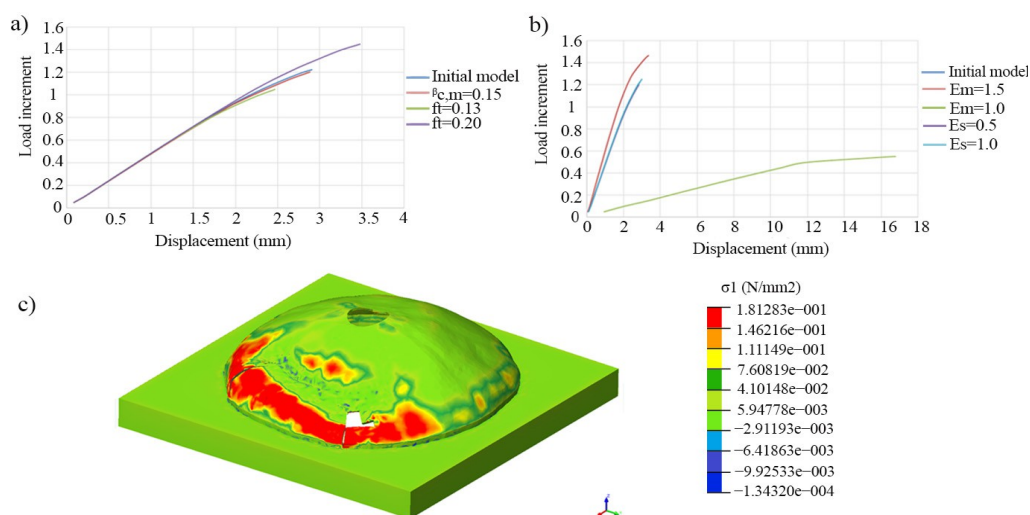
Figure 13. (a) Parametric analysis of different tensile strengths and shear retention factors; (b) Parametric analysis of different masonry and infill's Young modulus; (c) Maximum principal stress (σ_1), expressed in N/mm², at collapse of the initial considered model.
