Article

Detection of Terrain Deformations Using InSAR Techniques in Relation to Results on Terrain Subsidence (Ciudad de Zaruma, Ecuador)

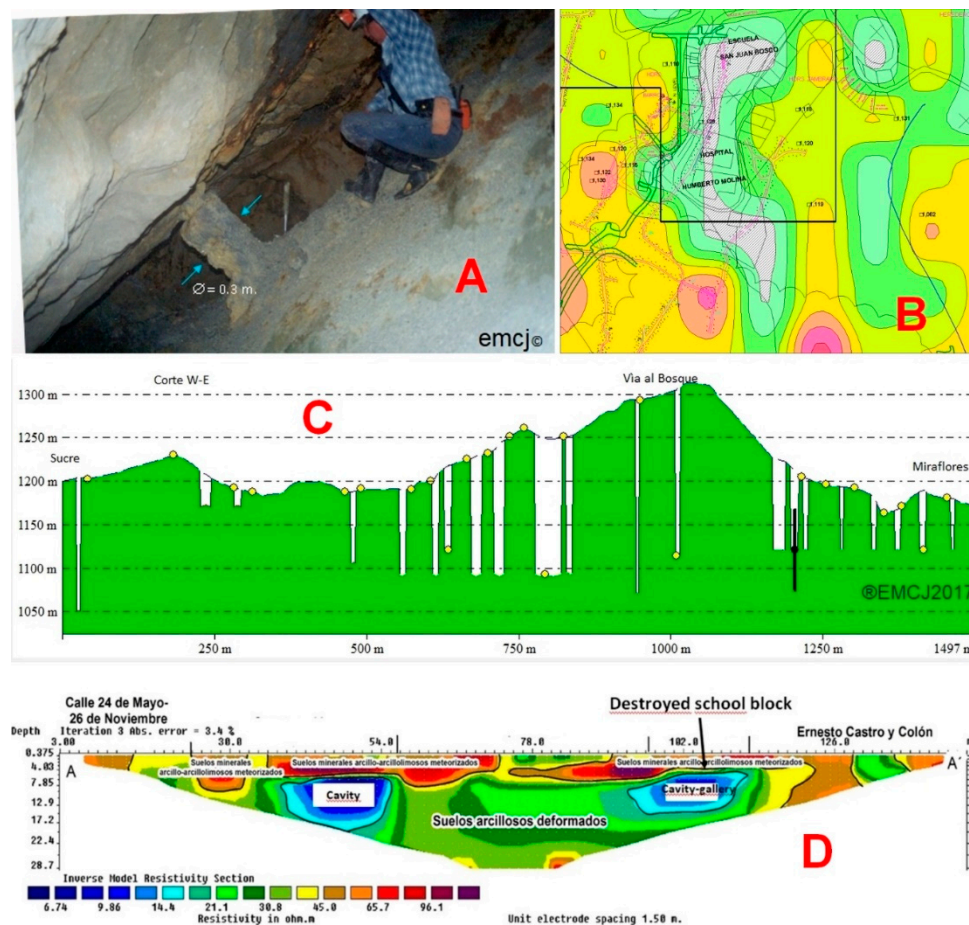
Figure 2. (A) Pillars exploited and destroyed, without resistance to the load of the upper rock and soil that in the sector reaches more than 50 meters thick. (B) Sinking dating back to 2001 using the flow pattern technique and morphological rupture lines. (C) W–E Topographic profile and subsidence caused by mining galleries in underground projection to the top of the galleries. (D) Electrical tomography of the subsoil in the streets May 24, November 26, Ernesto Castro, Colon and Gonzalo Pizarro. The collapse of the La Inmaculada-Fé y Alegría school block was possibly due to the instability caused by the underground gallery that exists below (blue spot). This sinking was reactivated in 2019.

In particular, the stress efforts caused by the bending and cutting component of these deformations have damaged the building materials making them almost fragile. These ground deformations and subsidence were verified in 2001 by inspecting the underground mining galleries, in addition to the geological characterization, without using the DInSAR technique, which did not exist at that time. The technique used and developed was the analysis of flow patterns and morphological rupture lines, developed by the authors of this article, and topographic–geological information of each gallery investigated by ex-National Directorate of Geology, National Directorate of Geology [2–4], among researchers. An example of the state of deformation in 2001 can be seen in Figure 2B in the hospital sector of the city Humberto Molina and the San Juan Bosco school, where there is a anthropogenic subsidence zone (area with black slanted lines), caused by the mining galleries represented by green and cyan lines.

A topographic profile W–E from Sucre Street to Miraflores Street, is presented, Figure 2C, from the surface to the top of the inventoried mining galleries at that time. This topographic profile shows the intensity of subsidence caused by the underground galleries. The last study carried out by the Secretariat of Risk Management by means of electrical tomography of the subsoil in 2016, verified that the areas susceptible to subsidence detected in the previous decade were activated and caused the collapse of the La Inmaculada-Fé y Alegría School. Subsequently in 2019, subsidence occurred on

24 May and 26 November on Ernesto Castro, Colon and Gonzalo Pizarro Streets. Subsidence that were previously detected, Figure 2D.

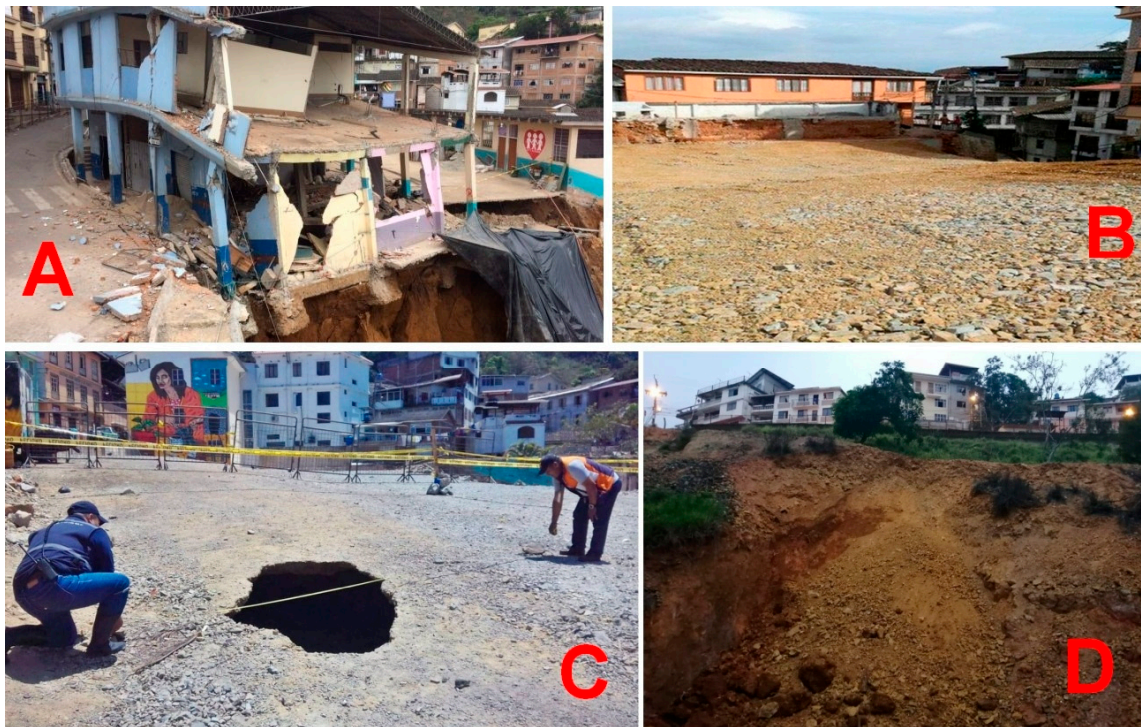
Figure 3 shows the collapse of the school in October 2016 (A), the technical filling done in 2017 (B), the new collapse in the same place (C) and the new collapse in the Gonzalo Pizarro Street sector (D), which occurred in 2019.

Figure 3. (A) Collapse of the Fe y Alegría School, in October 2916. (B) Technical filling done at the site in 2017. (C) Reactivation of the collapse in the place where the school was in 2017. (D) New collapse near Gonzalo Pizarro Street in 2019. Images taken from El Expreso Newspaper, Ecuador en vivo, Pichincha Universal and Arden los Socavones Facebook page.

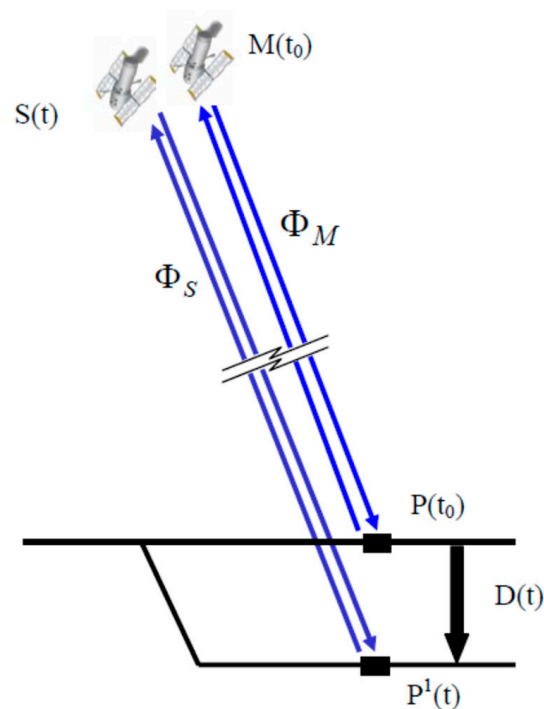
In reference to Figure 4 for the acquisition of an interferogram, have followed what M. Crosetto et al., describes about the basic principles of Interferometry from the Synthetic Aperture Radar (SAR) [30].

Figure 4. Displacement diagram of topographic relief and phase change of the signal [11].

At time t_0 , the sensor obtains a first SAR image, measuring the phase Φ_M (Equation (1)), an image called master, M. If a deformation of the ground D occurs, over a time, point P moves to P^1 . Subsequently, the satellite obtains a second image at time t, and measures the phase Φ_S . This image is called slave, S. The InSAR technique calculates the phase difference between Φ_S and Φ_M , a difference called interferometric phase $\Delta\Phi_{Int}$.

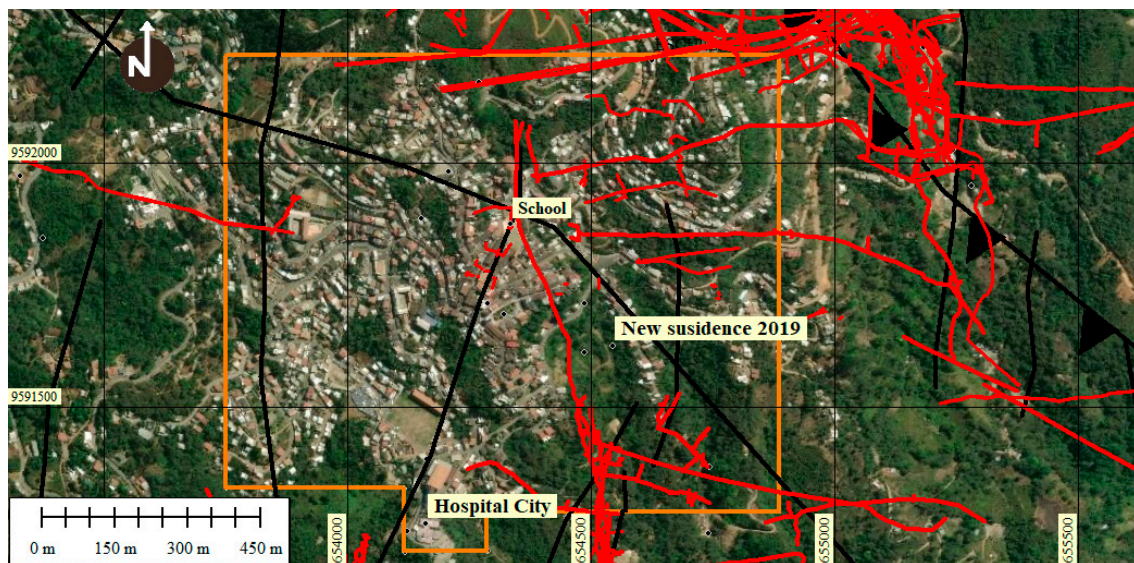
There are historical studies that report severely damaged buildings, possibly due to being in subsidence areas in the Colonial Center of the Zaruma city. Figure 5 shows the location of the city, the mining exclusion area (ocher color), the underground mining galleries (red lines) in the central part and to the east, the veins and mineralized structures a geological faults (black color lines). In the western part, there are no surveys of mining galleries except for one represented with a red color line (possibly, there is no survey of the mining cadaster in this area).

Figure 5. Underground locations of mining galleries outside and within the exclusion area of the Zaruma city. In ochre color, the Exclusion Zone polygon, the mining galleries from the center to the east in red lines, the mineralized structures and geological faults in black color lines. Dots black color are bocamines. Data source: Risk Management Secretariat.

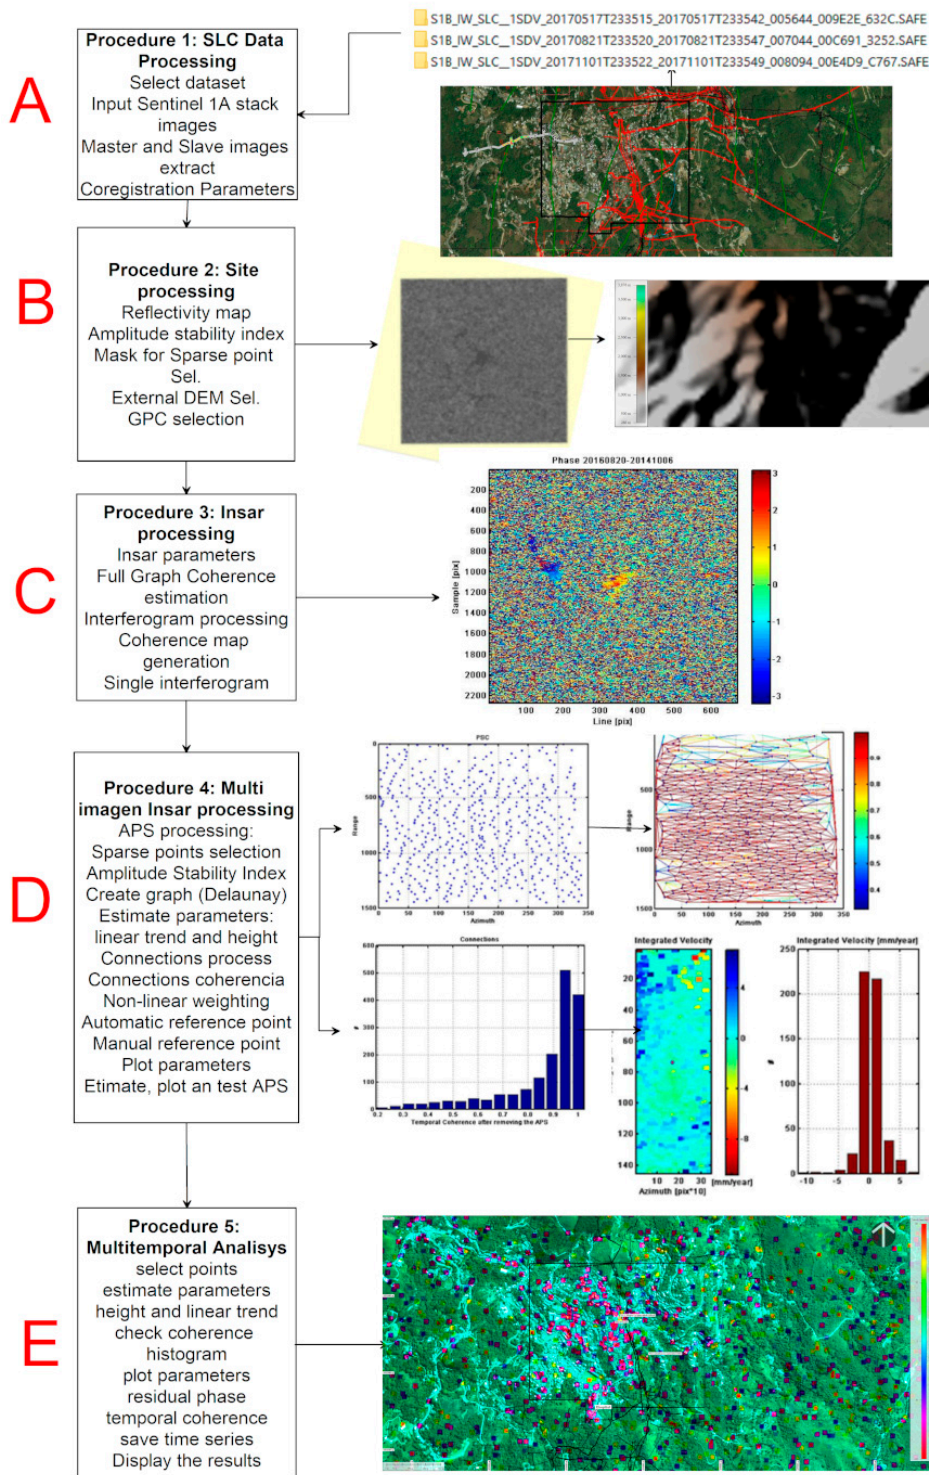
Figure 6. The SARPROZ software process used to obtain the relief deformations by DInSAR analysis. Steps (A–E) of each portion of the routine. See text for further explanation.

Procedure 1: SLC (A) data processing to import or update extracted data from Sentinel 1 images. Master and slave images are extracted and defined by selecting them manually or automatically. In the star chart in Figure 7A, the master image is close to half the perpendicular and temporal baseline domain between 1B and right, to try to minimize the effects of normal and temporal baselines. Finally, the Co-registration Parameters of the pixels of the corresponding master and slave images are defined for the elaboration of interferograms correctly.

Procedure 2: is called Site Processing (B), in which preliminary parameters of the images such as the reflectivity map are extracted, from the average time reflectivity of all the images in the stack. The amplitude stability index is calculated which is a unique number that provides a statistical property of the amplitude series with ranges between 0 and 1. A mask is generated for the selection of the scattered points based on a threshold value of the index of amplitude stability, whereby values above the threshold enter the interferometric process and values below this threshold will be masked and will not enter the process, Figure 7B. Select an external Digital Elevation Model (DEM), to eliminate the topographic phase and geocode the images with the option Ground Control Point Selection-GPC, for orbital correction, flattening of interferograms and definition of persistent dispersers. The basic characteristic of a DEM is that it has positioned reference points; in this case, it is in relation to the Shuttle Radar Topography Mission -SRTM- that has a high degree of confidence in its position. Other external DEMs of various spatial resolutions can be used, provided they have stable static reference points (stable reflectors) that have not changed over time. Finally, the complete graphic coherence is calculated, to estimate the coherence of all the possible connections (interferograms) in the image scene.

Procedure 3: called InSAR (C) processing in which the InSAR parameters for interferometric processing are defined by estimating the complete graphic coherence according to the loaded image stack and the average coherence of the generated interferograms. From this calculated coherence, an interferogram is generated between the master image and each of the slave images. In this procedure,

Procedure 4: called InSAR Multi Image Processing (D) in which the atmospheric noise APS is eliminated and the candidate points are selected to generate the persistent dispersion-PS, those that have a stable position in terms of deformation of the topographic relief. Based on these points, the program calculates the displacement height, relief velocity and the residuals of those parameters that serve to recover the delay of the atmospheric phase. The candidate points of persistent dispersion-PS in the urban area of Zaruma correspond to the constructions of buildings that remain stable over time both in radiometry and in the interferometric phase [34]. The stack of 20 images used is the most important factor for estimating the coherence of the pixels, since it allowed identifying suitable PS for the displacement analysis of the relief. Insufficient use of the images will produce an overestimate of the coherence in the entire scene, a poor estimation of the PS, therefore, in false displacements. PS location is considered reliable when 20 or more images are used. In this phase, the APS ambient noise is also estimated, which can affect the process of generating the interferograms due to different atmospheric conditions at the time of image acquisition. Eliminating atmospheric noise, APS is important as it improves the coherence and phase response signal of the images to obtain more accurate ground displacement data.

Procedure 5: called Multitemporal Analysis (E) is a procedure that, based on the previous atmospheric noise reduction procedure, is used for the analysis of MT-InSAR multitemporal interferometry based on persistent scatter (PS). With this procedure, dispersers were identified, whose signal is dominant within the total dispersion of the analyzed pixels and with which a deformation map of the topographic relief was obtained, in which the deformation rate is represented from the time series obtained. These maps are made up of thousands of PS (persistent dispersions) and each PS is associated with an annual linear velocity value (mm / year), and with the accumulated displacement on each date of image acquisition.

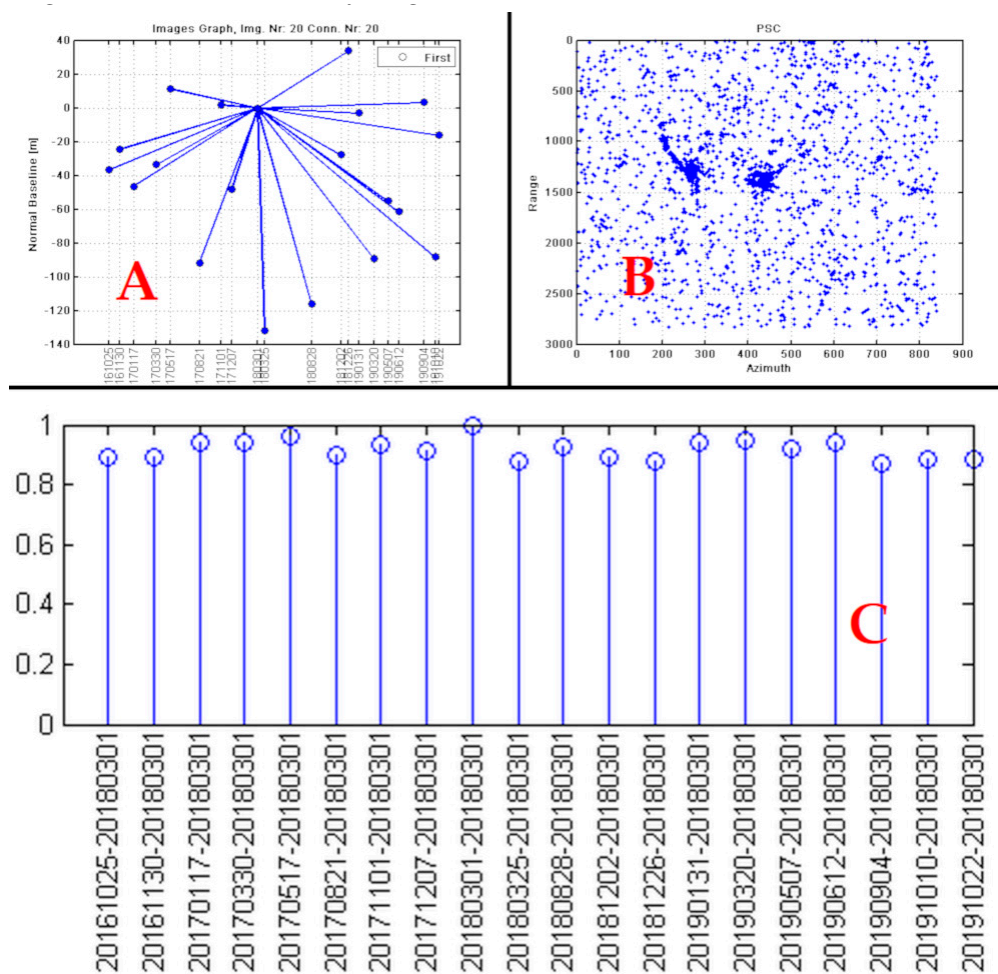
Figure 7. (A) Representation of the Sentinel 1 B image set, in the normal basal–temporal space, where each point and line represents an image and an interferogram, respectively. (B) Scattered points for PS-InSAR analysis. (C) Consistency greater than or equal to 0.85 of the Sentinel 1 image stack.

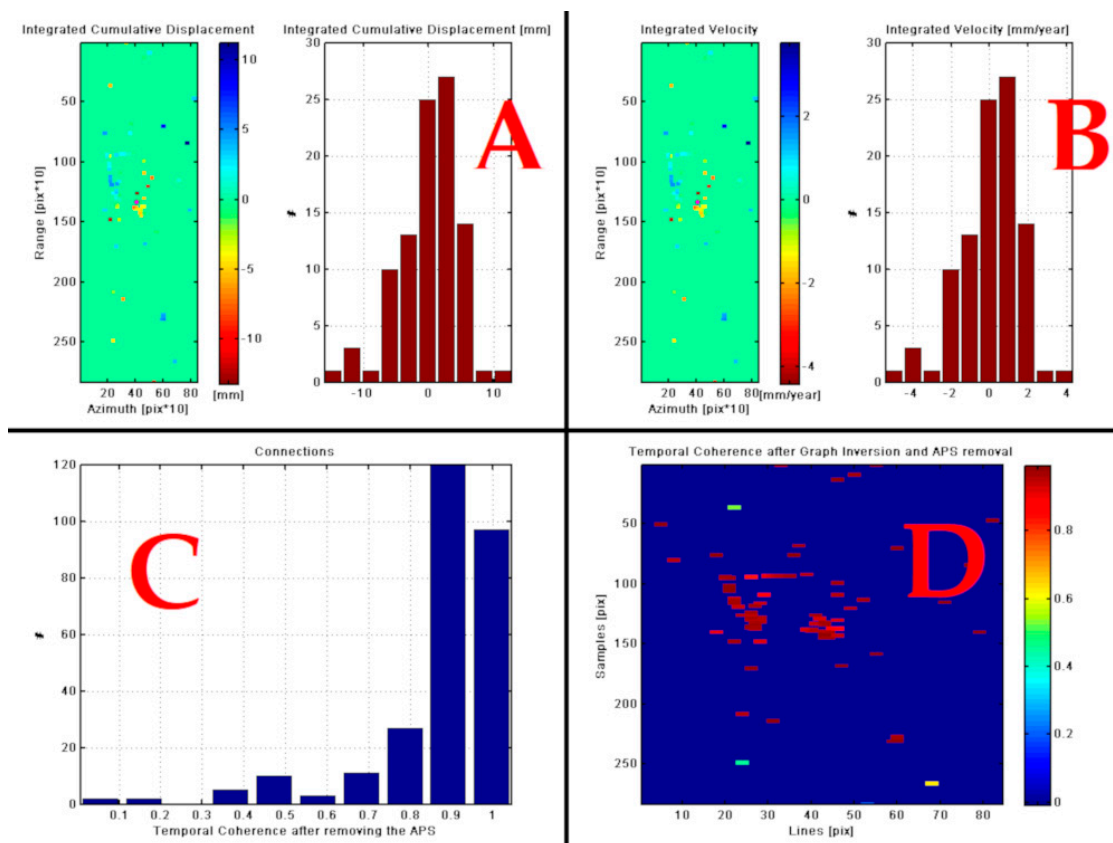
The histograms verified that the connection speed and the connection residual height are consistent in the distribution of the residual value of travel velocity (mm/year) / height (m), as presented in Figure 8A–C, where a histogram is seen, without jumps and high coherence (connecting lines with a red tendency), Figure 8D.

Figure 8. (A) Histogram of integrated cumulative displacement connections, (B) Integrated velocity, (C) Histogram and Temporal Coherence after removal of APS noise (D).

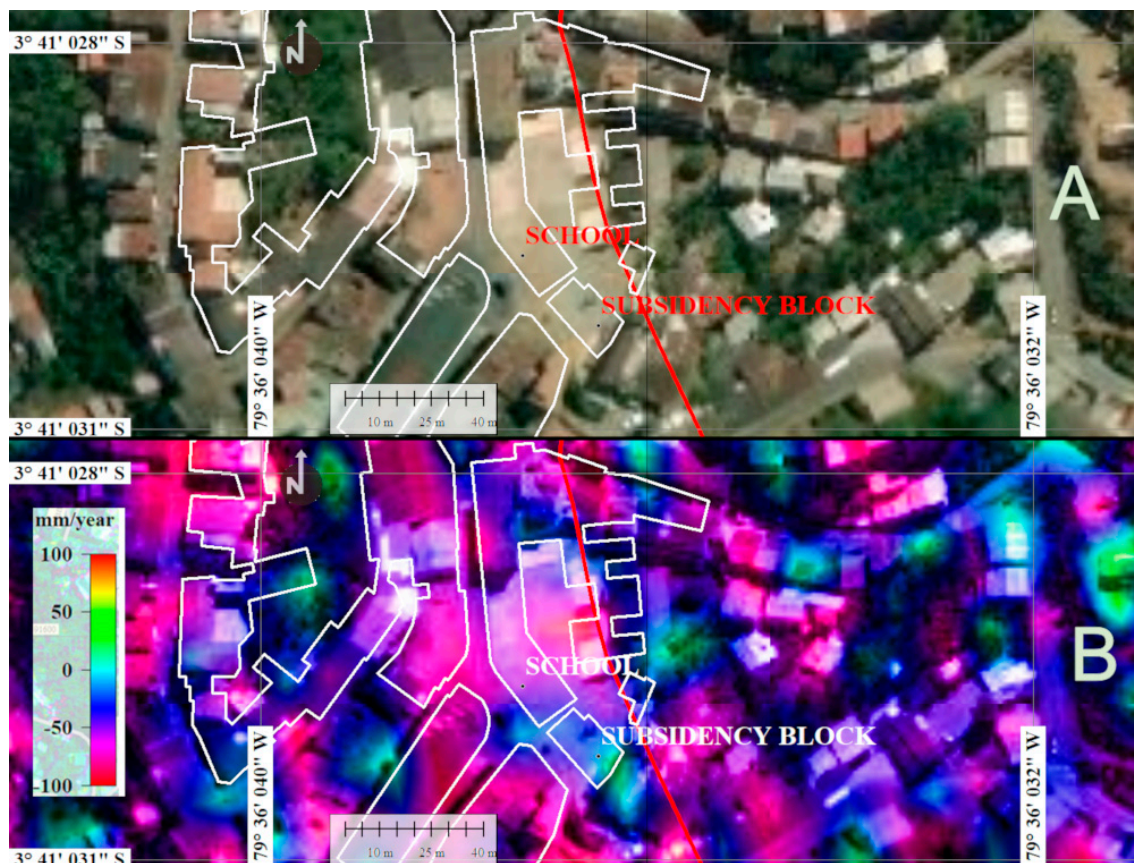
Figure 9. (A) Location of Fe y Alegría-La Inmaculada School in the study area before the collapse of the block of school classrooms. (B) Block collapse of school classrooms on October 25 of a day before the collapse that began on October 16, 2016, and completely collapsed in December 2016. The faint blue color indicates that before October 25, 2016 the sinking of the area was in process. Gallery is in red color and blocks houses are in white color.

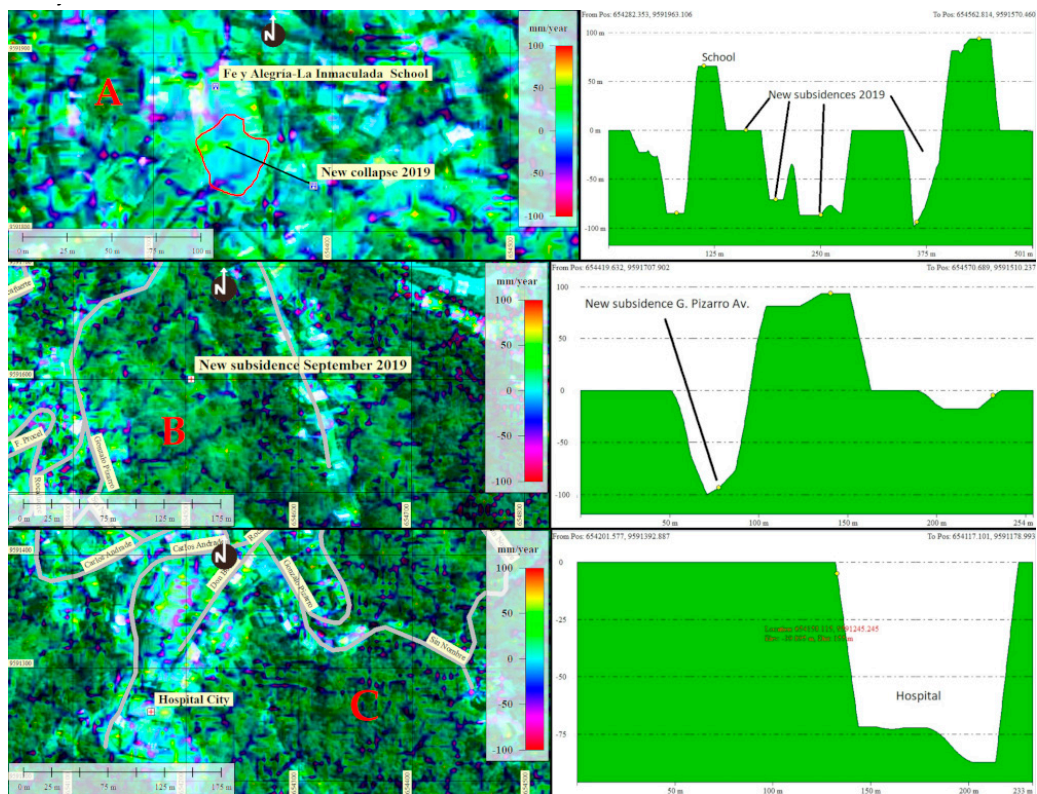
Figure 11 shows the velocity of elevation and subsidence of the terrain within a range of -20 to 50 mm, to classify the most accurate rank levels at the site. (A) The new collapse in the Fe y Alegría school, (B) the new subsidence in Gonzalo Pizarro Street and in (C) the subsidence that are occurring in the city hospital, among other places that were analyzed by the authors in 2001 [2] and served to verify the results of this article.

Figure 11. (A) Lifting velocity and subsidence of the ground at Fe y Alegría School (A), Gonzalo Pizarro Street (B), the city hospital(C), obtained from the interferometric analysis. These results corroborated previous studies and verified the analysis performed in this article.

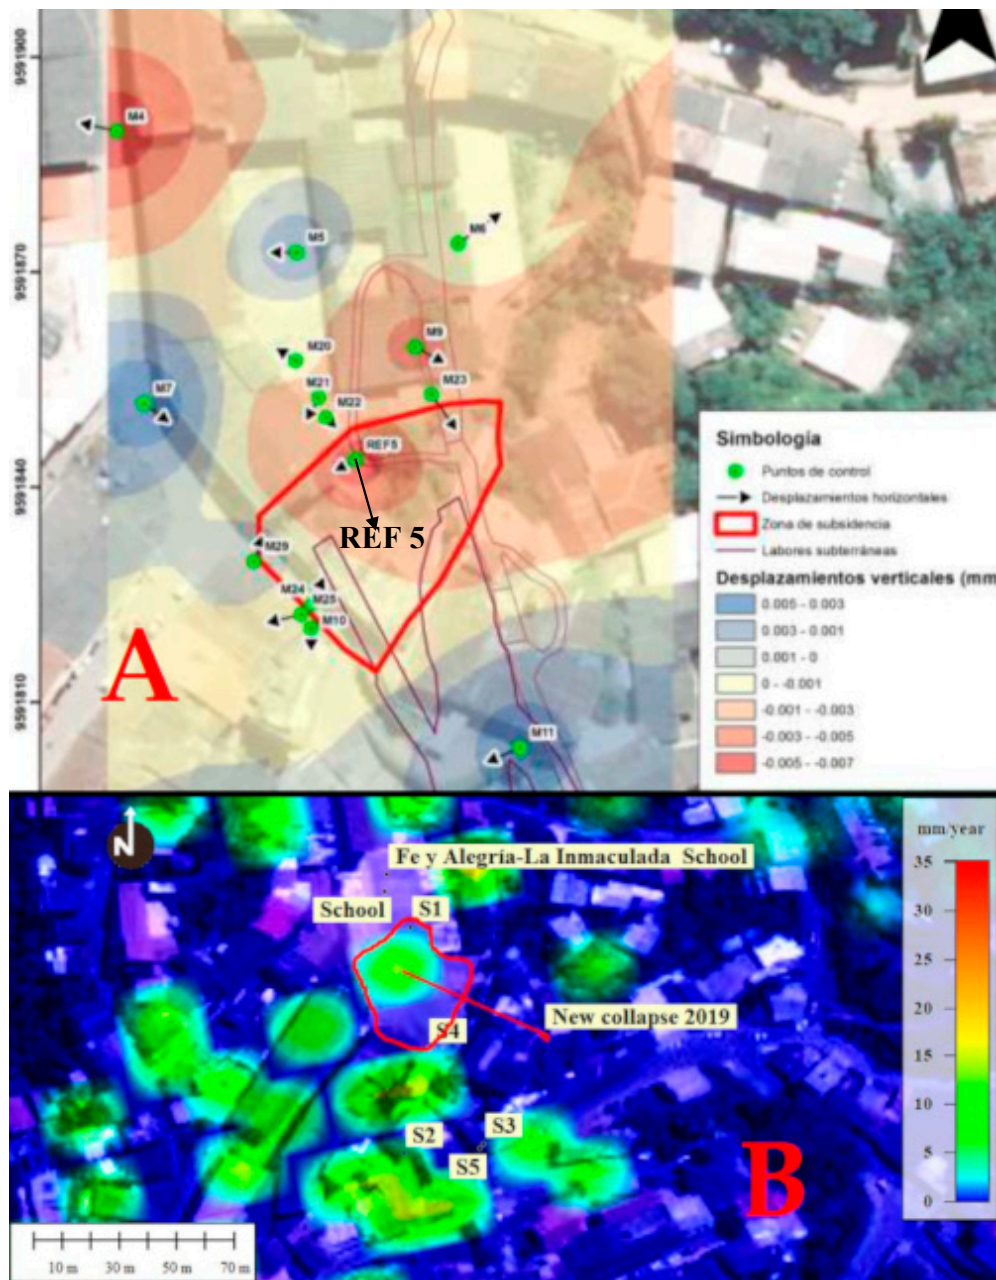
Note the correlation between the sinking areas CF5 of Figure 13A and the new collapse occurred at the same site in 2019 of Figure 13B.

Figure 13. Correlation between the results obtained from areas of subsidence by InSAR Interferometry with the geotechnical investigations of subsidence carried out by INIGEMM and the author of the thesis [37]. Image 13A has low resolution since its origin. Note the correlation between the sinking areas CF5 of (A) and the new collapse occurred at the same site in 2019 of (B). S1 to S2 surveys conducted by INIGEMM.

It is necessary to highlight the correlation that exists between the area of maximum subsidence REF 5 in Fe y Alegría-La Inmaculada School that seen in Figure 13A of the INIGEMM and the new collapse occurred in the same site in the 2019 of Figure 13B elaborated with the InSAR methodology. There is a correlation between subsidence in other nearby sectors. INIGEMM considered geotechnical parameters such as cohesion, angle of friction, UCS classification, and other parameters

Most interferograms reveal continuous surface movements in the central part of the exclusion zone of the city of Zaruma, at sites where several underground mining galleries were located (Figure 13).

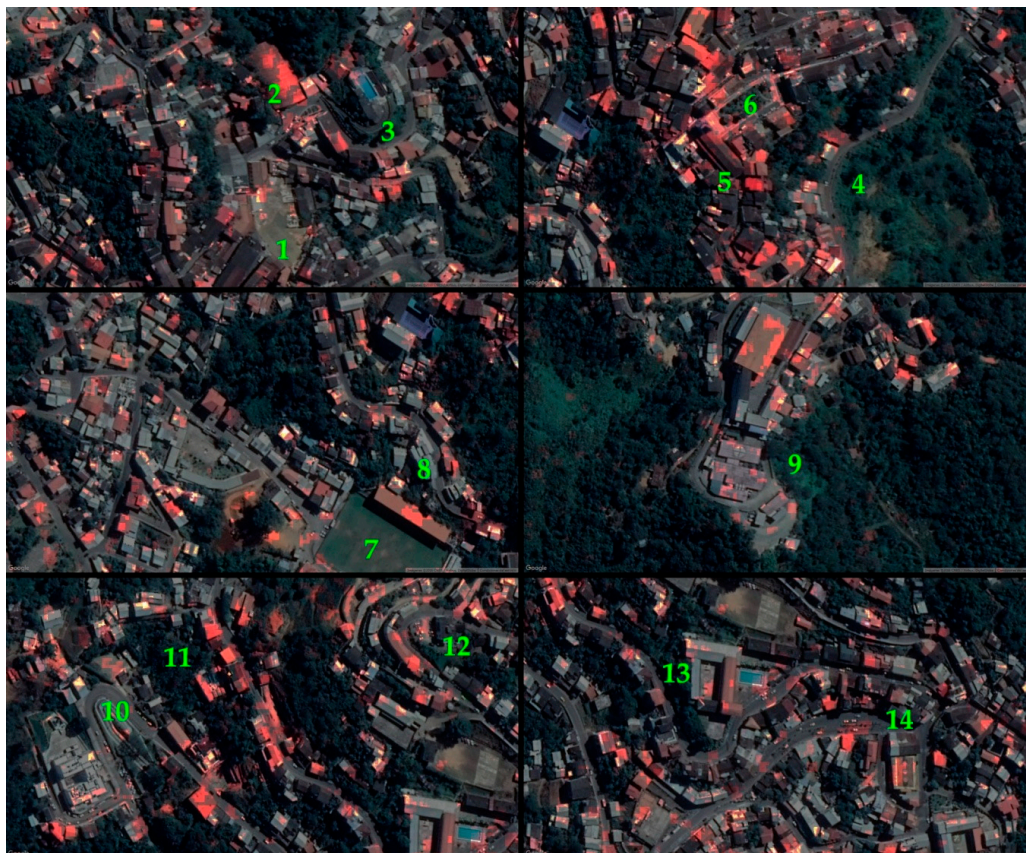
The sectors that presently present subsidence according to the SAR interferometry study, can be seen in Figure 14 and are the following: the municipal market, the Fe y Alegría-La Inmaculada School (1), sports coliseum (2), municipal pool and jail (3), Gonzalo Pizarro Street (4), Church (5), Central Park and Municipality (6), City Stadium (7), El Oro Avenue, (8), City Hospital, San Juan Bosco School (9), Gil Gilbert Street (10), Roground Hotel (11), El Sexmo (12), November 26 School(13), Reinaldo Espinosa Street (14), among other sectors.

Figure 14. DInSAR analysis, determined that there are many constructions with potential sinkholes in some sectors of the city (red spots on the roofs).
