# An historical building information modelling approach for the preventive conservation of historical constructions: Application to the Historical Library of Salamanca

Cultural heritage  
Preventive conservation  
Historical building information modelling  
Internet of things  
Monitoring network  
Wearable mobile mapping system

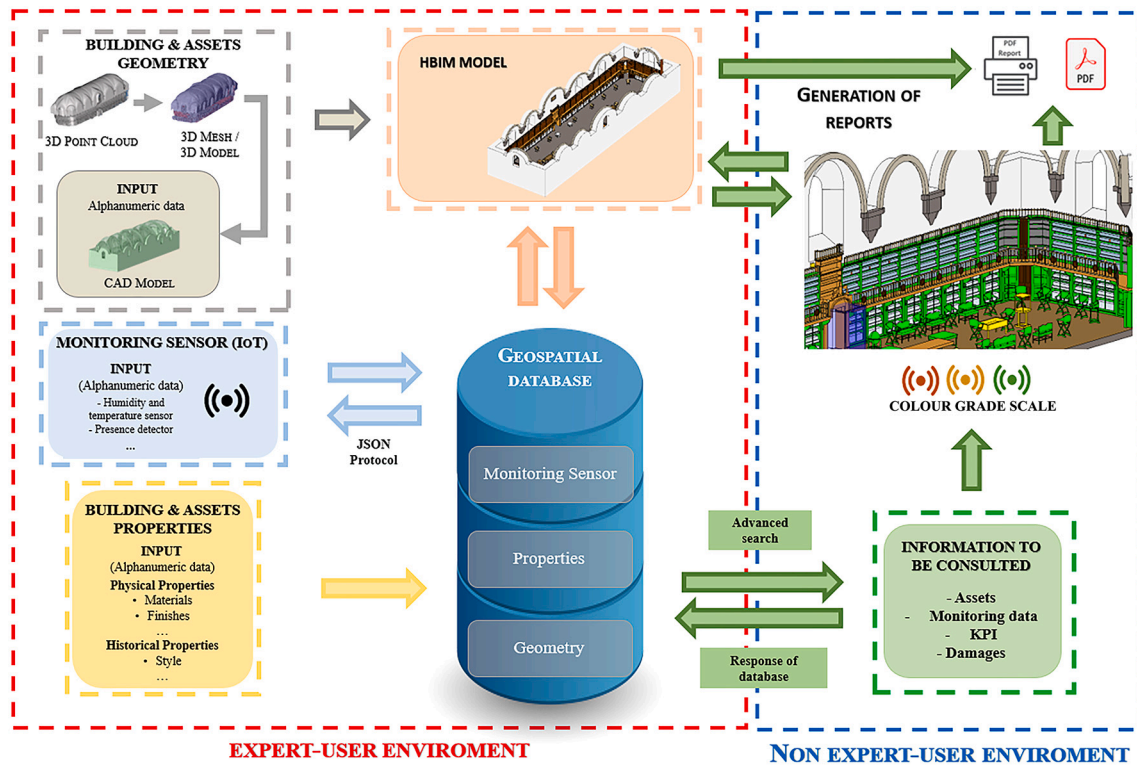
Fig. 1. Graphical representation of the HBIM methodology implemented.

The proposed HBIM methodology will be based on three interconnected steps (Fig. 1): i) the 3D digitalization of the heritage site by means of WMMS; ii) the monitoring of the main bioclimatic parameters for the preventive conservation of the assets placed within the library and; iii) an HBIM model that manages the information derived from the previous steps and the information related to the assets. Additionally,

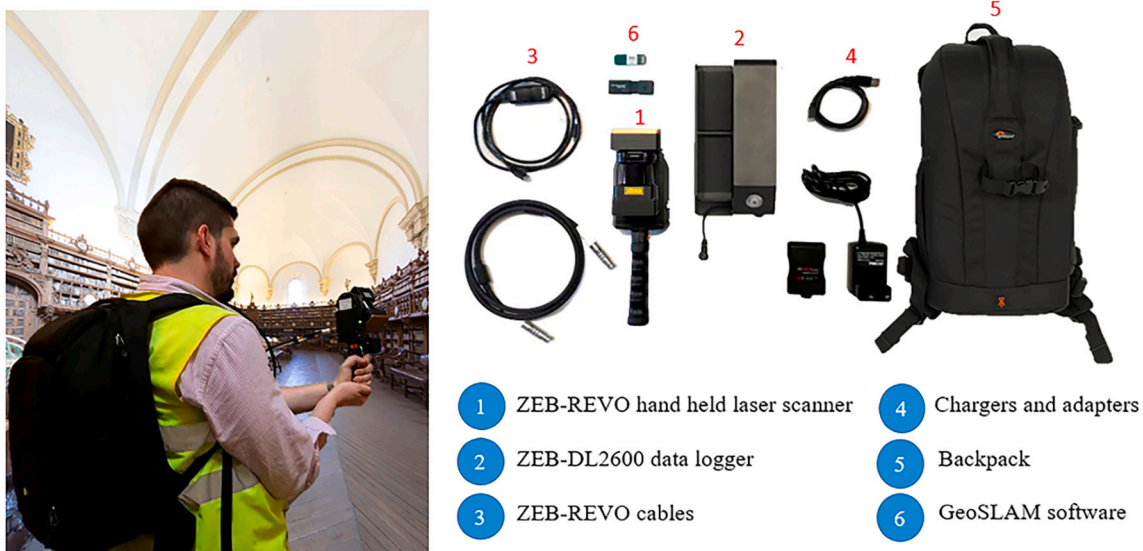
Fig. 2. WMMS used: a) user working with the wearable laser scan (Zeb-Revo). b) Zeb-Revo equipment.

The WMMS used for the present work was the ZEB-REVO back-pack mapping system. This device, commercialized by the GeoSLAM company [31], comprises a 2D rotating laser scanner head Hokuyo UTM-30LX-F (Hokuyo Automatic Co., Ltd. Osaka, Japan) rigidly coupled to an IMU on a rotary engine. The data captured by these sensors is stored in a processing unit placed in a small backpack (Fig. 2). The 3D point cloud is generated by combining the information coming from the scanning head with that from the IMU sensor. To this end, the full SLAM approach of the robotic operative system (ROS) library is used [32]. This approach uses an incremental and interactive procedure to register the segments captured by the scanning head one-by-one. Finally, this registration is refined following a similar framework to the well-known Iterative Closest Point algorithm. The error accumulation derived from the incremental procedure is minimized by a global registration on the basis that the starting and ending points are the same (closed-loop solution).

This sensor has a default range of 0.60–30 m for indoors environments and 0.60 to 15 m for outdoor ones, capturing 40,000 points per second (Table 1). Additionally, to the scanning head, the device has a GoPro camera that allows recording a video when the laser is capturing the scene. The manufacturer ensures an accuracy of 1–3 cm for a 10 min scan, with the closing of a single loop [33]. Further detailed specifications of this device are included in Table 1.

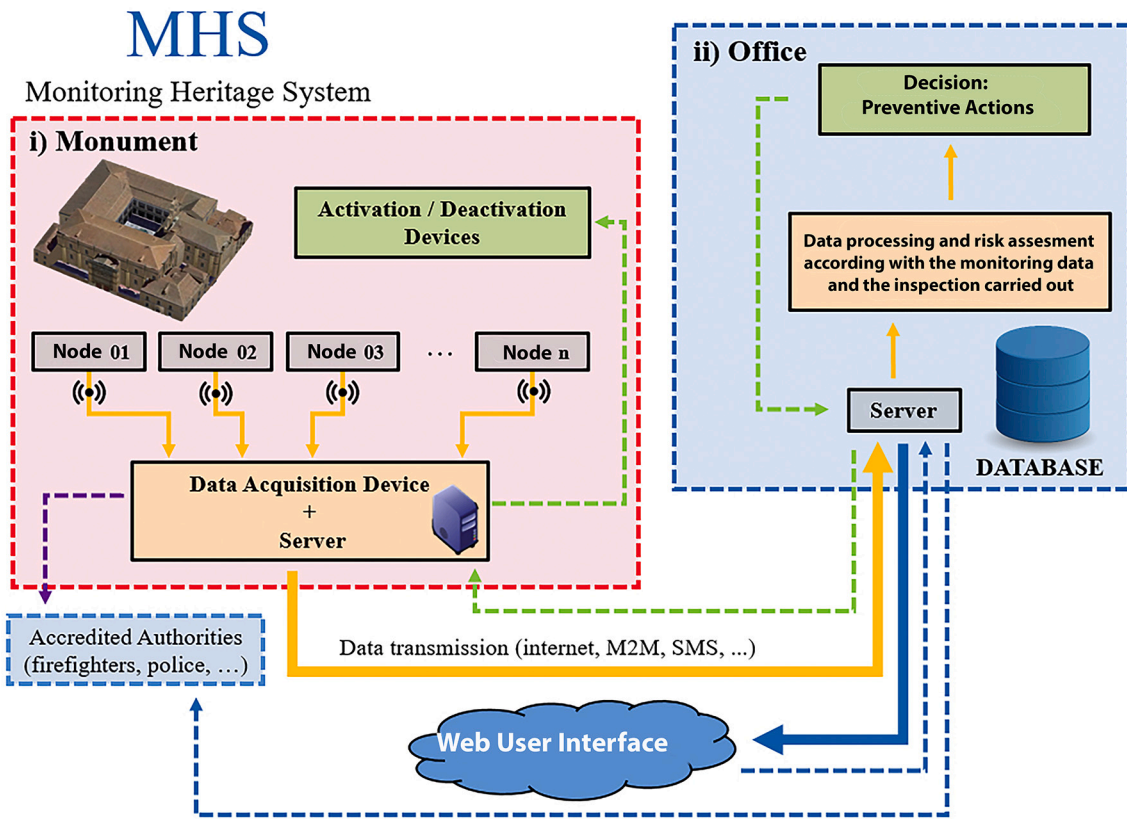
Fig. 3. Scheme of the monitoring network implemented.

In parallel to the digitalization of the site, a monitoring network was installed (Fig. 3). The aim was understanding the conservation needs of the indoor assets of the Library. This monitoring network focused on measuring the main bioclimatic parameters by means of the commercial system MHS (Monitoring Heritage System) [34]. This monitoring system has been developed by the Santa Maria La Real Foundation (<https://www.santamarialareal.org/>), highlighting for its minimal visual impact and great autonomy. The number, location and type of node depend on the specific needs, thereby requiring a pre-monitoring stage to define them property. Table 2 shows the general specification of the nodes used by this monitoring network.

The information captured by the local nodes is transmitted to a central node through a Zigbee communication protocol with a bandwidth from 900 MHz to 2.4 GHz. Finally, this information is sent to a dedicated server and can be consulted through a web-based application, as shown in Fig. 3.

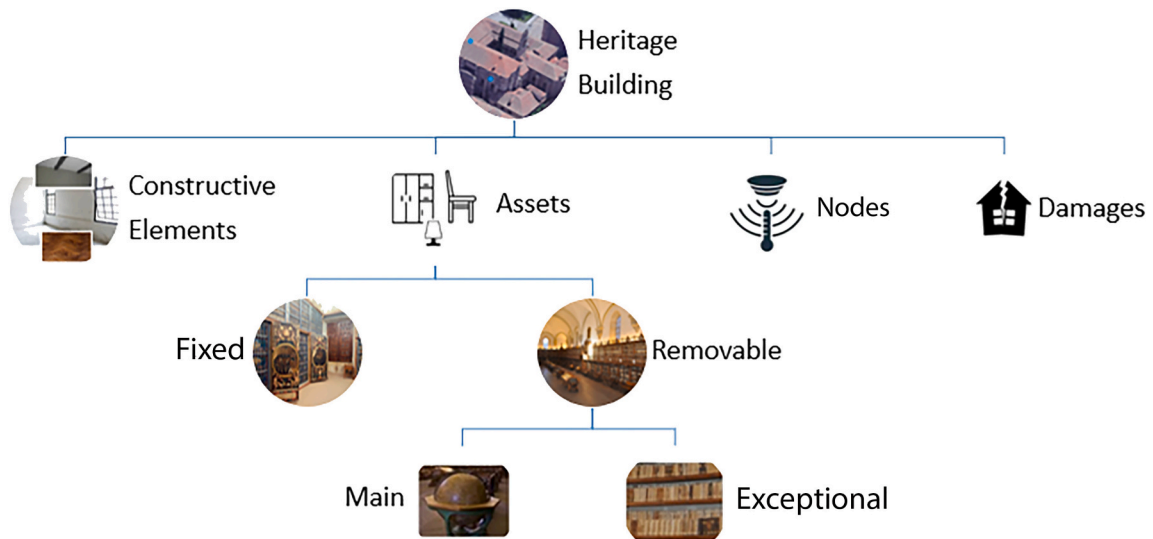
Fig. 4. Object classification proposed.

In contrast to this low LoD, the current methodology introduces an exhaustive LoI to handle the properties of each material, changes suffered, or damages presented. In order to establish this LoI correctly to each object, the elements were classified depending on the information each one needs into 4 main groups (Fig. 4) (Table 3): i) construction elements; ii) assets; iii) nodes; iv) damages.

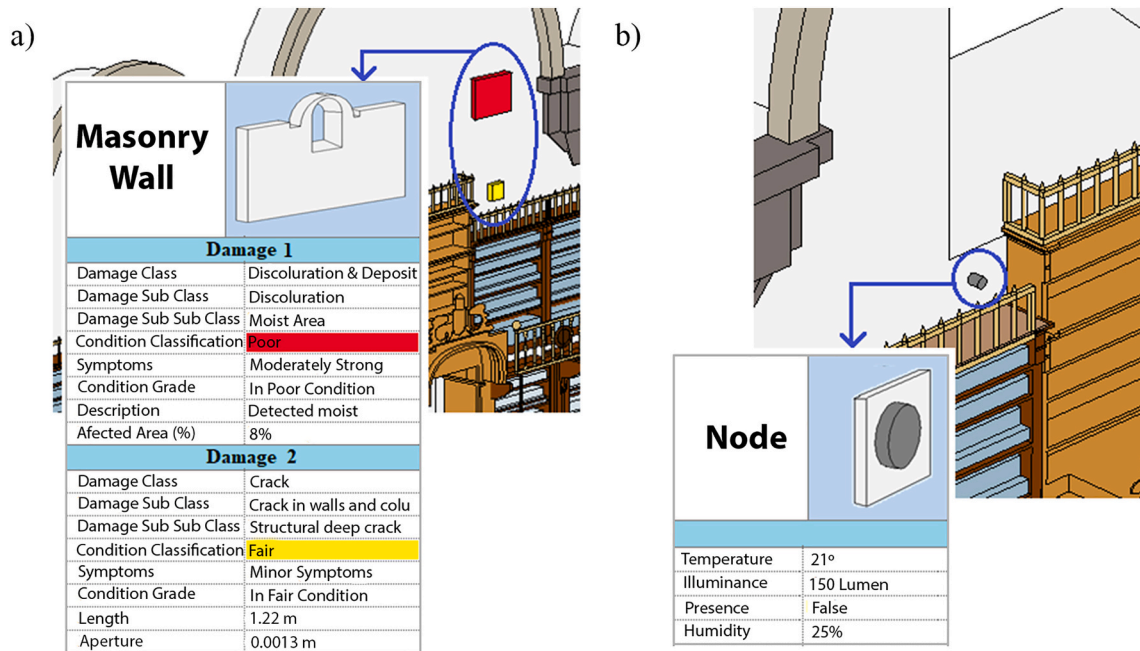
Fig. 6. Damage and node objects within the HBIM model. a) Two damages with different risk attached in a construction element. b) Node patch placed in the library and its parameters.

Damages are represented by means of custom patch-objects, as proposed Sousa et al. [41]. Patch-objects are geometrically simple elements with a low LoD, but with a very complete LoI. In this sense the geometry of each damage is modelled by means of rectangular patches attached to some construction element or asset. Each patch has different size and colour depending on the affected area and relevance of the damage (Fig. 6a). The LoI of this object includes an exhaustive definition of the damage according to the damage atlas developed within the framework of the HeritageCare project [27,28]. This atlas classifies each damage according to a three-level system, i.e. class of damage, sub-class of damage and sub-sub-class of damage. Moreover, these objects include: i) a condition classification; ii) a status risk; iii) urgency to take an action; and iv) affected area. It is worth mentioning that the third information label depends on the values adopted by the status risk (Table 4). The fourth information label refers to the extension of the damage, allowing that the user can introduce the metric values of the damage in two ways: i) by introducing the percentage of the affected area with respect to the constructive element (HeritageCARE approach) [27] or; ii) by introducing the area or volume of this damage. In the case of cracks, this second approach uses two metric parameters: i) the length of the crack and; ii) the aperture of the crack. These parameters allow to monitor the evolution of the damage through time.

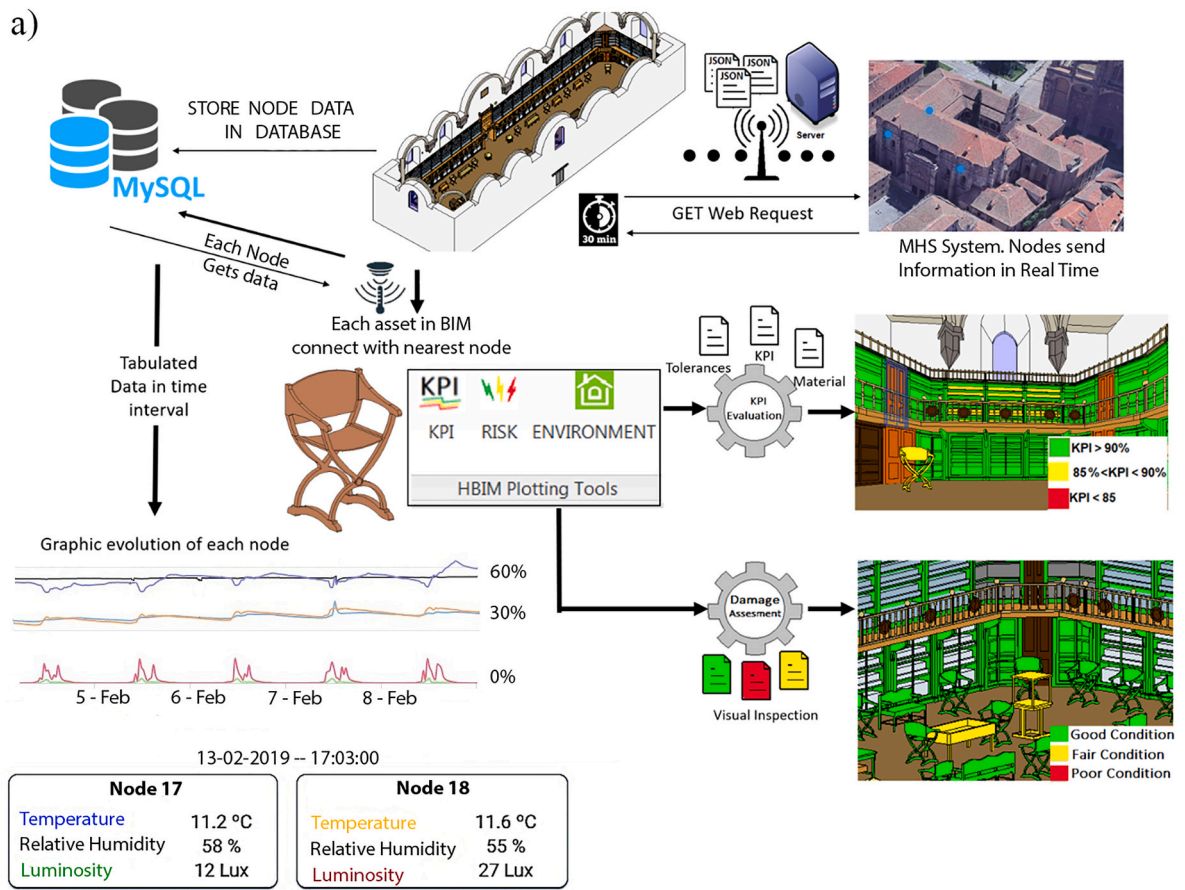
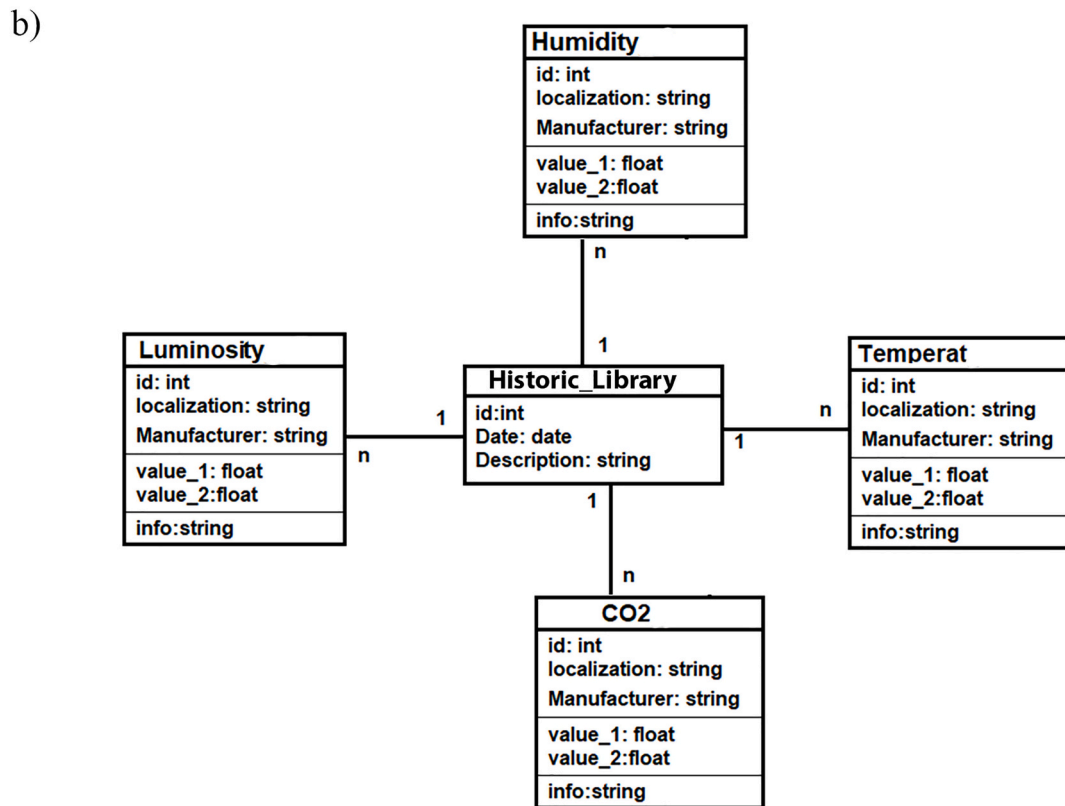
Fig. 9. Connection of the monitoring network with the HBIM environment: a) general workflow; b) Structure of the MySQL database.

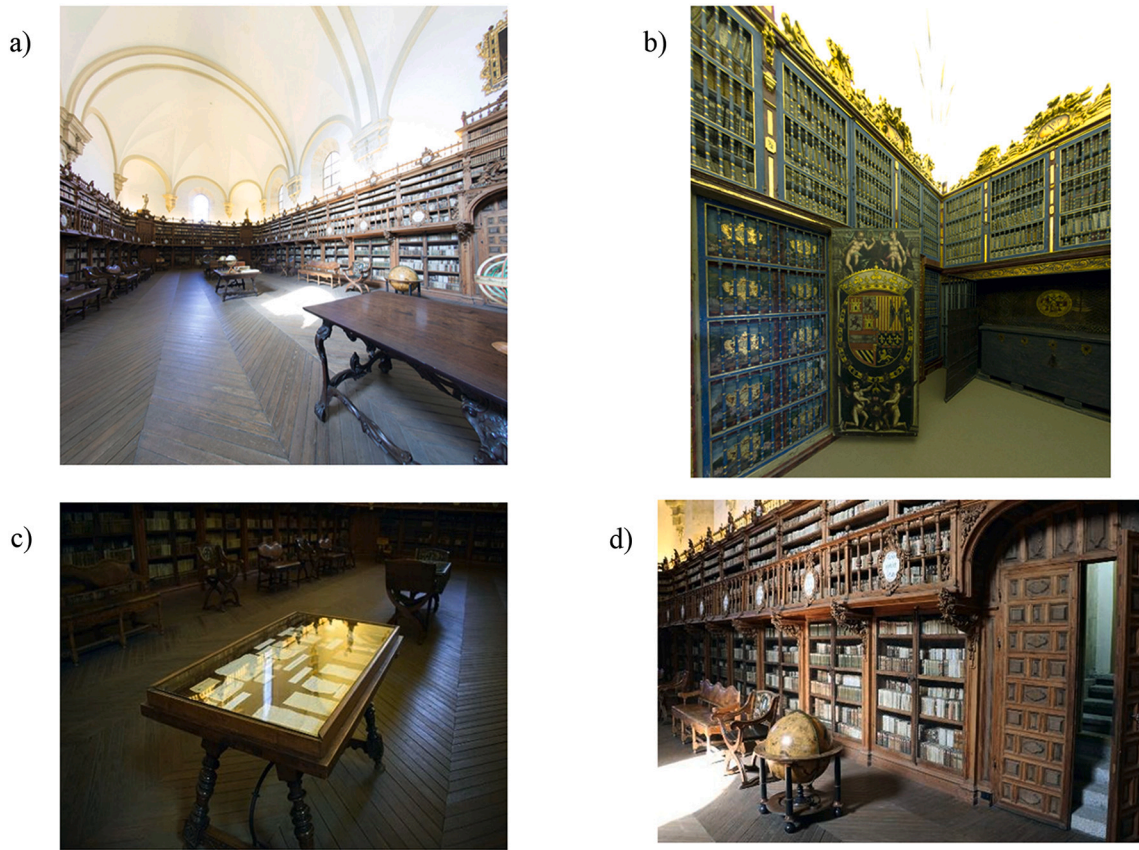
Fig. 11. a) General view of the Library and arrangement of the shelves. b) Manuscript Room. c) Table where several manuscripts are exhibited. d) Books and world globes.

and closed with a Renaissance grille. The gallery is covered with a lunette vault in the centre and a polygonal shape at its ends [44] (Fig. 11a).

and History. The codex *Las Virtuosas y Claras Mujeres*, the incunabulum *Libro de Ajedrez*, *Libro del Buen Amor* or *the Appian's Cosmography* stand out among the books contained in the library. All of them are stored in wooded Baroque style shelves, designed by Manuel de Lara Churriguera [45]. Apart from the documents and books, there are several celestial and armillary wooden spheres, tables, leather and wood chairs and vitrines (Fig. 11).

the 11th century and the incunabula of the XV century (Fig. 11b). These books are organized in two themes of study: i) Canon Law and; ii) Theology. This room is the old medieval ark of the university, initially used to keep money and, later on, forbidden books.

the inspection, a conservation assessment of each construction element was carried out as well. This assessment included an analysis of the damages presented on the elements following the approach proposed by Masciotta et al. [27]. Each damage is defined by the following variables: i) the class of damage; ii) the condition grade; iii) a short description of the damage; iv) its extension along the construction element and; v) a risk assessment. The result of this inspection allows identifying different types of damage located in the following construction elements: i) structural deep cracks on the bearing wall and on the lunette vault due to the initial accommodation of the structure; ii) moist areas on the vault's keystone coming from the timber roof and iii) some discolorations on the timber floor. Apart from these damages the inspection highlighted the absence of UV filter on the windows, which could promote the photo-degradation of some assets as well as inappropriate air ventilation in the *incunabulum* room (Fig. 11b).

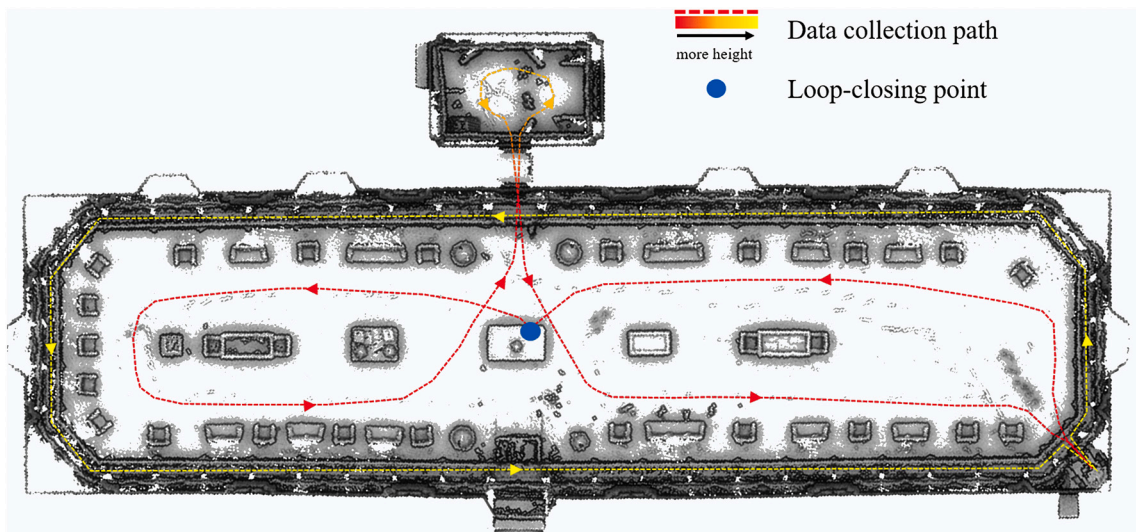
Fig. 12. Data collection path executed for the digitalization of the Library.

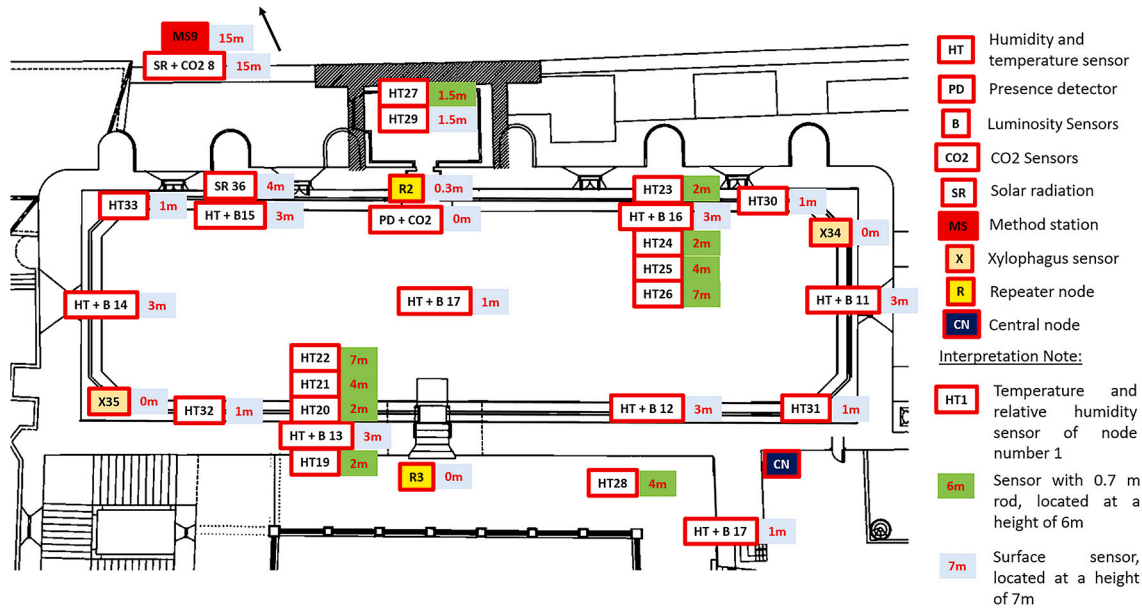
Fig. 13. Nodes distribution in the Library.

The final stage of the in-field works involved the installation of a monitoring network. A total of 39 wireless nodes were placed along the Library (Fig. 13 and Fig. 14): i) 23 for monitoring humidity and temperature; ii) 1 for detecting the presence of people; iii) 8 for monitoring luminosity; iv) 2 for monitoring CO<sub>2</sub> in the environment; v) 2 for monitoring solar radiation; vi) 2 for monitoring the presence of xylophagous; vii) and 1 methodological station. In addition to the two local nodes, there was a central node. This node sent the information to the central computer (Fig. 3). The data thrown by each node can be consulted online, providing real time values (Fig. 15). The monitoring

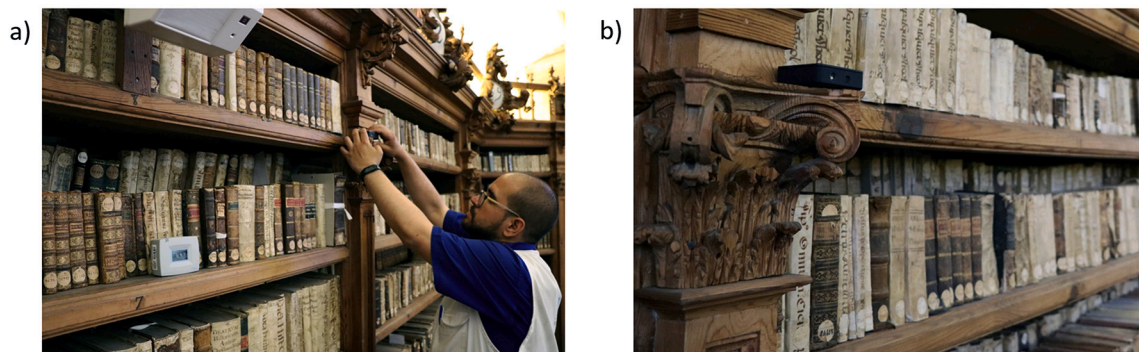
Fig. 14. Nodes installation in the Library.

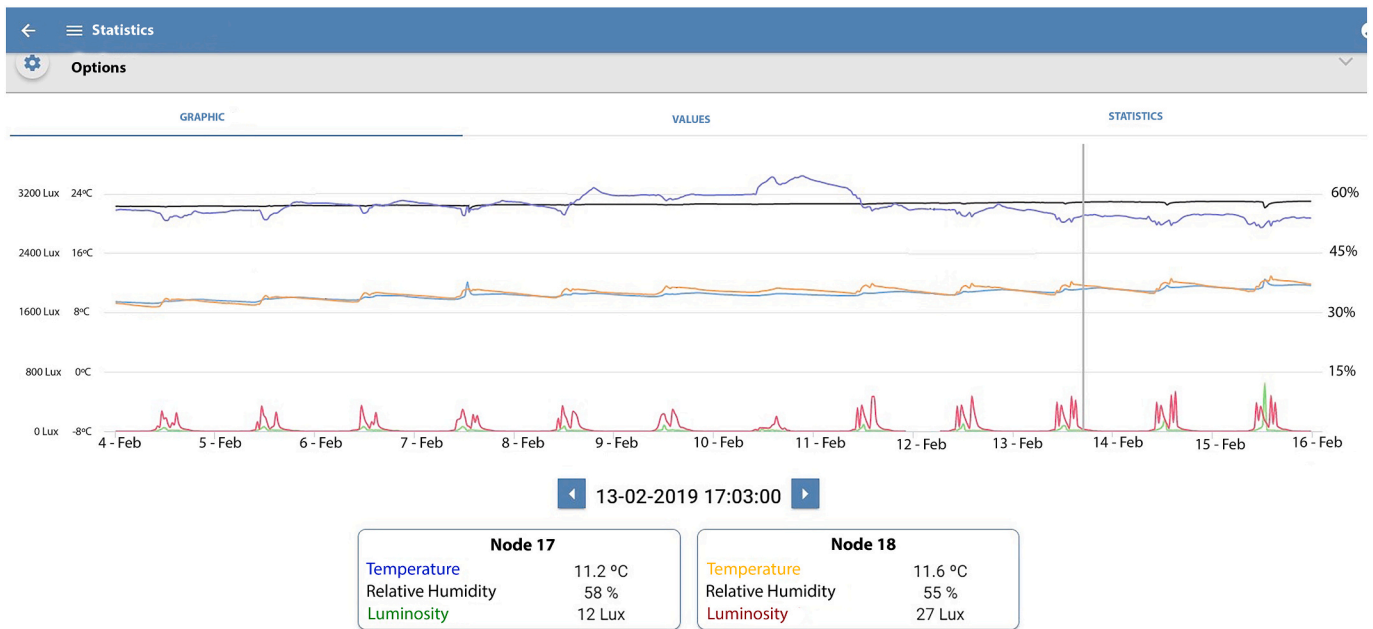
Fig. 15. Real time data captured by the nodes 17 and 18.

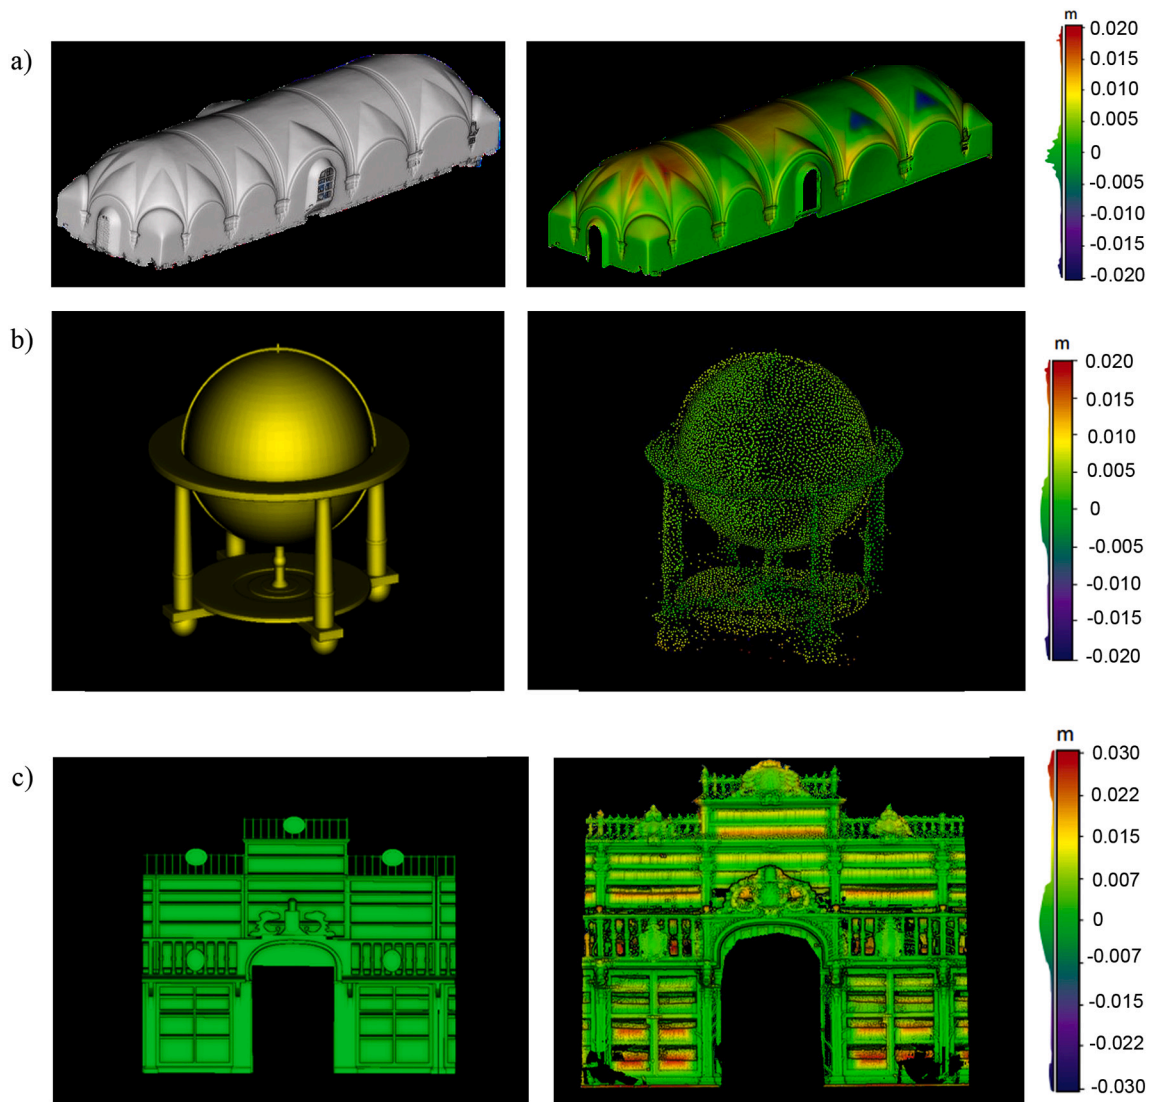
Fig. 16. Discrepancies between the original point cloud and the solid model: a) vault of the Library; b) an armillary wooden sphere and; c) a shelf at the entrance of the Library.

The geometrical model of the Library was obtained by using a semi-automatic reverse engineering procedure. This approach starts with the triangulation of the WMMS point cloud, using to this end a 3D Delaunay triangulation. Then the mesh model is processed by applying the stages proposed by Attene [46], which incorporates several automatic and sequential stages: i) a hole filling stage using the radial basis function [47]; ii) a repair stage based on the minimum threshold distance algorithm [48]; iii) a topological and geometric noise removal stage through the use of local re-triangulation methods and anti-aliased Laplacians filters [49]. After this processing stage the mesh is modelled in order to create a suitable solid model for BIM purposes. For basic shapes (e.g. walls or spheres) the RANSAC Shape Detector algorithm was used [50]. For complex shapes a section-based modelling procedure was applied as suggests Sánchez-Aparicio et al. 2019 [40]. All these stages were complemented with standard reverse engineering procedures such as the extrusion for modelling the thickness of different elements (e.g. the walls or the vaults), as well as Boolean operators for creating the windows. Fig. 16 shows a comparative study between several solid models and their corresponding point clouds. As could be observed, the reverse engineering procedure carried out allows to reproduce with an acceptable accuracy the different constructive elements and assets placed within the Library. The largest discrepancies take places on those parts with complex decorative elements which were considered not relevant for the preventive conservation policies of the Library. These decorative elements were included in the information tab of the families (see

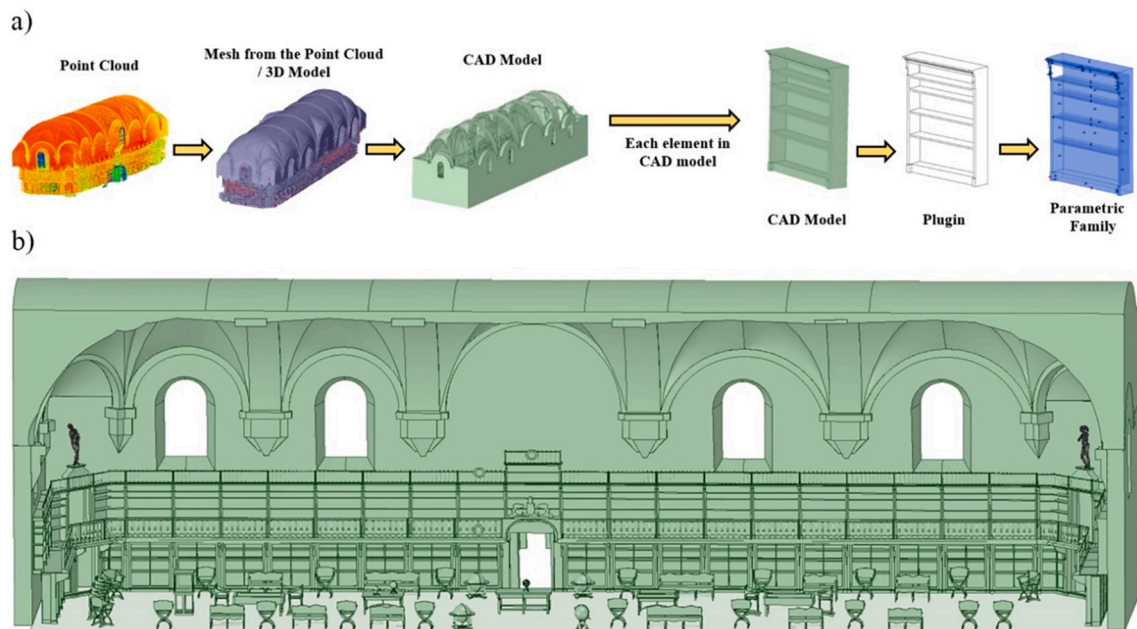
Fig. 17. Geometrical model of the Library: a) workflow; b) detail of the final solid model.

The different solid models generated (Fig. 17) were introduced within the BIM environment, using the Heritage 5.0 Plugin to assign the same information attributes to each specific family. The LoI of each asset, node or damage include several common parameters between them (i.e. Condition grade, Inspection Periods, Short Description, Asset ID or Status), which have different values in each particular family. The Heritage 5.0 Plugin allows to add all the common attributes to the desired family in an automatic way, making this task easier and faster (Fig. 18). The data introduced of each family was obtained from the technical inspection (see Section 3.2.1). Additionally, the damages and nodes from the monitoring network were imported by means of path-based families (Fig. 19).

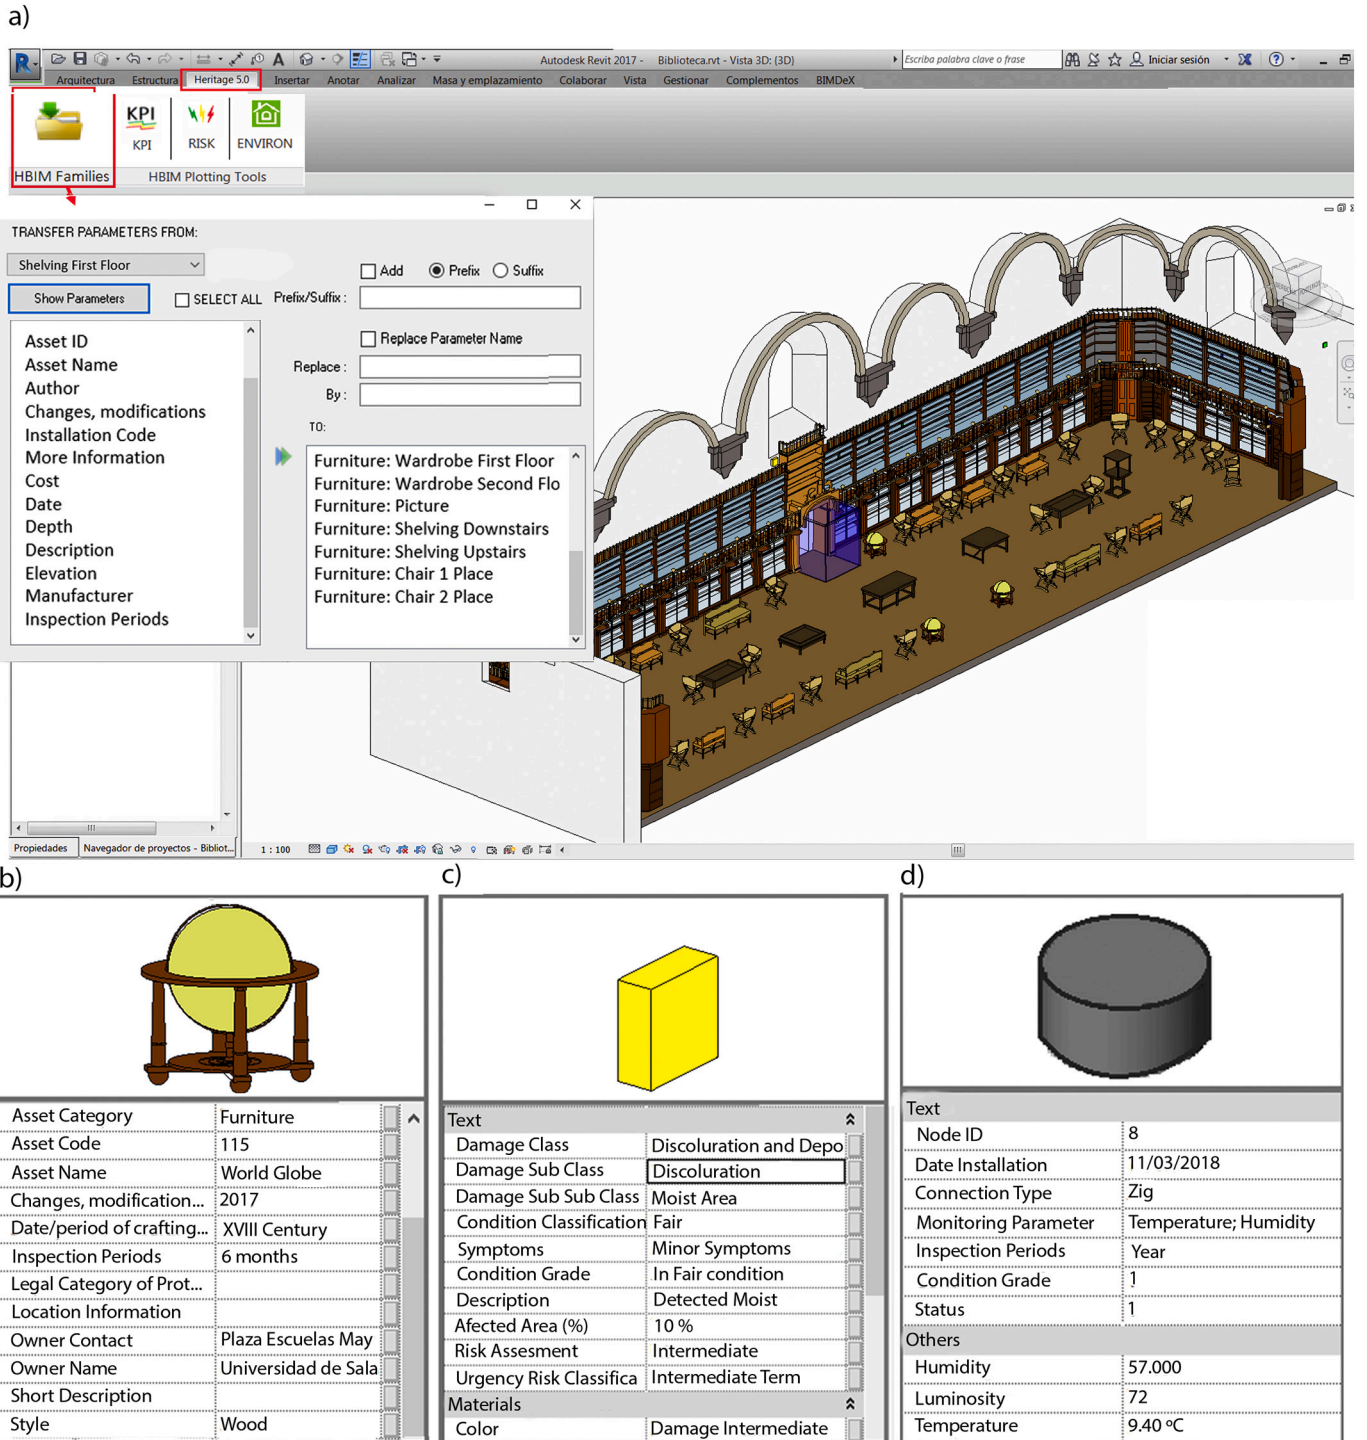
Fig. 18. Application of families to the different solid models created: a) assigning a new family; b) movable asset; c) damage observed in the wall and d) node of the monitoring network.

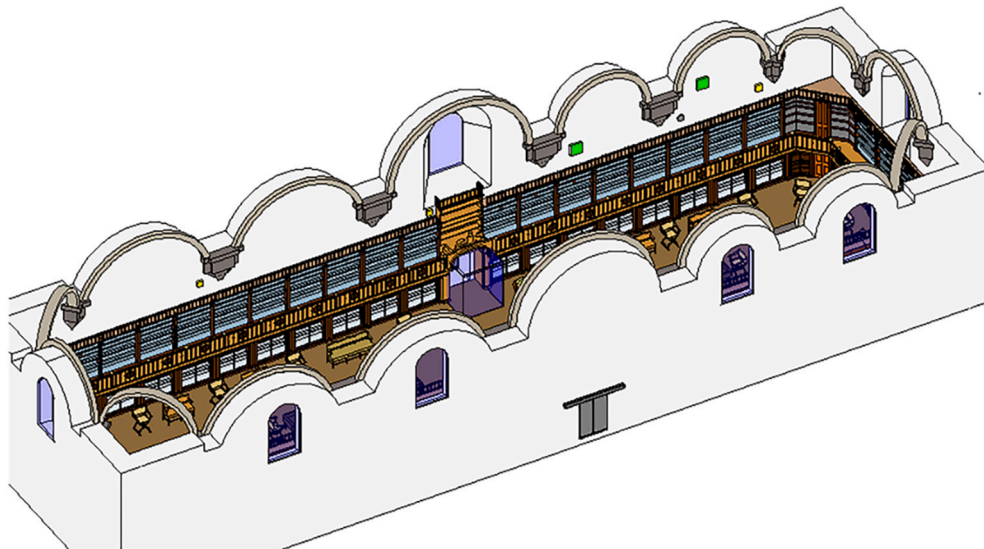
Fig. 19. General view of the HBIM model on which is possible to observe the path-based families used to represent the damages and nodes of the monitoring network.

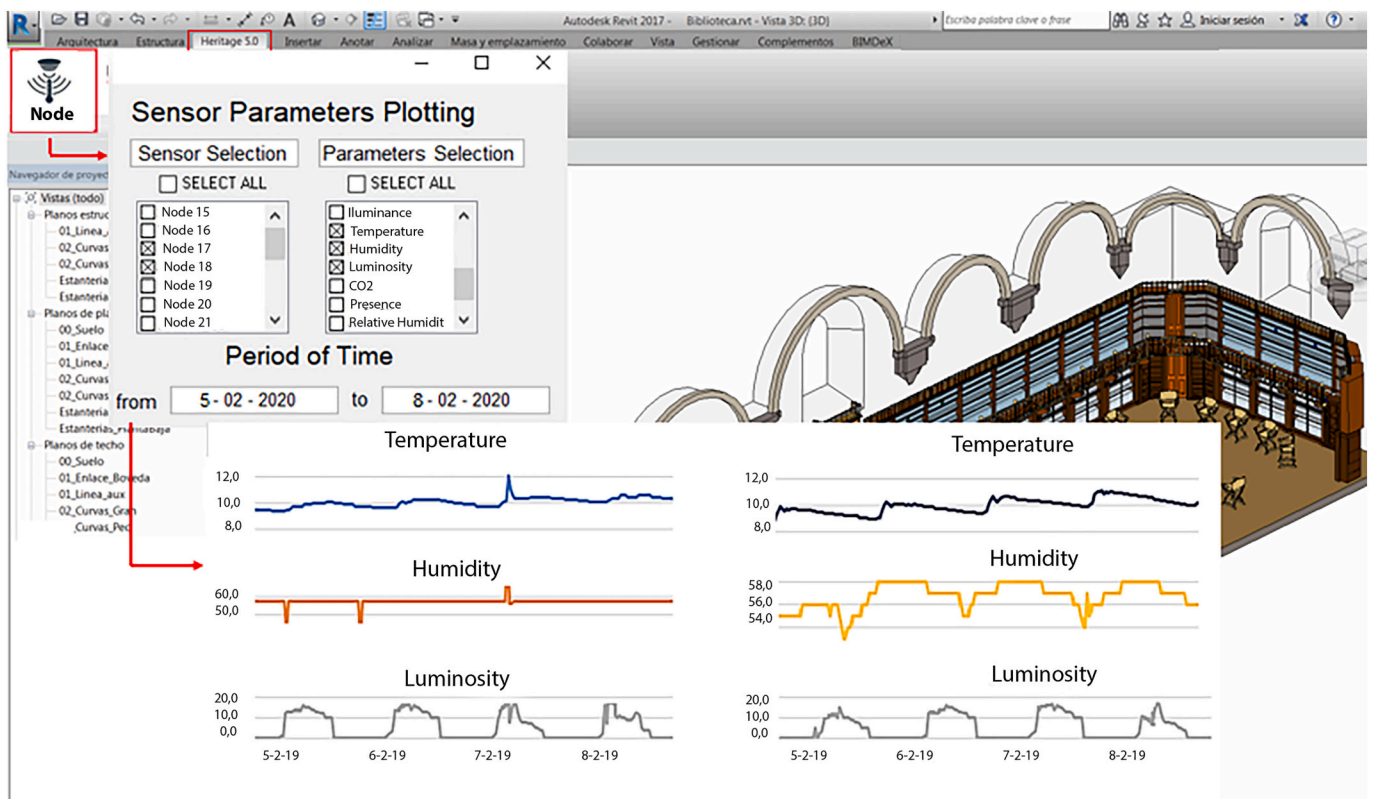
Fig. 20. Appearance of the Heritage 5.0 plugin when the user consults the data of one node.

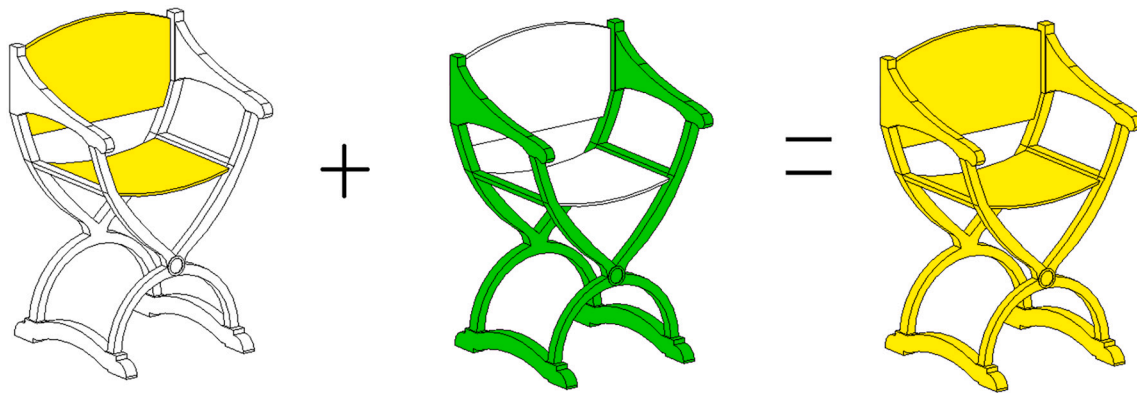
Fig. 21. Computation of the KPI for objects with different materials. Green colour represents a KPI above 90% and Status = 1. Yellow colour represents a KPI between 85% and 90% and Status = 2. (For interpretation of the references to colour in this figure legend, the reader is referred to the web version of this article.)

Additionally, the data stored in the database is used to compute the KPI on each asset of the HBIM. In this case the user can decide the range of dates included in the computation of the KPI. It is worth mentioning that the plugin computes different KPI for the same node according to the different materials presented on the assets (see Section 2.4). Finally, the nearest KPI is assigned to each asset. This KPI is introduced within the *Status* label as an integer value which varies from 1 (green) to 3 (red). Each family has a *Status* label per measured parameter (i.e. Status for temperature or Status for relative humidity). In those cases on which the family is integrated by different types of materials, and thus by different ranges of admissible tolerances, the system uses the most unfavourable KPIs to colorize the family (Fig. 21).

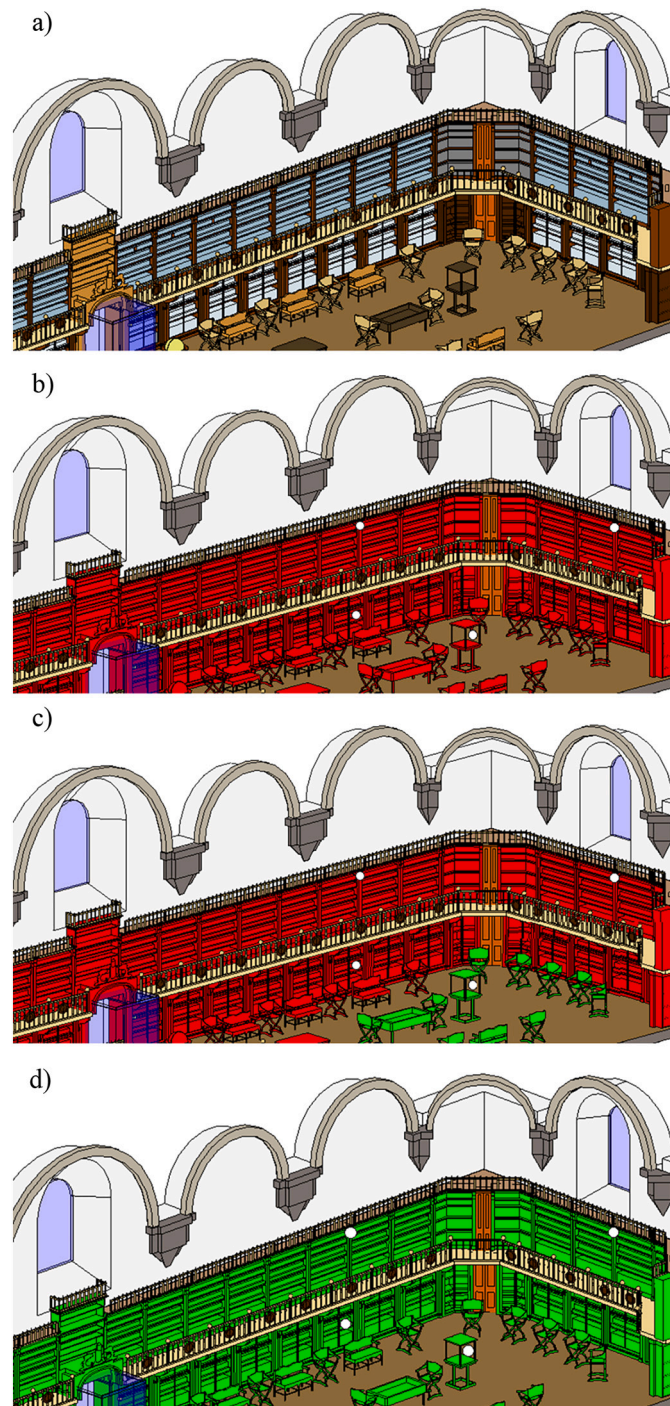
**Fig. 22.** HBIM model with the KPI plotted: a) general view; b) Computation of the KPI for temperature conditions; c) Computation of the KPI for Humidity conditions And; d) Computation of the KPI for Luminosity conditions. White circles represent the nodes position. The assets plotted in green has a *Status* label of 1, assets in yellow has a *Status* of 2 and assets in yellow a *Status* of 3. (For interpretation of the references to colour in this figure legend, the reader is referred to the web version of this article.)

carried out on the Library, considering as the reference period one month. Table 7 and Fig. 22 shows the results of computing the KPI for one cold month such as February. As could be observed, most of the assets are plotted in red which suggest that the bioclimatic conditions could promote some damage on the assets. In all the cases the temperature ranges are not within the acceptable ranges defined in Section 2.5, showing an average value of 12.2 °C with a minimum value of 10.9 °C and a maximum temperature of 16 °C. For this month the relative humidity has an average value of 62% with a minimum value of 58% and a maximum value of 64%, exceeding in most of the cases the admissible ranges (Table 5). Regarding the luminosity, all the nodes of the monitoring network showed optimal values (up to 95%) even for very sensitive assets such as books or manuscripts.

Similar results were obtained for one warm month (July). In this case the average temperature exceeds the recommended upper bound with an average, maximum and minimum values of 25.4 °C, 27.9 °C and 18.6 °C respectively. These values of temperature could accelerate the degradation of the assets as well as becoming uncomfortable for visitors. The relative humidity during this month was also outside the admissible range, with an average value of 45%. This low value could cause assets to become dry and brittle.

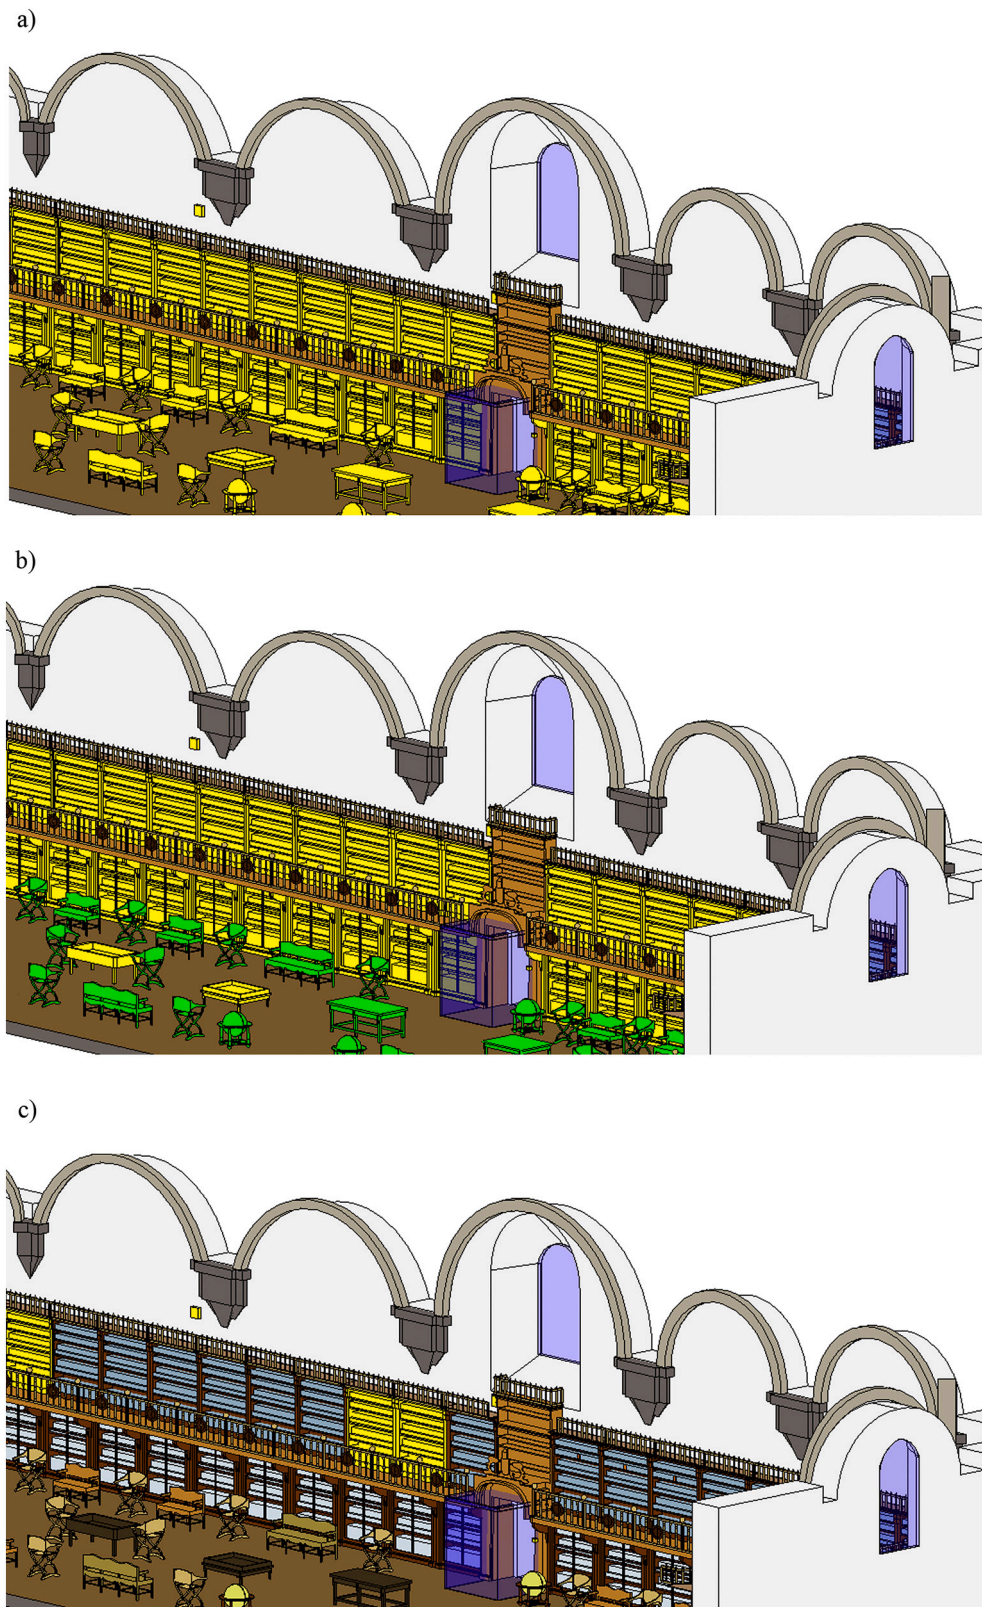
Fig. 23. Graphical plots within the HBIM model: a) Urgency risk considering the absence of ultraviolet (UV) filter and a proper ventilation system; b) urgency risk according with the conservation status of the assets and; c) assets with presence of discolouration.

plugin highlights the assets with a specific damage (Fig. 23c).
