Heritage site preservation with combined radiometric and geometric analysis of TLS data

Historical constructions
Masonry construction
Damage mapping
Construction diagnosis
Terrestrial laser scanner
Radiometric classification
Geometric features

construction promoted by the presence of chemical, biological and physical alteration agents. To validate the proposed strategy, a historical construction inside the Fortress of Almeida, in Portugal, was chosen as a case study: the San Francisco Master Gate.

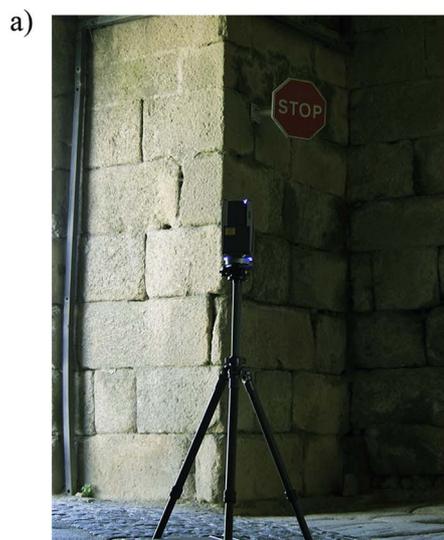
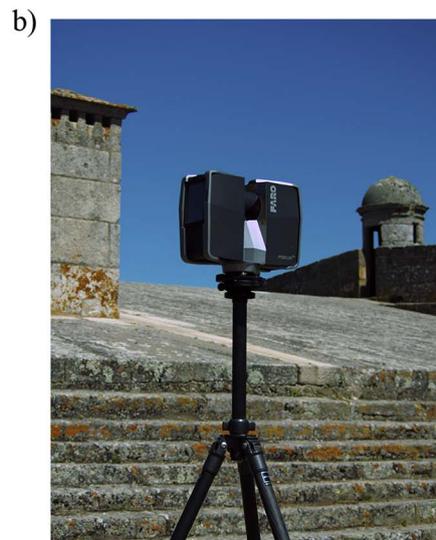
Fig. 1. TLS system during the data acquisition: (a) inside the barrel vault and (b) on the roof.

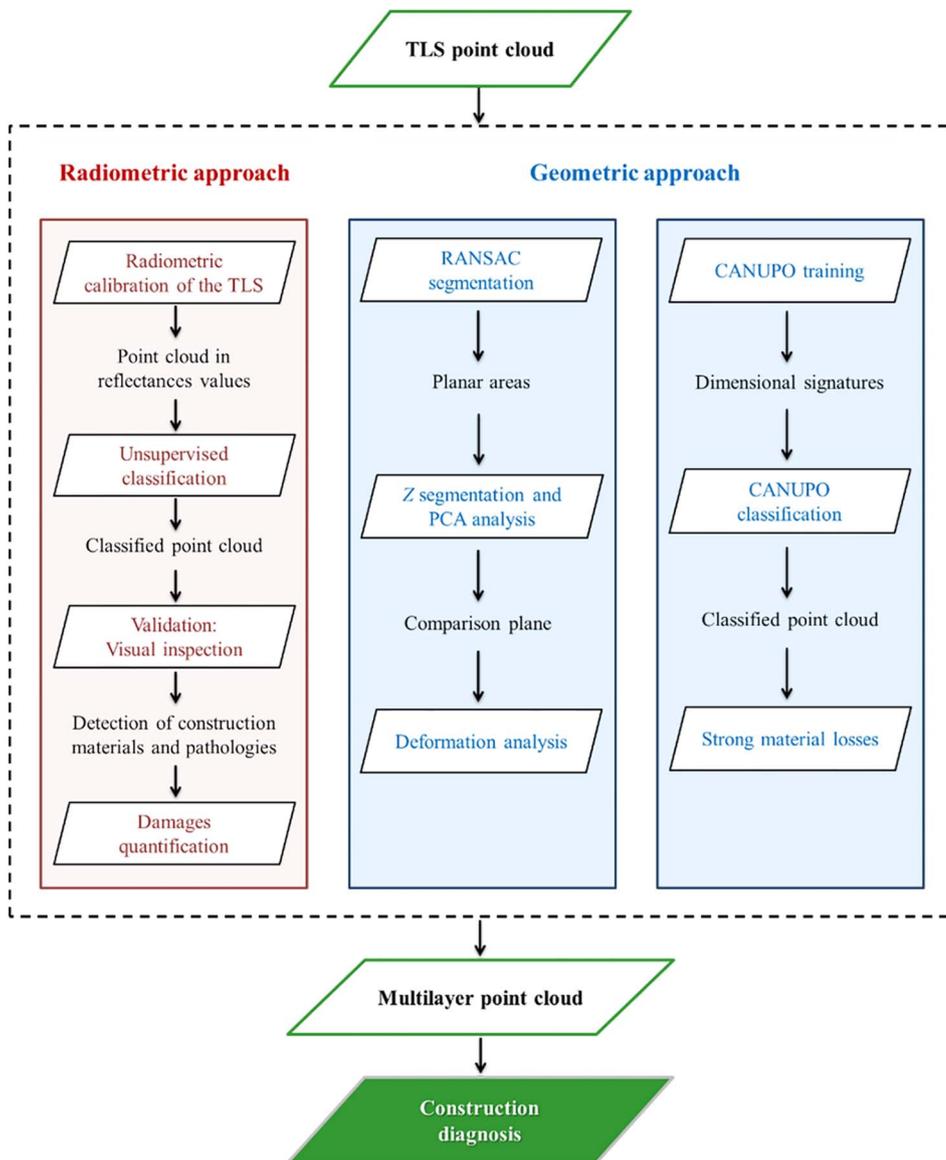
Fig. 2. Scheme of the workflow followed to perform the mapping and evaluation of pathologies in the constructions.

in Fig. 2, the characterization of visual indicators of damage in the selected constructive elements (façades and barrel vault) were evaluated. To that end, a radiometrically calibrated TLS was used to analyse the backscattered intensity in surface reflectivity values instead of raw digital levels (Fig. 12).

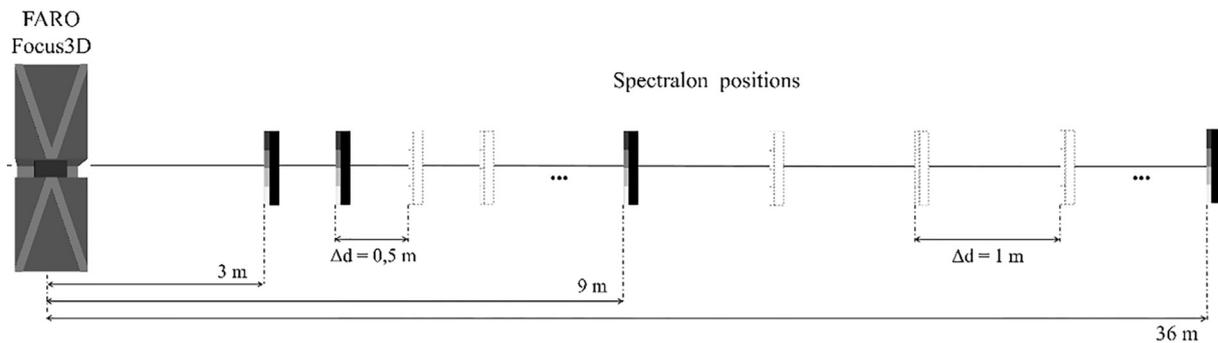
Fig. 3. Illustration of the FF3D120 data acquisition design to study the behaviour of the backscattered intensity regarding different scanning distances.

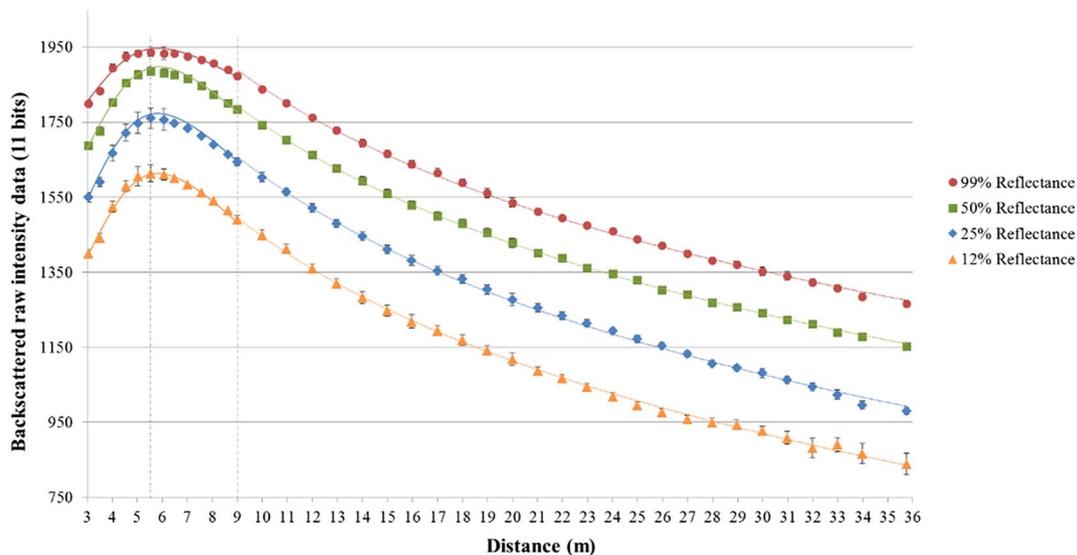
Fig. 4. FF3D120 backscattered intensity behaviour with distance. Measurements from a 4-panel Spectralon placed at different distances increments.

each acquisition was made, resulting in the graph illustrated in Fig. 4.

For this range of distances, the logarithmic behaviour of the FF3D120 backscattered intensity data was adjusted using the next empirical equation (Eq. (1)).

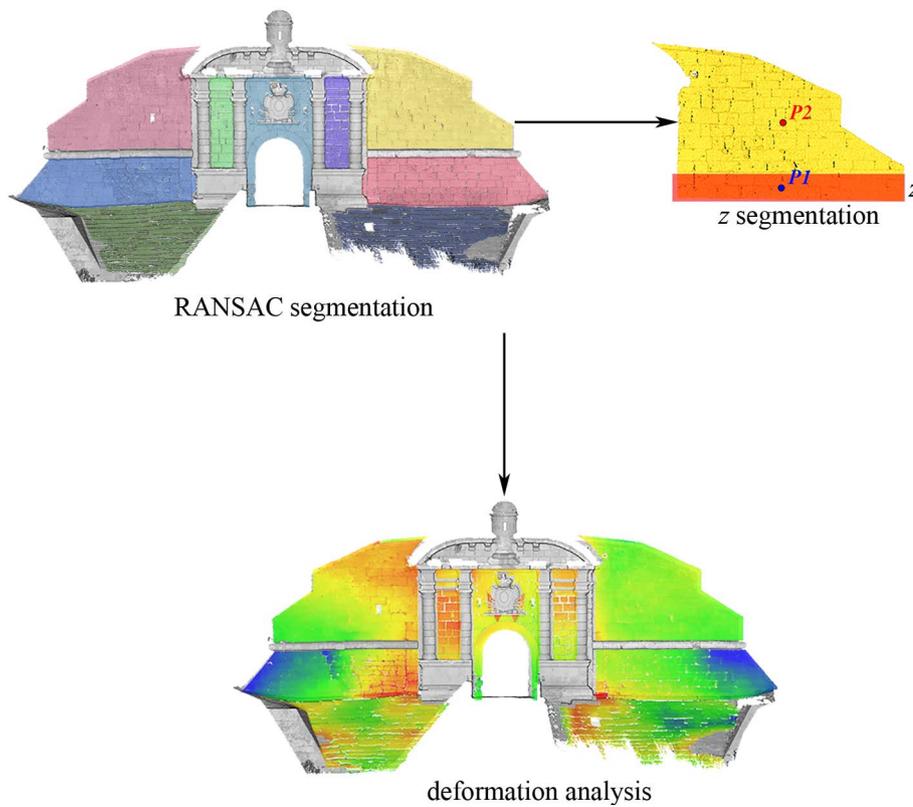
Fig. 5. Graphical representation of the workflow followed to evaluate the deformations in the façade.

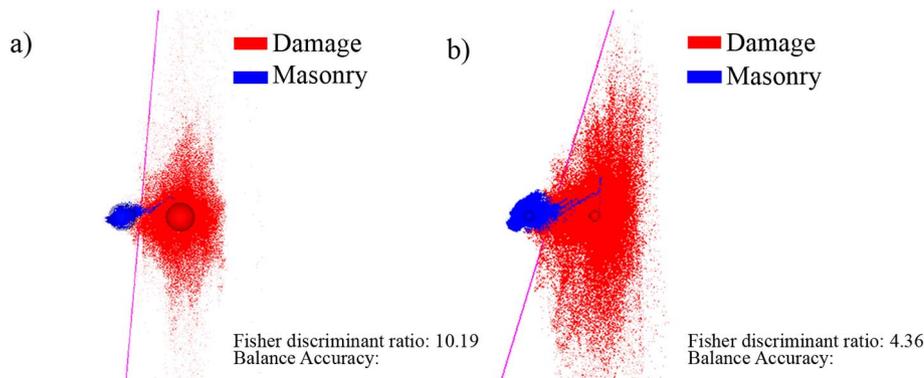
Fig. 6. Results during the CANUPO training: (a) Classifier A; (b) Classifier D. In red is the damage class, in blue masonry and in magenta the hyperplane of maximal separability. (For interpretation of the references to colour in this figure legend, the reader is referred to the web version of this article.)

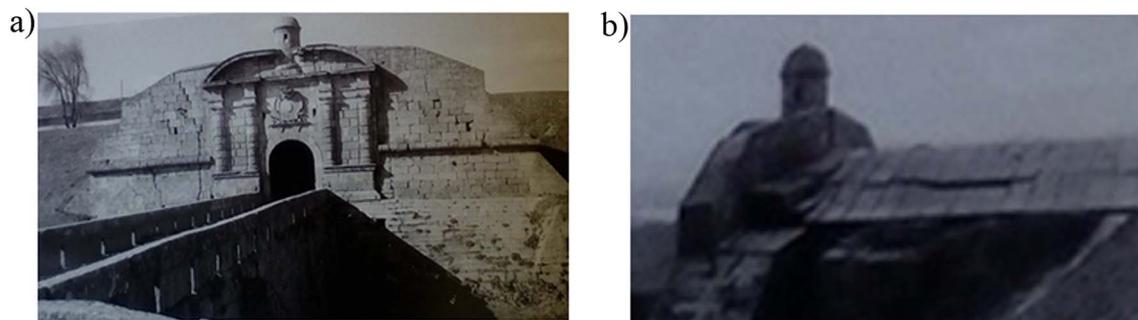
Fig. 9. State of damage in the Master Gate of San Francisco in 1962: (a) façade B with vertical cracks and loss of material; and (b) crack on the roofing system (stone roof).

The French invasion in 1810 will pass down in history as the most destructive event both for the fortress and the Master Gate of San Francisco. The constant bombing and the explosion of the gunpowder storehouse destroyed the castle and generated great damage to the fortress and specifically to this Master Gate. By 1815, the order to start reconstruction work on the Gate was issued, although since the war ended in 1814, the urgency of reconstruction was low and the construction works were kept to a minimum. It was not until the 1960s that a significant restoration project occurred (Fig. 9).

of-plane deformations on the vertical plane of the façade. No tilting configuration is visible, since the deviations are almost constant with a maximum of 0.13 m. The deviations are most probably due to construction defects or derived from the intensive reconstruction carried out during 1986 (Fig. 9a).

Concerning the roof, a large discrepancy with respect to the hypothetical original roof can be observed, with a maximum value of 0.21 m (Fig. 18). This disparity increases in the centre of the construction system (the part with less thickness) suggesting an accommodation of the infill and corroborating the significance of the reconstruction carried out during 1960 and 1986 (Fig. 9). The greatest deviations are due to the significant permanent deformations that occurred around the crack that is now apparently stabilized (Fig. 9b).

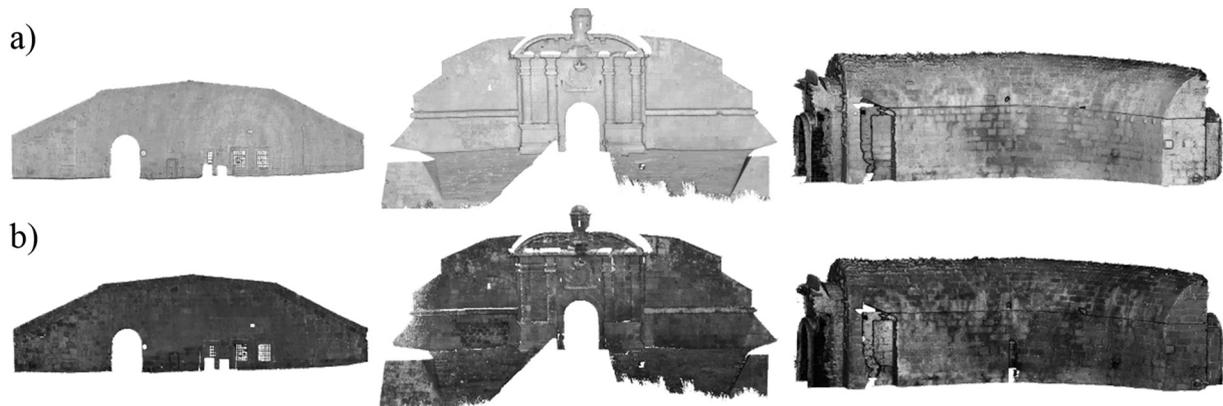
Fig. 12. Comparison between the point clouds: (a) raw intensity data in digital levels and (b) in reflectance values after applying the radiometric calibration.

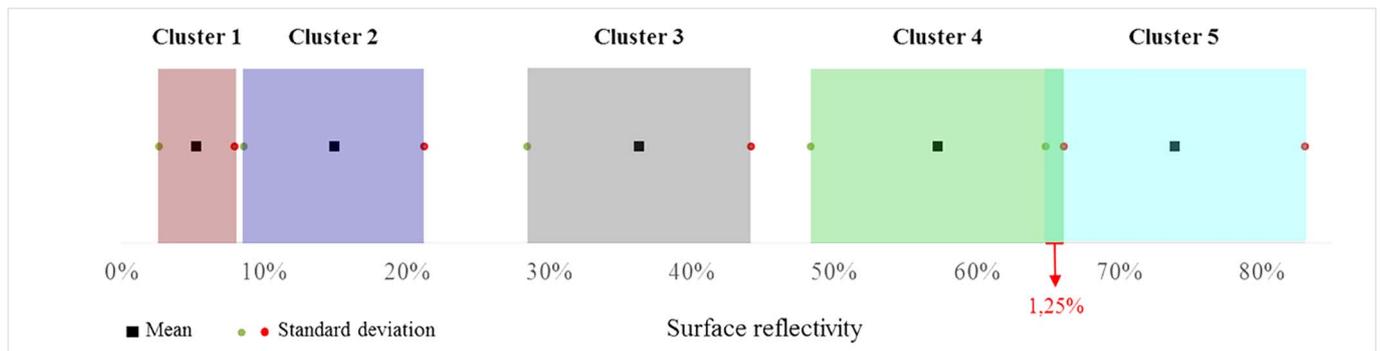
Fig. 13. Graphical representation of the separability between clusters. It is worth mentioning the presence of a little overlap between cluster 4 and 5.

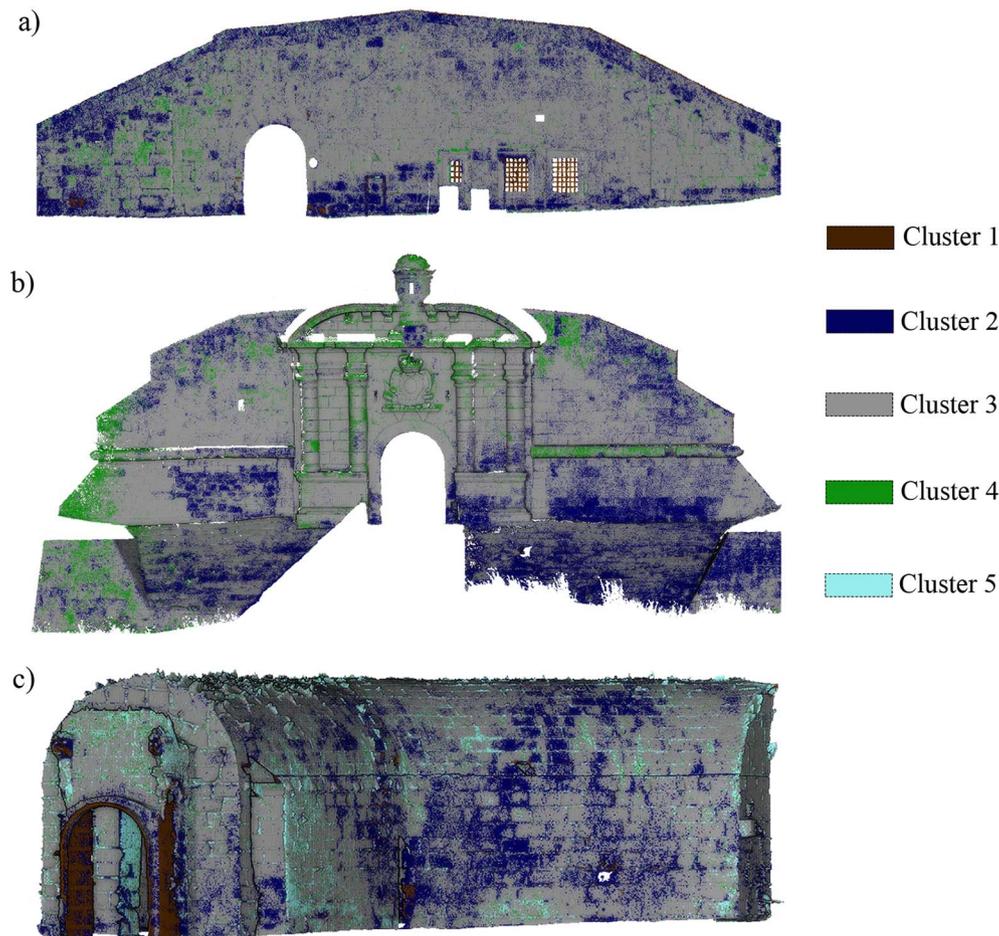
Fig. 14. Results obtained for the Fuzzy K-means unsupervised classification carried out: (a) façade A; (b) façade B; and (c) barrel vault.

By applying the Fuzzy K-means clustering algorithm [31], each point of the point cloud was coloured according to the more related cluster of the five established for the three constructive elements studied. As Fig. 14 shows, in all three classified models, there were areas

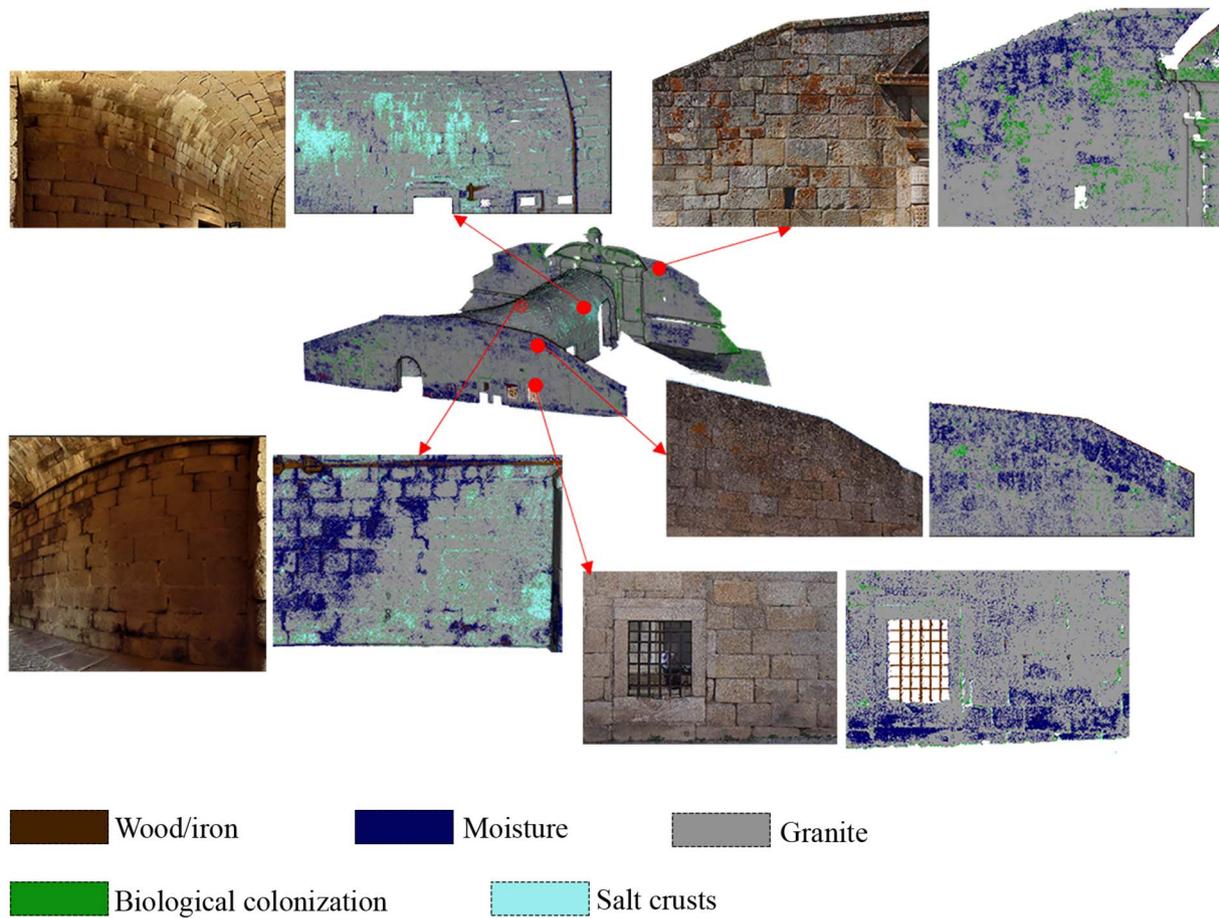
Fig. 15. Validation and interpretation of the classification through an expert visual inspection.

Focusing on the pathological analysis, the results show that in the three analysed locations, there is a high percentage of moisture (black deposit) (Fig. 15). In contrast, there is not a similar presence of biological colonization or salts in the three constructions. Façade B presents a greater affection for biological colonization (mainly orange lichens) due to its orientation, and the barrel vault has a larger area affected by efflorescence than the rest.

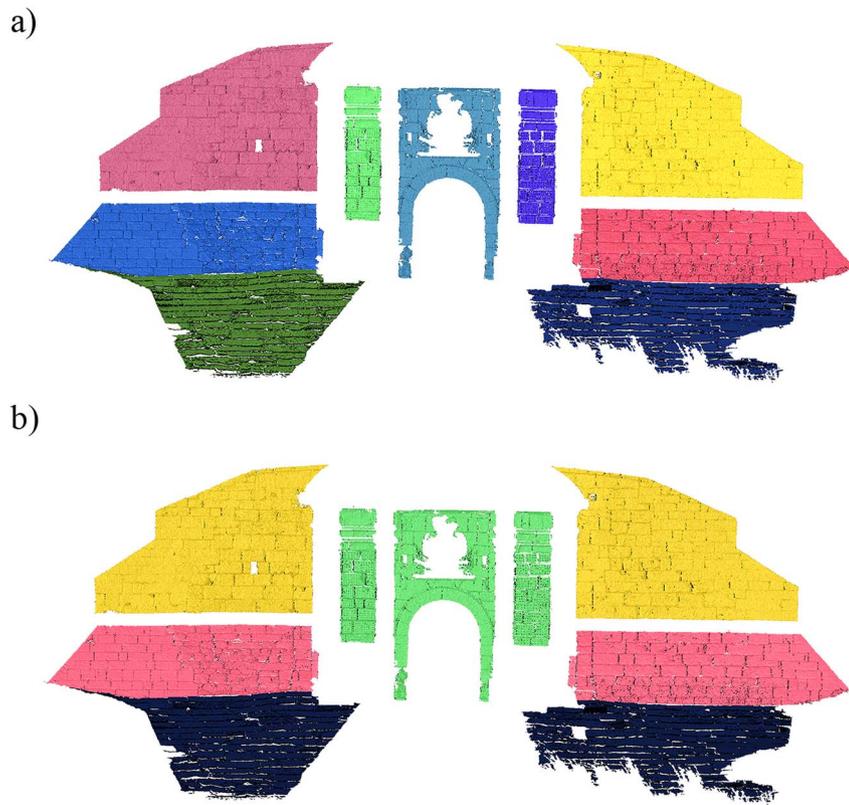
Fig. 16. Segmentation carried out on façade B: (a) clusters obtained through the RANSAC shape detector; (b) planes clustered according with their similarity.

Regarding façade B, several planes were obtained by means of the RANSAC shape detection, requiring an additional clusterization process. This segmentation was based on the similarity, in terms of plane normal and centroid position, between clusters (Figs. 16, 17 and 18).

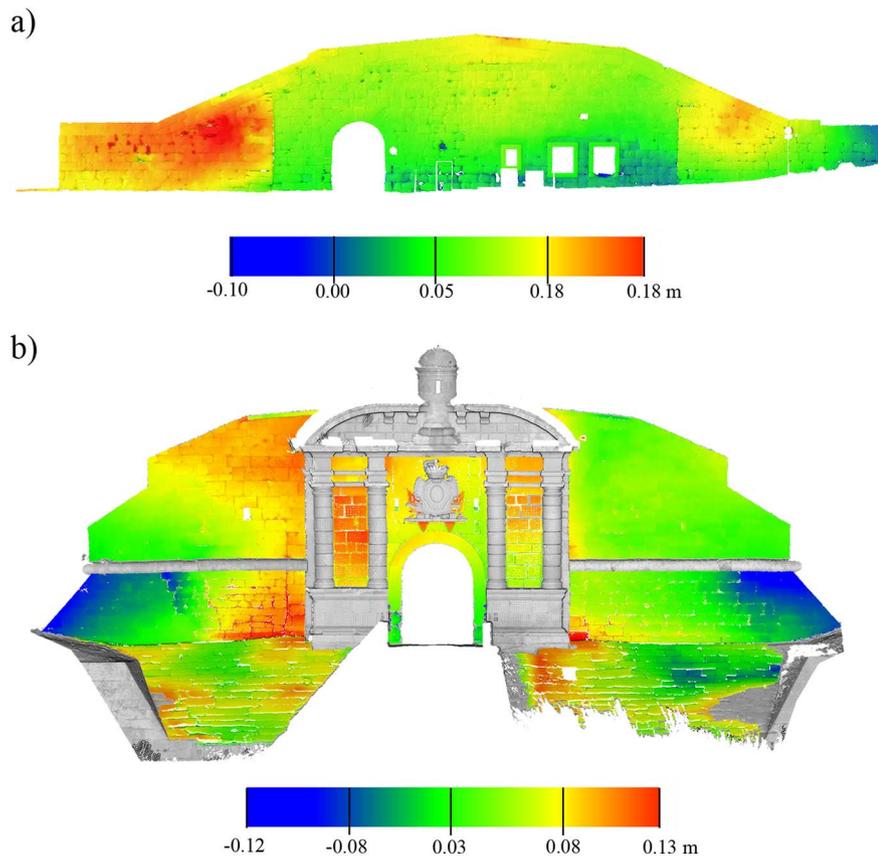
Fig. 17. Results obtained during the deformation analysis: (a) façade A, with a unique vertical plane; and (b) façade B with vertical and non-vertical planes.

With respect to the deformations, façade A shows out-of-plane deformations (with a maximum displacement of 0.18 m) on the lateral retaining walls (Fig. 17b). Those two walls are completely split for the gate building by a construction joint (Fig. 23). On the left side, the maximum deformations are close to 0.18 m but with a random distribution without showing the tilt of the wall. This deformation could

be due to a construction defect. On the other side, the maximum deformation appears on the top of the wall, indicating a local tilt on the wall or a bubble in the wall. The maximum value is also close to 0.18 m (Fig. 17b). Concerning Façade B (Fig. 17a), it is possible to observe out-

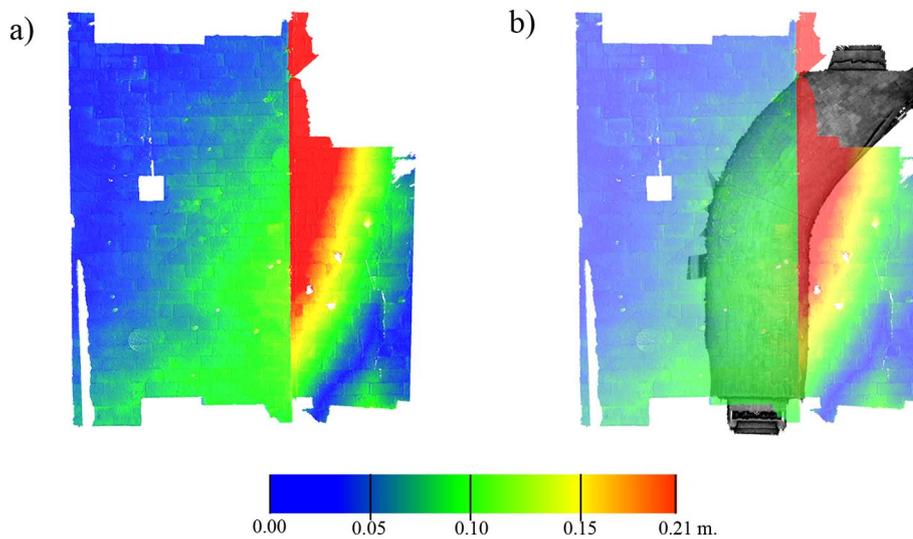
Fig. 18. Deformation analysis carried out on the roof: (a) graphical representation of the results obtained; (b) relation between the roof's deformation and the barrel vault position.

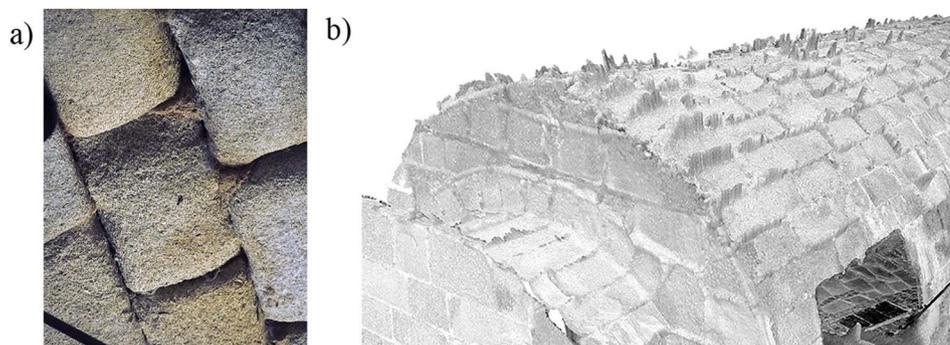
Fig. 19. Block's blistering (a) Photo taken during the visual inspection; (b) Detail of part of the barrel vault point cloud.

Results obtained after the radiometric approach carried out on the barrel vault highlight a strong presence of salts and moisture (Fig. 19). These pathological processes, which promote the blistering of the masonry blocks (especially on the joints), are characterized by a local change in the dimensionality of the constructive element. Therefore, they require the use of an additional strategy to characterize these areas (Fig. 19).

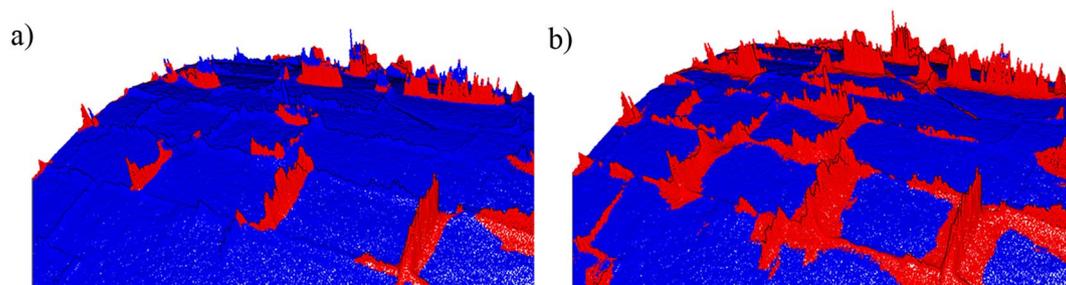
Fig. 20. Results obtained during the training phase, in red are the damage areas and in blue non-damaged areas: (a) Classifier A; (b) Classifier A_mod. (For interpretation of the references to colour in this figure legend, the reader is referred to the web version of this article.)

Classifier A shows the best qualitative and quantitative results (Table 4). However, it is possible to observe the presence of a high number of false negatives (Fig. 20a). This phenomenon arises from the block and the joint roughness on small scales, showing a dimensionality response similar to the eroded parts. According to this response, classifier A was tuned by manually changing the hyperplane position (classifier A_mod). This modification declined the quantitative indices (Table 5) slightly but, from the qualitative point of view, led to more

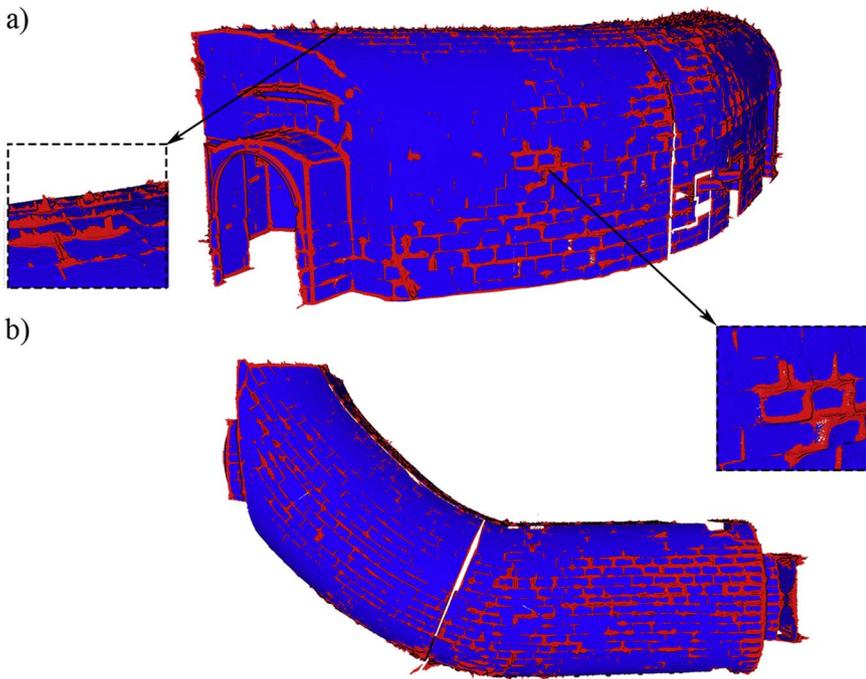
Fig. 21. Point cloud segmented by the A_{mod} classifier (in red are the damage areas, in blue non-damage areas): (a) isometric and (b) plant view of the of the barrel vault. (For interpretation of the references to colour in this figure legend, the reader is referred to the web version of this article.)

In general terms, the CANUPO approach shows excellent correlation with the damage exhibited on the barrel vault (Fig. 21a), highlighting the most eroded parts of the structure. However, some mismatches can be found on the edges of the point cloud as well as in the shadow areas, suggesting the need to use additional filters to enhance the results obtained.

Finally, on the barrel vault, the high presence of salts and moistures (7.85% and 15.83% of the total surface) have promoted the disaggregation of the masonry blocks, especially in the intersection between the barrel vault and the façade B (Fig. 21), due to the

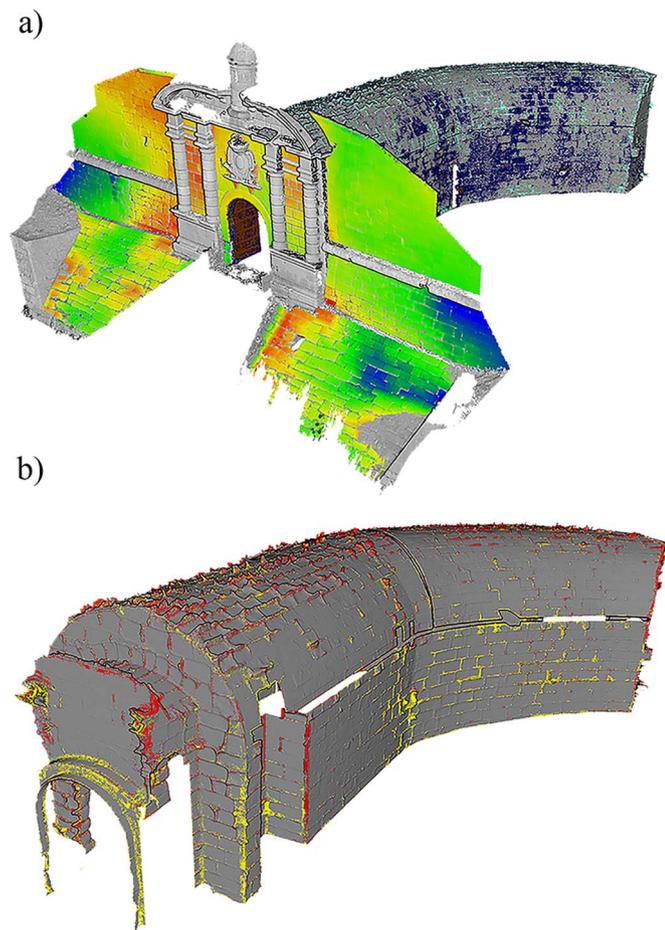
Fig. 22. Multilayer point cloud: (a) isometric view with the deformation state of the façade B and the pathological processes detected by radiometry on the barrel vault; (b) relation between pathological processes presented on the barrel vault. In red, areas affected by strong erosions and salts, in yellow areas with erosions and moistures. (For interpretation of the references to colour in this figure legend, the reader is referred to the web version of this article.)

construction but also about the damage presented on the construction (Fig. 22a).

Considering the pathologies detected at the barrel vault, an analysis of the most important parts (areas with strong erosion as well as the presence of moisture or salt crusts) was performed, combining the results provided by the radiometric classification with the results obtained by the CANUPO classifier (Fig. 22b).

atmospheric contamination and the infiltrations of salts and water derived from the infill placed on it. Part of these infiltrations, specifically 12.34% of them, are present on the most eroded parts of the barrel vault (Fig. 22b).

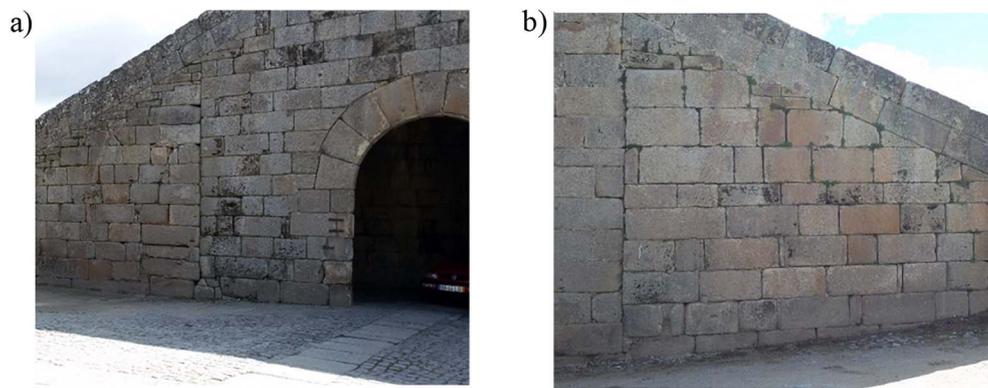
Fig. 23. Construction defects observed on façade A: (a) on the left side; and (b) on the right side.
