PHD DISSERTATION

Damage evaluation in constructions based on geomatic and dynamic approaches

Ávila, 2016

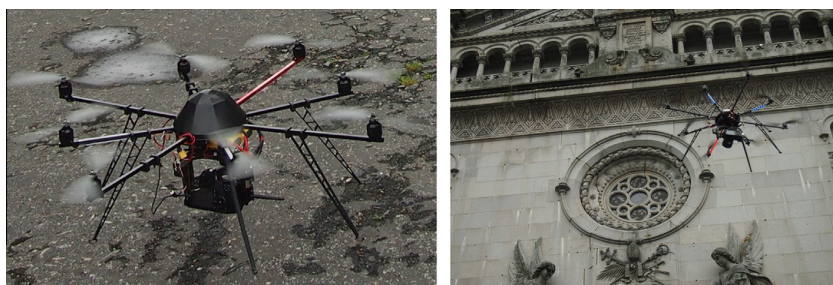
Fig. 1. Image of the UAV platform and the digital camera (left). Image taken during the data collection of the point cloud SfM (right).

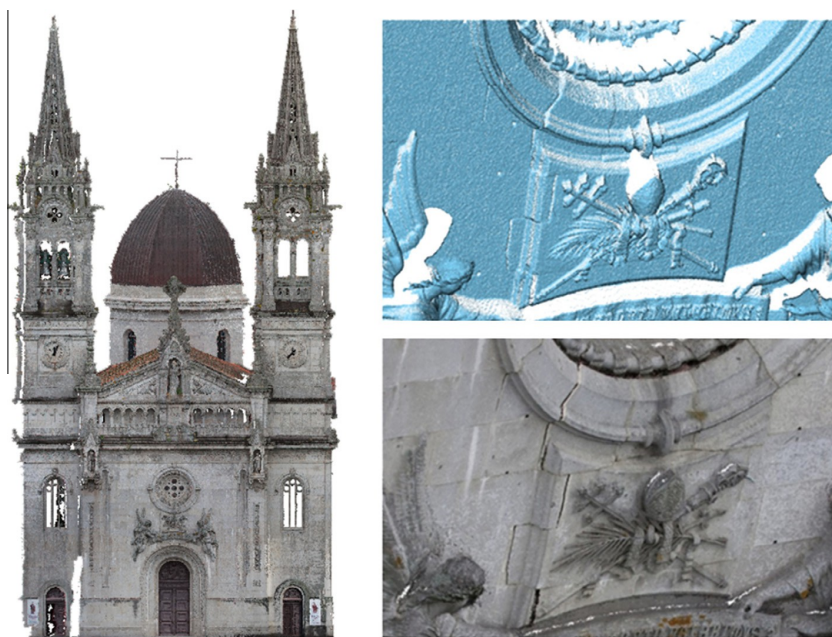
Fig. 7. Front elevation of the point cloud obtained through SfM technique and PW software (left). Detailed comparison between the laser scanner point cloud and the one obtained in PW software (right).

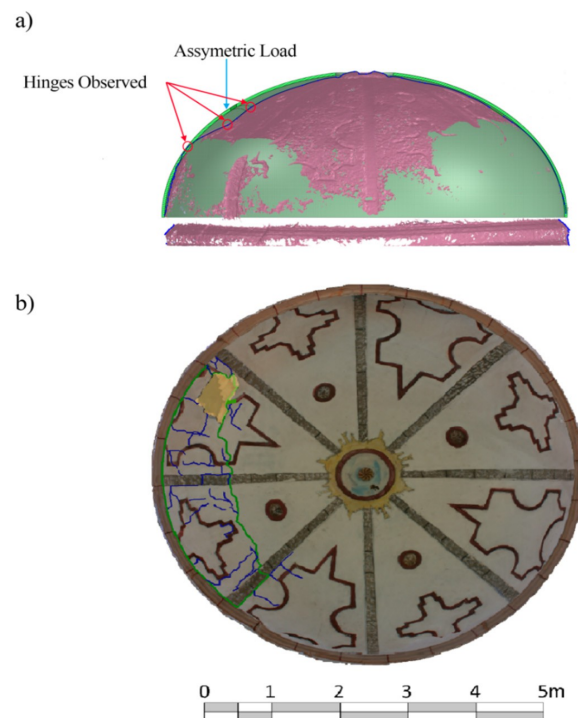
Figure 7. Results of the visual inspection over the different photogrammetric products: (a) Surface comparison between the initial proposed model and the most deformed one estimated by the SfM point cloud; (b) Damage inspection in the orthophoto, in green the main observed cracks, in blue the secondary cracks, in yellow the material removal.

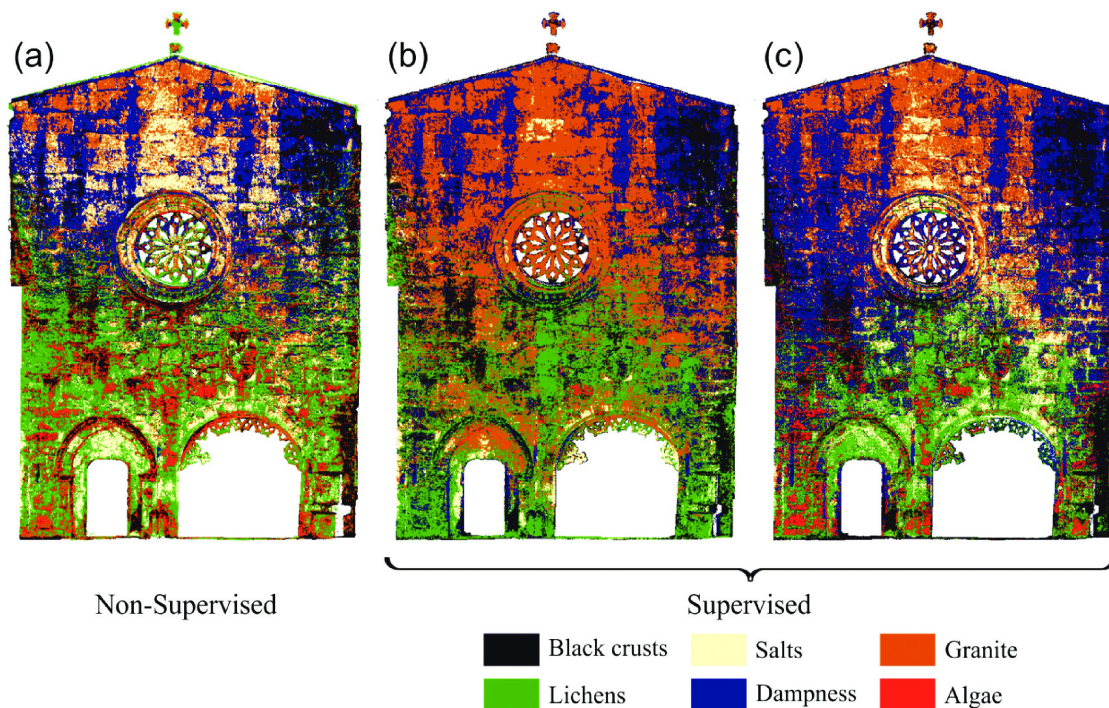
Figure 13.6 (a) Non supervised classification with merged classes. (b) Supervised classification with six channels. (c) Supervised classification with three channels (only active sensors).

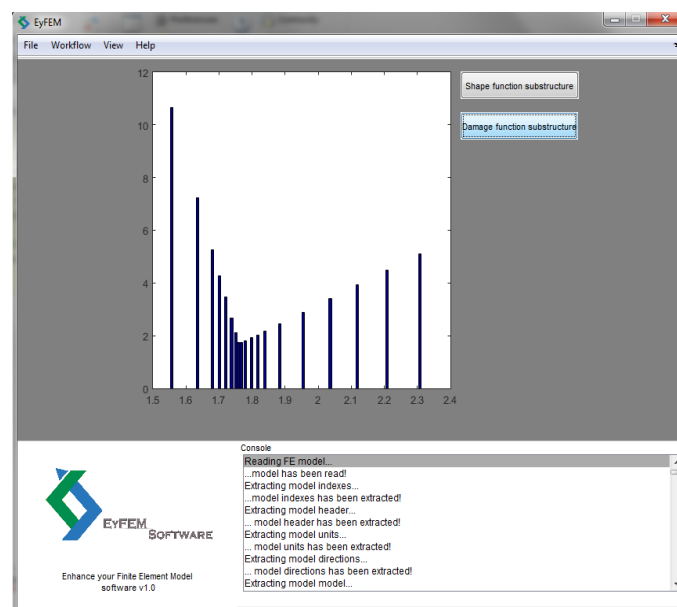
Figure 1. *EyFEM* interface
