Journal of Building Engineering

Analysis of structural integrity through the combination of non-destructive testing techniques in heritage inspections: The study case of San Segundo's hermitage (Ávila, Spain)

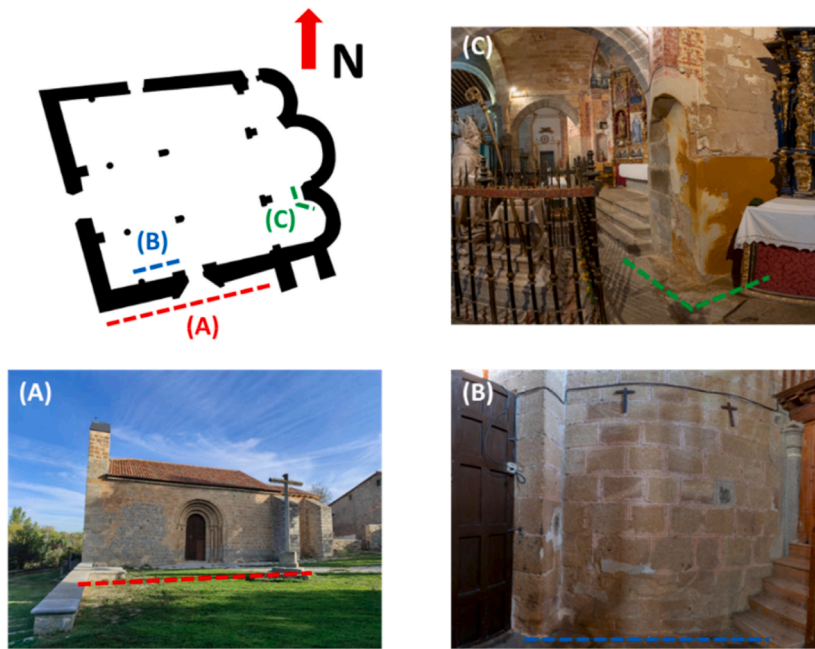
It is convenient to mention that the described methodology has been applied in two areas of the church. The first one, in the wall of the south façade (Fig. 8ab – orthogonal view of the interior and exterior of the wall) and the second in the lateral area of the altar, where a high degradation of the materials can be seen (Fig. 8c – side view). Each of these zones has been independently analyzed.

Fig. 8. (a) and (b) south façade wall, interior and exterior of the wall. (c) View of the altar.
