# Practical Use of Multispectral Techniques for the Detection of Pathologies in Constructions

*L.J. Sánchez-Aparicio, S. Del Pozo, P. Rodríguez-González,  
J. Herrero-Pascual, A. Muñoz-Nieto and D. González-Aguilera*

### Abstract

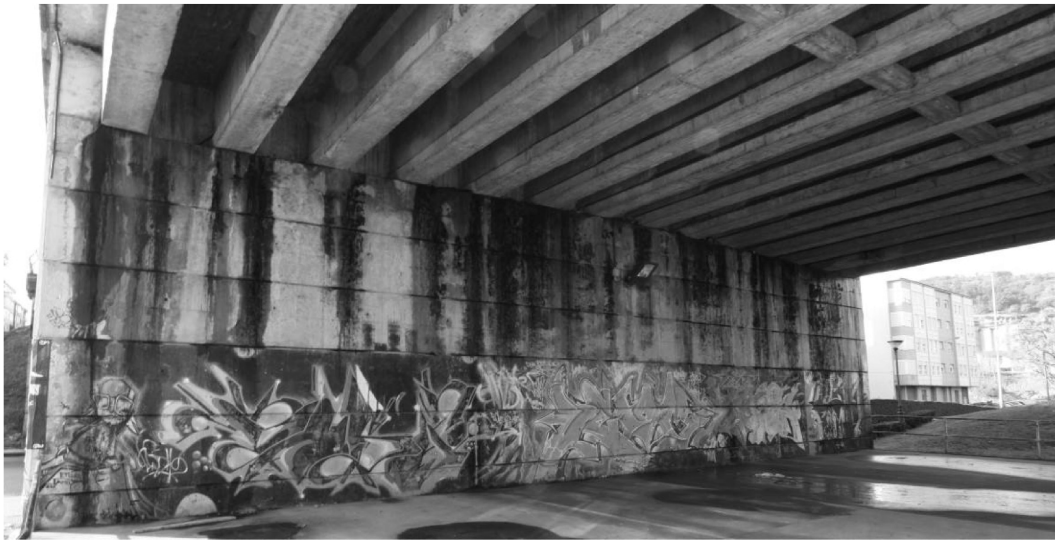
Figure 13.2 Pier of the Ribeiriño bridge.

Located in Ourense county (northern Spain), Ribeiriño bridge (Fig. 13.2) is a key to the communication network between the cities of Santiago of Compostela and Madrid (capital and largest city of Spain). Predominantly built in reinforced and pre-stressed concrete (arc, abutments, bearings and piers) following the Spanish standard EH-68 (Ministerio de Fomento 1968). The construction entered in service in 1971.
